Non-Compliance Event 14-day Report

NCE Ref	CRRDA-NCE-TSD -002	NCE Ref (DA)	CRRDA-003
Reported by	Delivery Authority	Date Reported to CG	21 April 2020 (note: a 7-day extension was agreed to by the Coordinator-General)
Date, time and location of event	Inspection completed at the Boggo Road worksite on 19 February 2020 and 27 March 2020. NCE Notification 31 March 2020.		
Short description of the Event	<p>The relevant project works for the Boggo Road worksite are operating under a Construction Environmental Management Plan (CEMP) (Rev 3) and sub-plans which included an Erosion and Sediment Control (ESC) Sub-plan. In accordance with Imposed Condition 18, this sub-plan must also be consistent with the Guidelines for Best practice Erosion and Sediment Control (International Erosion and Sediment Control Association, 2008) (IECA, 2008). These management plans have been reviewed and endorsed by the Project's approved Environmental Monitor (EM).</p> <p>In accordance with IECA, 2008, site specific ESC design (Site Establishment Works and Piling Works – 8.01.2020) was prepared for this phase of construction works to manage site runoff from changing groundcover, landform, gradients and site dra

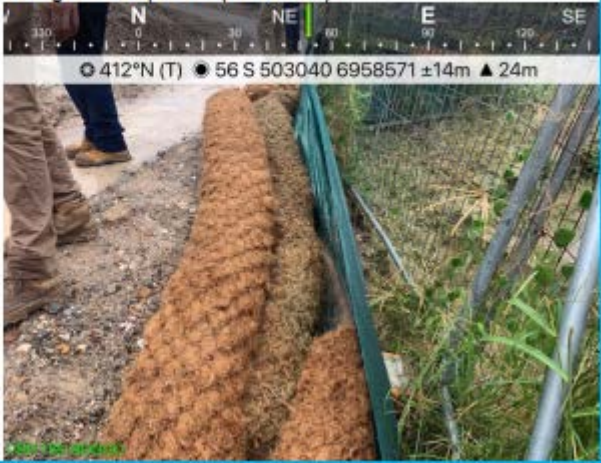
NCE Ref	CRRDA-NCE-TSD -002	NCE Ref (DA)	CRRDA-003
	<p>BOGGO</p>

NCE Ref	CRRDA-NCE-TSD -002	NCE Ref (DA)	CRRDA-003
	BOGGO	<p>Stormwater drain not installed as per ESCP. Dimensions are not as described within additional design detail (email CK 11 Feb). A clearly defined channel is not evident, it is not clear how this matches the as-built channel base of 1.5m. Sed fence damaged.</p>  	
	BOGGO	<p>QR corridor access road across main drainage channel, without adequate boundary ESC measures. The main drainage channel was occluded with potential to cause over-topping and escape of stormwater past internal ESC controls.</p>

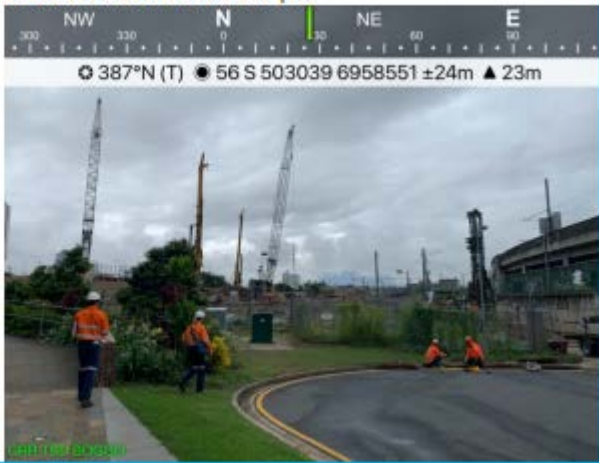
NCE Ref	CRRDA-NCE-TSD -002	NCE Ref (DA)	CRRDA-003
	<p>BOGGO</p> <p>Maintenance of ESC measures at stormwater pit immediately downstream of site's final sed pit.</p>

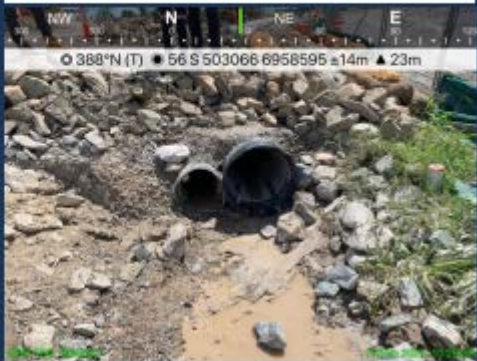
Additional actions to be undertaken (and timeframes for completion)	<p>Rectification work was undertaken, refer to site photos below.</p> <div> <div> <p>South eastern quadrant</p>

</div> <div> <p>Additional larger flume pipe installed (post 12 Feb inspection) next to previous smaller original pipe.</p> </div> </div> <div> <div> <p>South eastern quadrant</p>

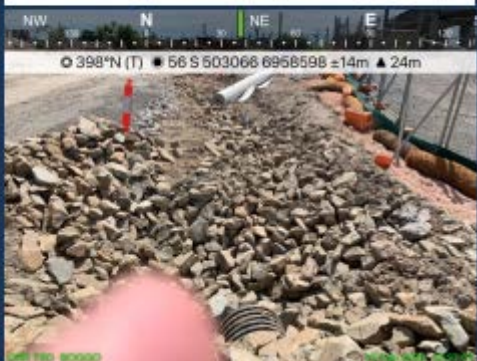
</div> <div> <p>Looking upstream. Newly installed drainage channel upstream of flume and vehicle crossing to replace previous undersize channel.</p> </div> </div>

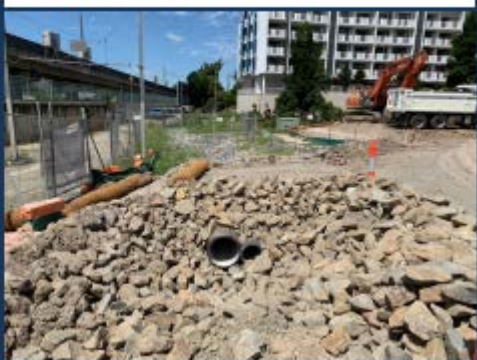
NCE Ref	CRRDA-NCE-TSD -002	NCE Ref (DA)	CRRDA-003
	<p>South eastern quadrant</p>

<p>Looking downstream. Newly installed drainage channel upstream of flume and vehicle crossing to replace previous undersize channel.</p>	
	<p>In addition to the above measures, the site is still changing as the construction program progresses. The Delivery Authority has requested that the Contractor undertake regular reviews at a frequency to ensure changes to site conditions can be captured and suitable controls installed as more areas become hard standing, slope changes and other opportunities arise to minimise clean water entering site (such as rainwater runoff from the site office roofs and hard standing areas).</p> <ul style="list-style-type: none"> • Site Erosion and Sediment Control design to be reviewed and updated on an ongoing basis to ensure all changes to site conditions have been captured and suitable erosion and sediment controls nominated. • Site supervisor to be fully briefed on the Erosion and Sediment Control Plan and ESC design. • Site supervisor to perform daily checks of vulnerable areas for ESC maintenance (i.e. especially around stormwater drains) and ensure the ESC design is implemented. <p>Actions completed by 29.05.2020</p> <ul style="list-style-type: none"> • Provision of Erosion and Sediment Control Plan (ESCP) which reflects the current site conditions and has been certified by a Certified Professional in Erosion and Sediment Control (CPESC). • Confirmation that the nominated erosion and sediment controls are implemented on site.
