## Non-Compliance Event 14-day Report

| NCE Ref | CRRDA-NCE-TSD -001 | NCE Ref (DA) | CRRDA-002 | |

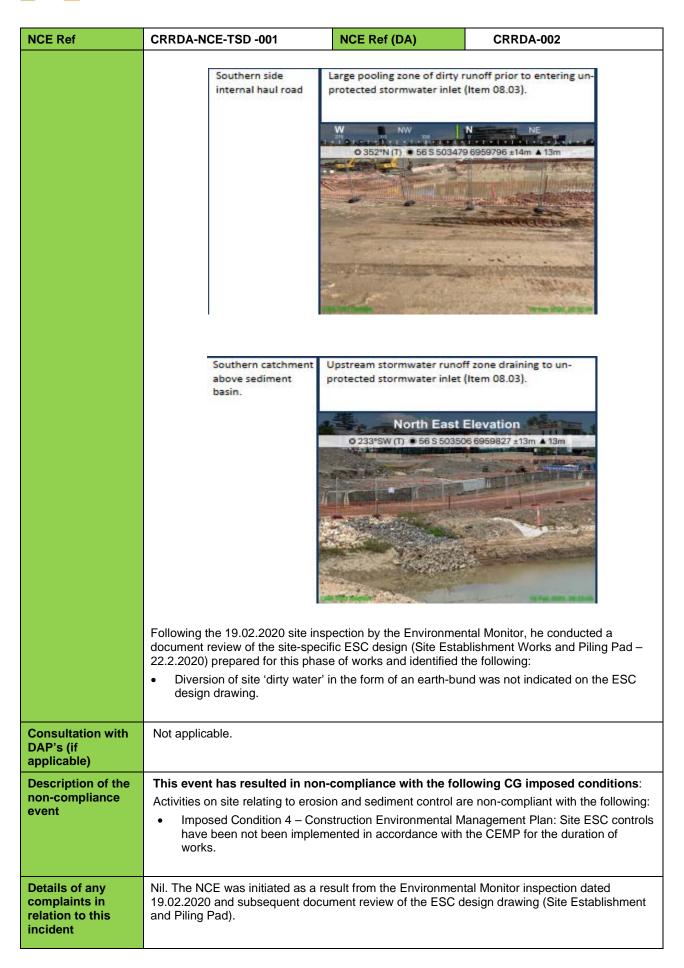
| NCE Ref | CRRDA-NCE-TSD -001 | NCE Ref (DA) | CRRDA-002 | |
|---|---|---|--|--|
| | <ol> <li>Based on evidence of site scouring, it was identified that overland flow had left the site through a damaged erosion and sediment control device, earth-bund, and entered a stormwater inlet.</li> <li>Following review of the ESC design (Site Establishment Works and Piling Pad – 22.2.2020) prepared as part of the ESC sub-plan, it was identified that even though the earth-bund control had been constructed it was not included on the ESC design drawing.</li> </ol> | | | |
| | Southern side | Overland flow rilling by sedi | ment laden runoff | |
| | internal haul road | entering un-protected storm NW N 0 390°N (T) • 56 \$ 503478 | NE E | |

| NCE Ref | CRRDA-NCE-TSD -001 | ICE Ref (DA) | CRRDA-002 | | |
|--|---|--|--|--|--|
| Root cause of non-compliance | <ul> <li>The erosion and sediment controls not properly maintained which allowed site water to travel to open drain.</li> <li>The ESC design drawing had not captured all latest site conditions and had not nominated</li> </ul> | | | | |
| | an erosion and sediment control for this location within the worksite. | | | | |
| Description of environmental effects and impacts | Site water (unknown quality) entered stormwater inlet on site during a rain event breaking through bunding that wasn't repaired following the disturbance from plant and equipment moving along the haul road. | | | | |

| NCE Ref | CRRDA-NCE-TSD -001 | ICE Ref (DA) | CRRDA-002 | | |
|--|---|--|--|--|--|
| Actions already undertaken to mitigation environmental effects of this NCE | Update of ESC design drawing to reflect site condition and inclusion of additional erosion and sediment control for this location, i.e. earth-bund. | | | | |
| Additional actions to be undertaken (and timeframes for completion) | <ul> <li>Site Erosion and Sediment Cont basis to ensure all changes to si and sediment controls nominate</li> <li>Site supervisor to be fully briefed design.</li> <li>Site supervisor to perform daily especially around stormwater dr</li> <li>Completed actions by 29.05.2020</li> <li>Provision of Erosion and Sedime conditions and has been certified Control (CPESC).</li> </ul> | trol design to be review the conditions have be d. If on the Erosion and Street checks of vulnerable a ains) and ensure the left control Plan (ESC) d by a Certified Profes | Sediment Control Plan and ESC areas for ESC maintenance (i.e. ESC design is implemented. | | |
