Cross River Rail Project

Monthly Environmental Report

January 2020

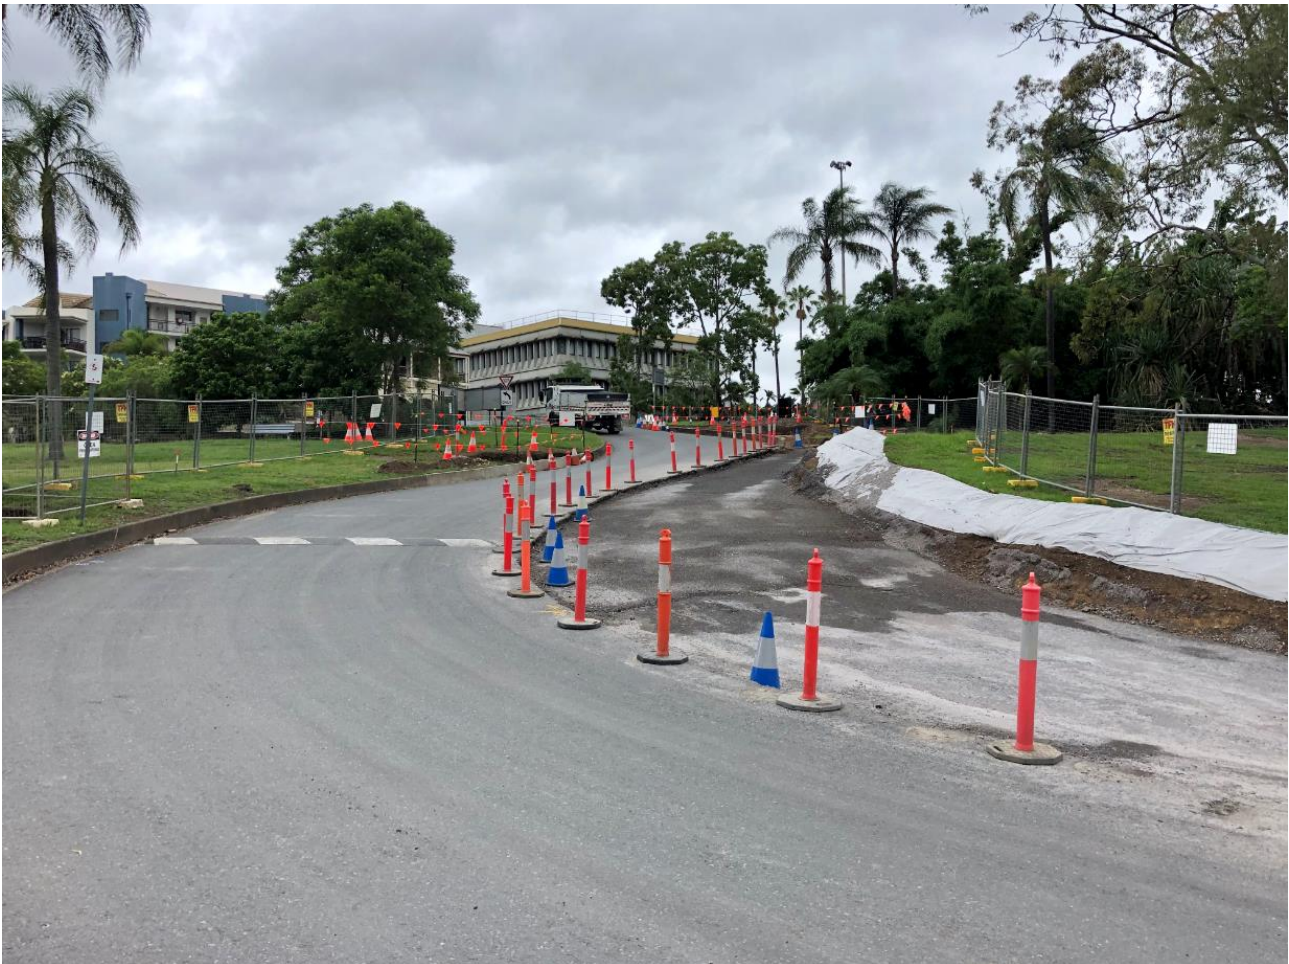
Plate 1: Widening of the Victoria Park Access Road, off Gregory terrace, Spring Hill

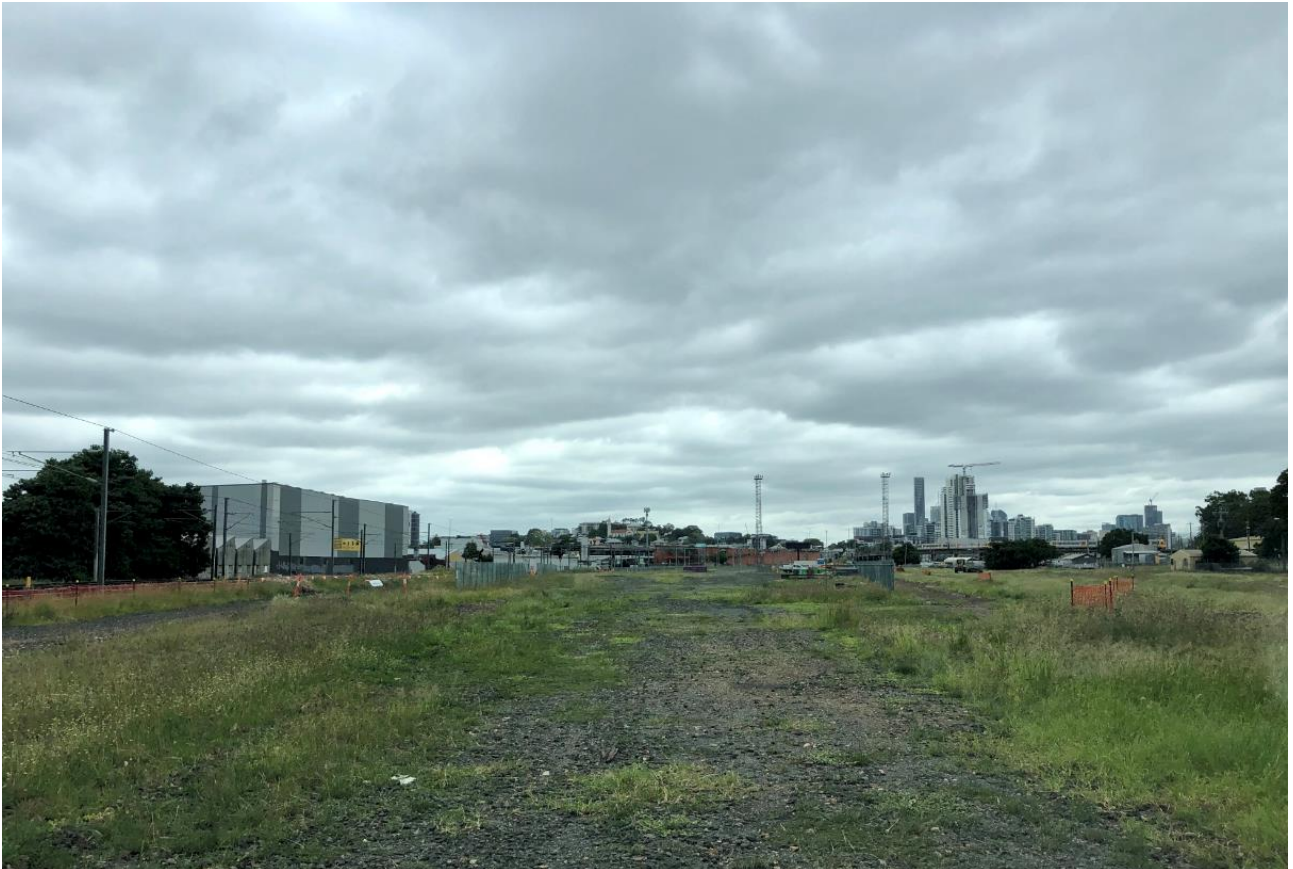
Plate 2: View of Mayne Yard North Facing South, Albion

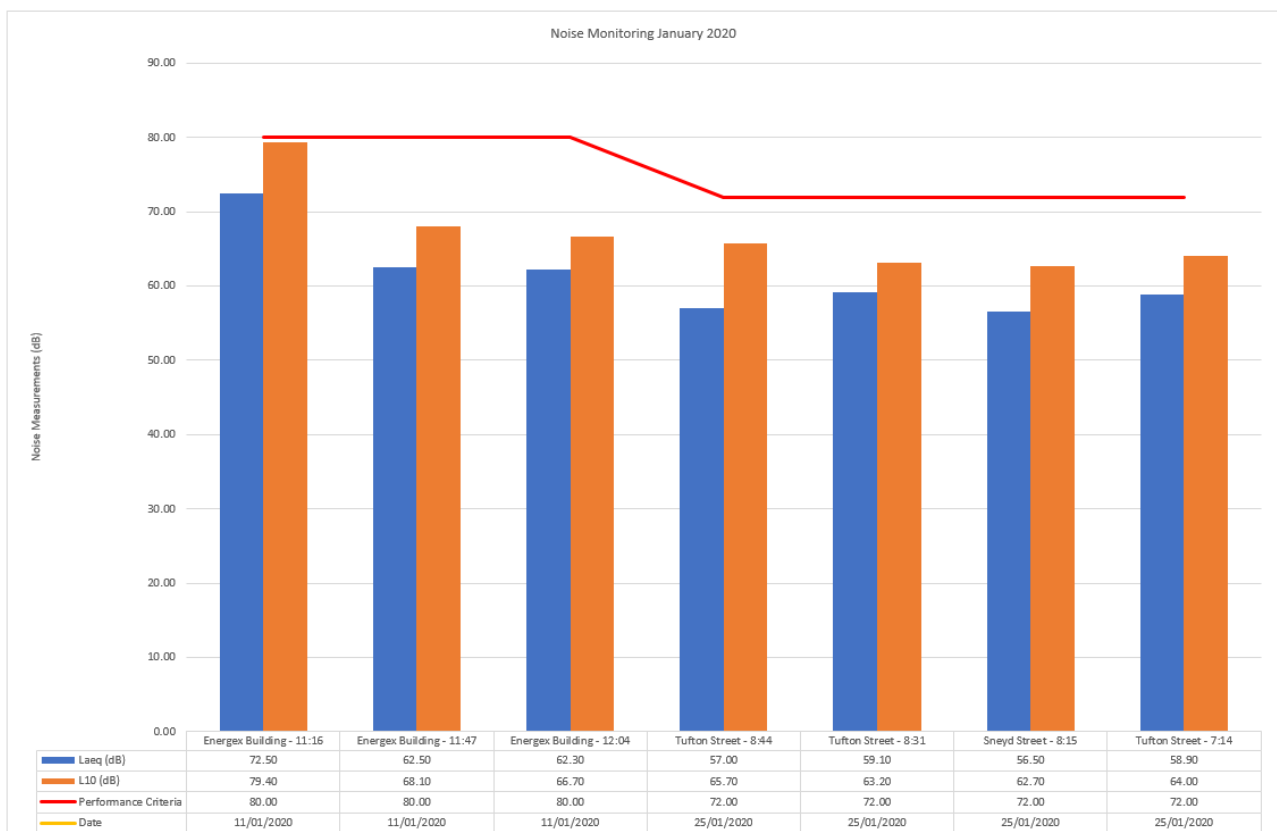
4.1.2 Noise monitoring Results

- The demolition of the QR Shed within the Rail Corridor and the BTS building near the Energex Office (relevant receiver) and,
- The Concrete sawing associated with the demolition of the Cattle Overpass in the Rail Corridor at the Brisbane Exhibition Grounds (RNA). Monitoring was undertaken along Tufton Street high-rise residential development (relevant receiver).

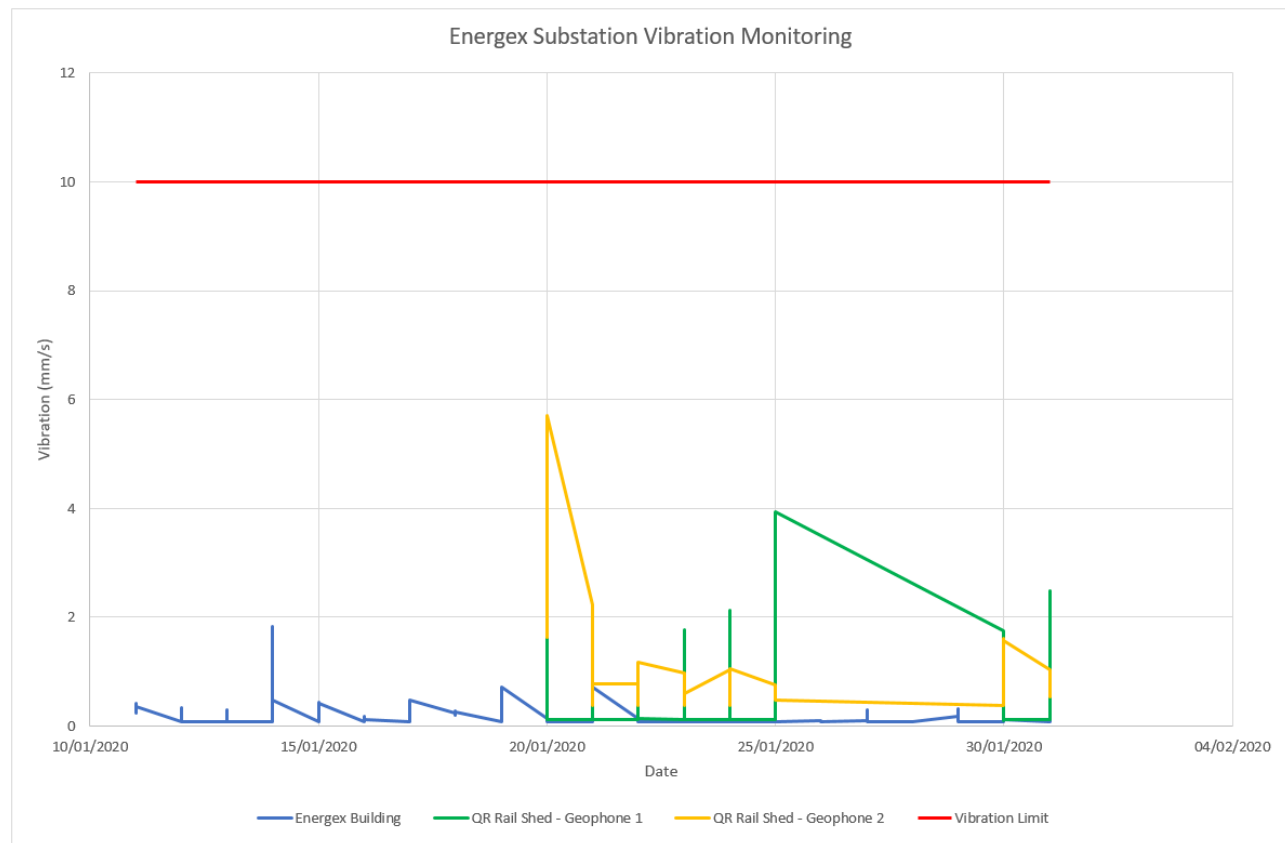
4.1.4 Vibration Monitoring Results

Energex confirmed with the project team the substation could sustain vibrations up to 10mm/s before actions would require to be taken.

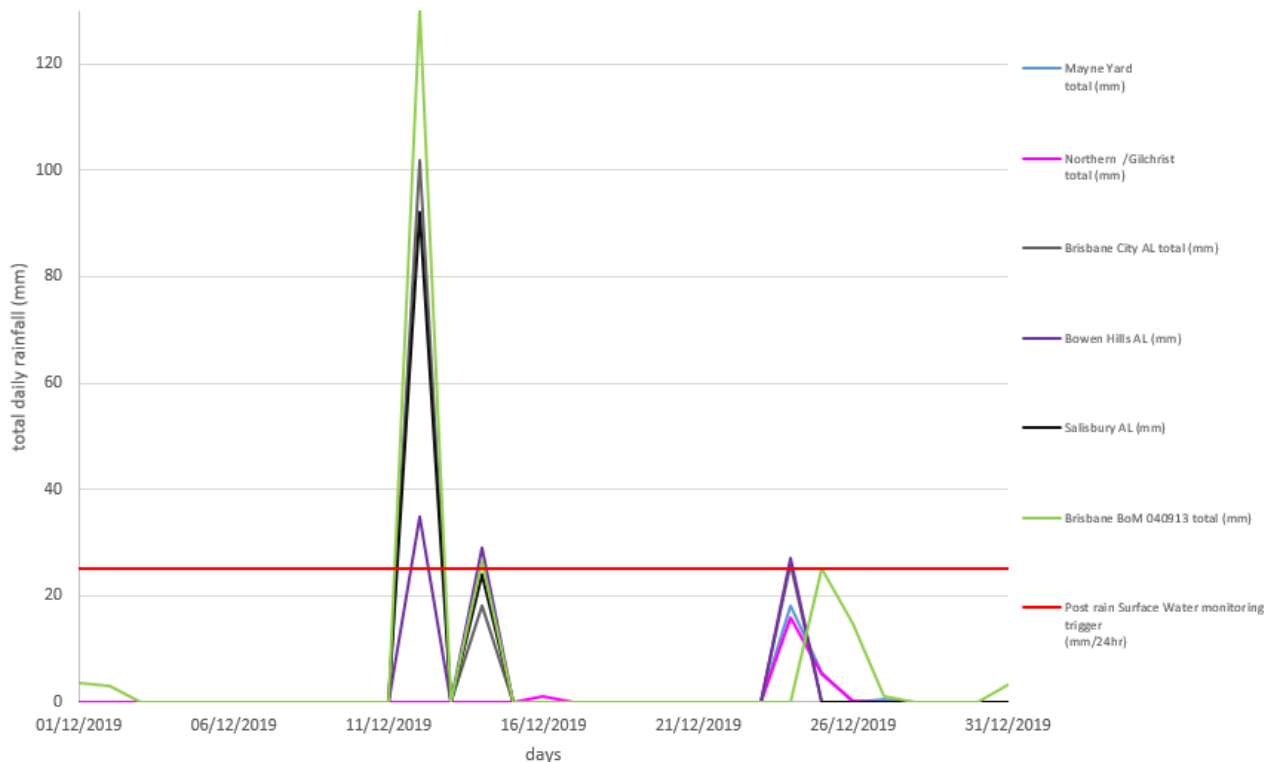
Rainfall records - December 2019

Between December 2019 and January 2020, Unity undertook five (5) surface water sampling rounds. Three rounds consisted of background conditions monitoring. Two rounds consisted of post rain events monitoring.

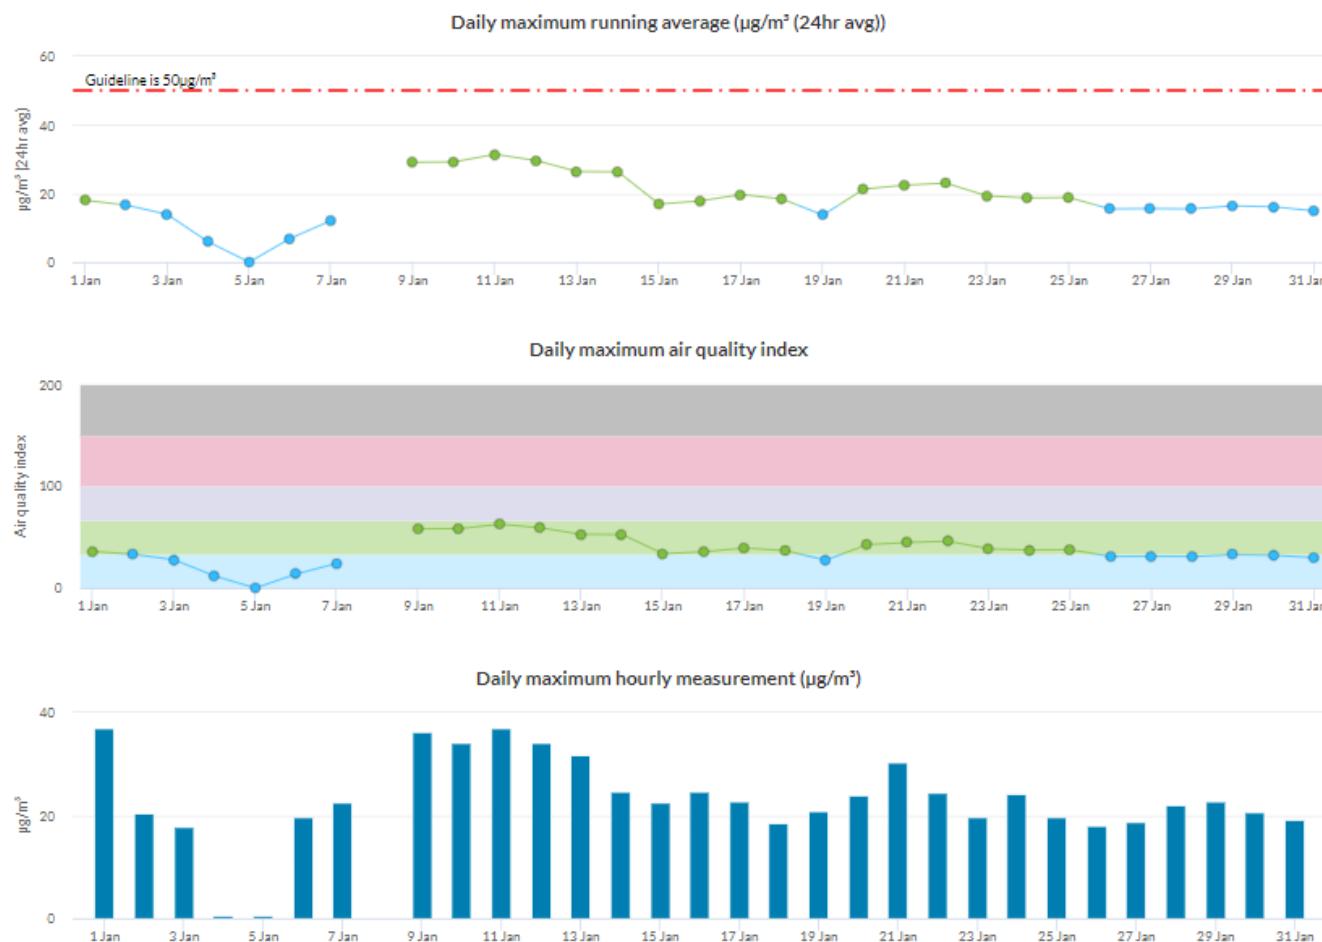
The guideline for Particle PM₁₀ is 50µg/m³ (24hr avg).

Figure 1: Brisbane CBD – DES Station - PM₁₀ graph for January 2020 (reproduction from the DES website accessed February 2020)

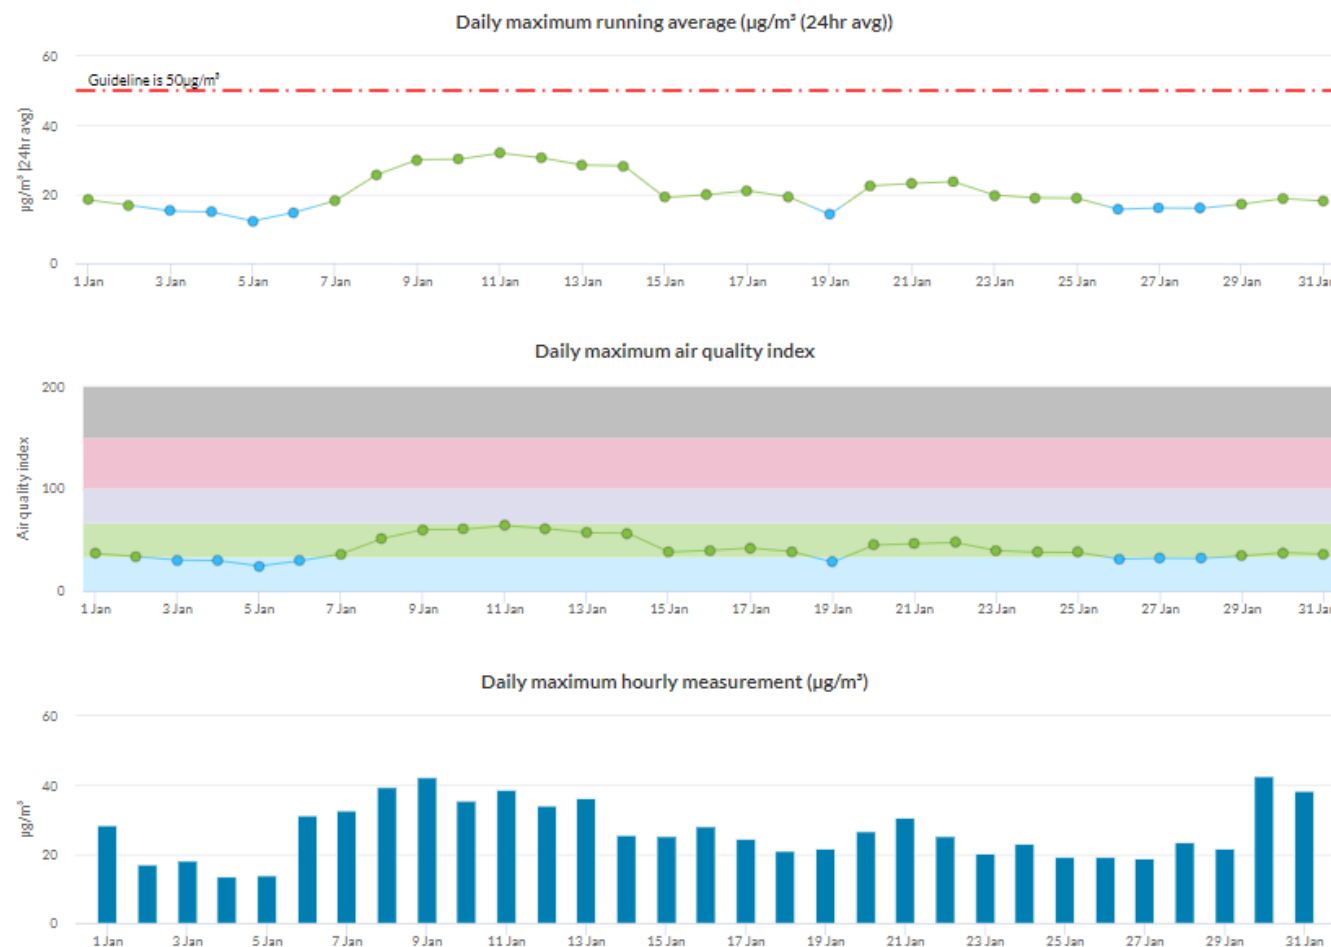
The guideline for Particle PM₁₀ is 50µg/m³ (24hr avg).

Figure 2: South Brisbane – DES Station - PM₁₀ graph for January 2020 (reproduction from the DES website accessed February 2020)
