Cross River Rail Project

Monthly Environmental Report

March 2020

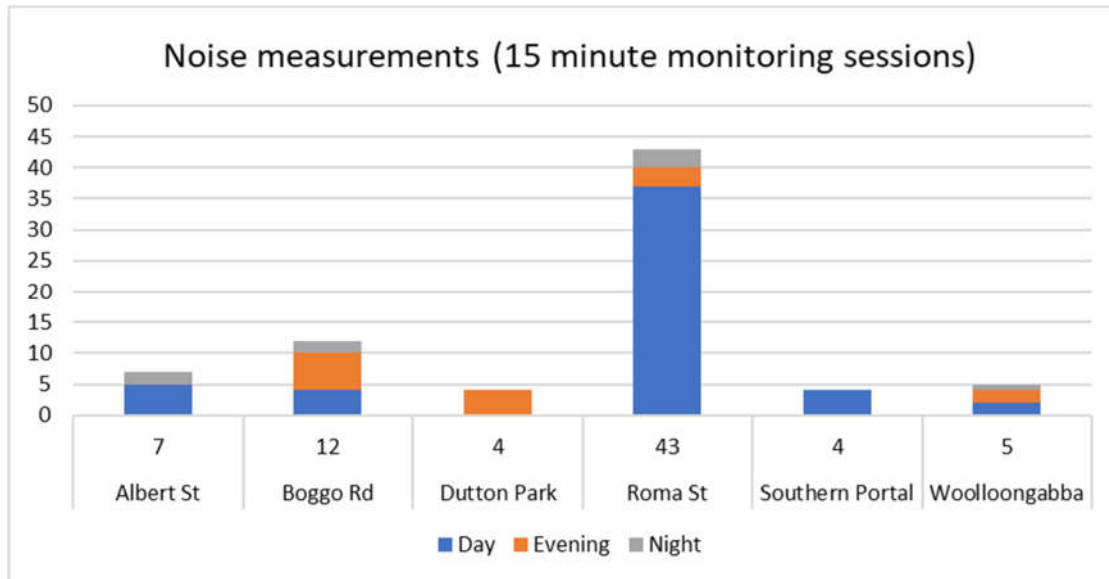
Noise monitoring was undertaken at the Albert Street, Boggo Road, Roma Street and Woolloongabba precincts as well as Dutton Park Station on seventy-one (71) occasions throughout the month, as summarised in the graph below and detailed in the appendices. The contractors indicate the project requirements were met on all occasions.

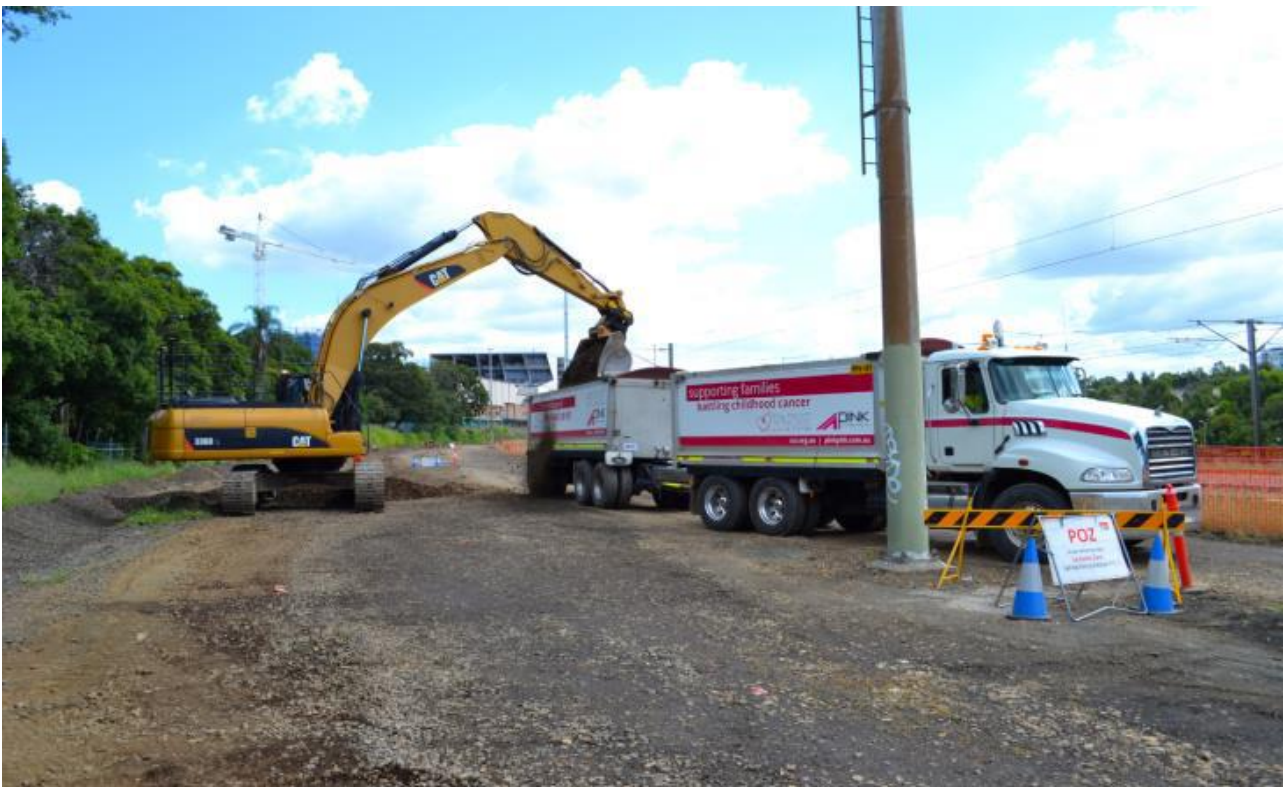
Plate 1: Normanby - Loadout of Unsuitable Material Offsite

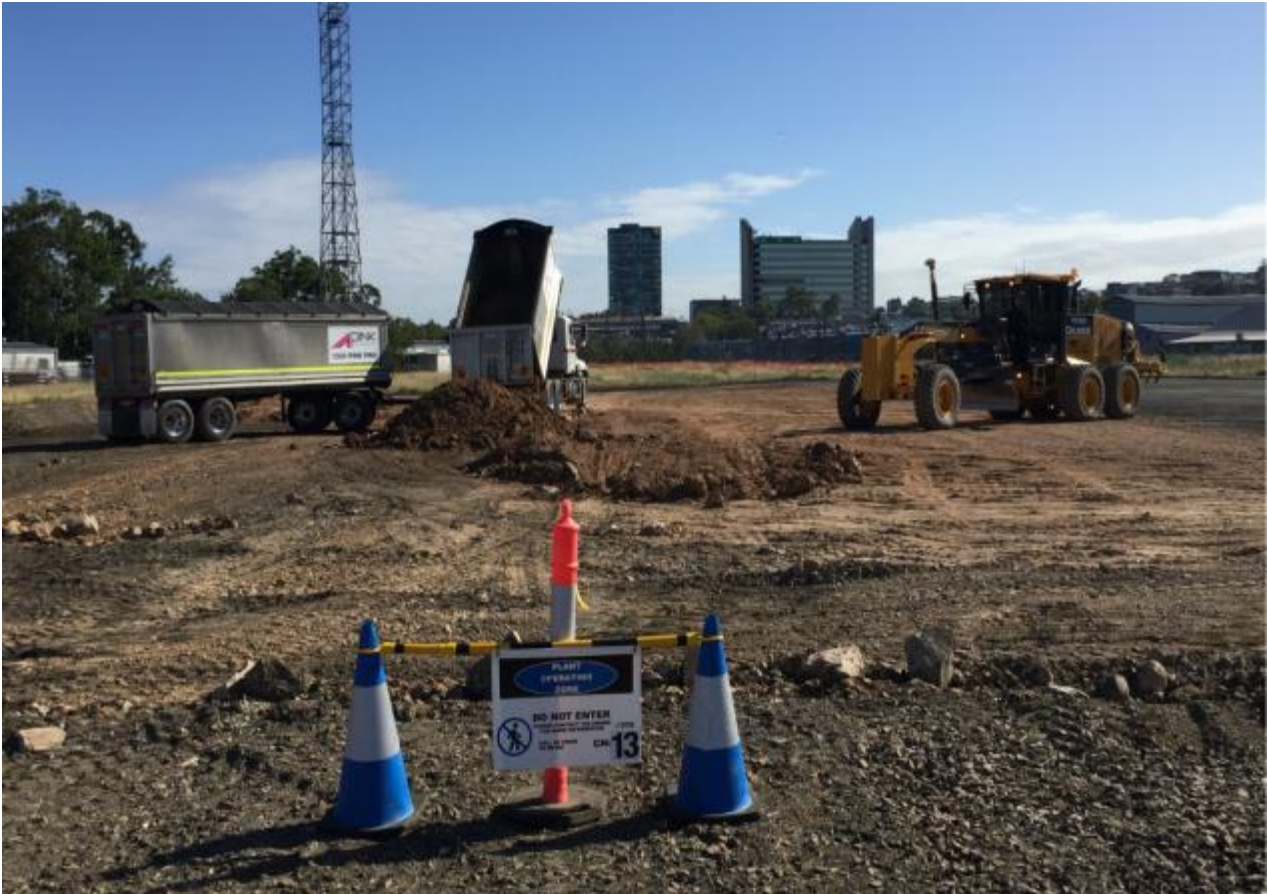
Plate 2: Mayne - Commencement of Preload Material Import

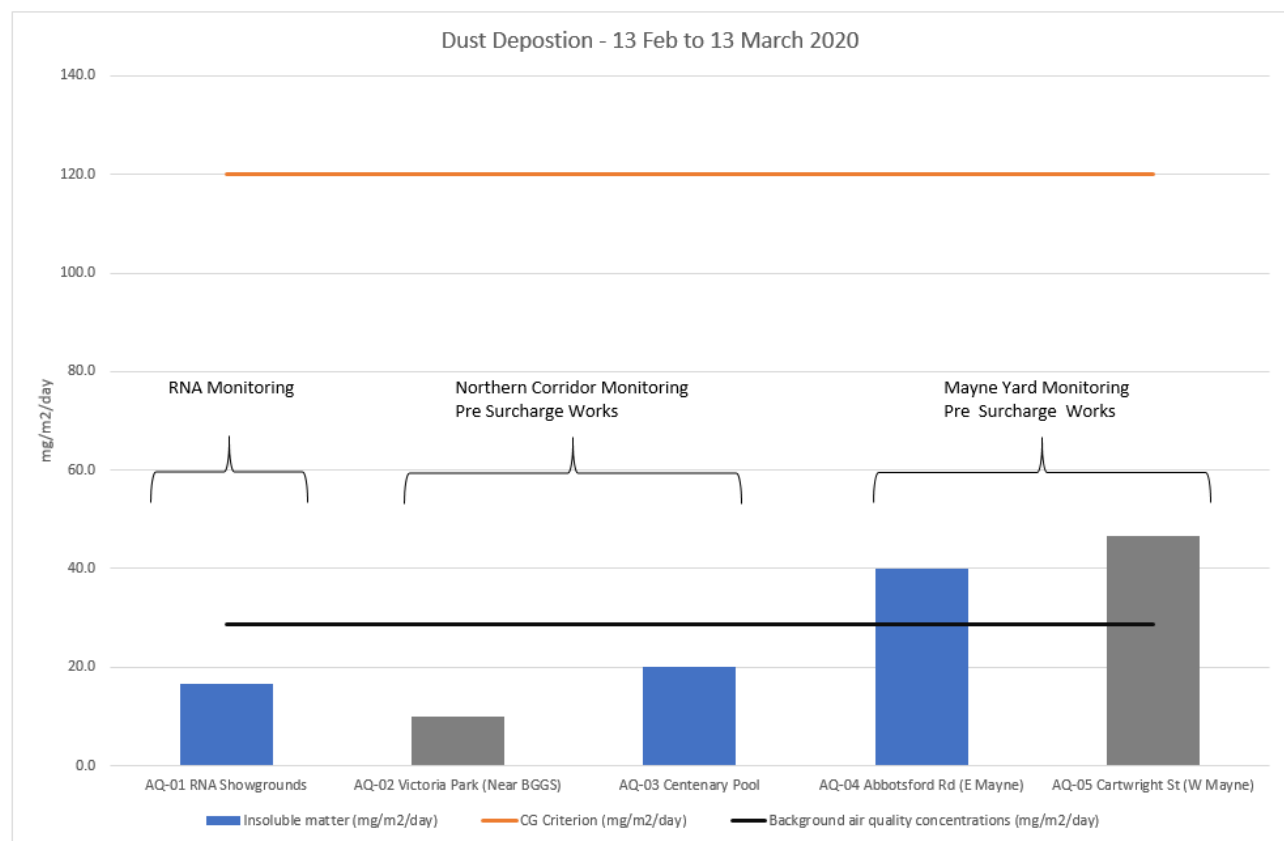
The dust deposition gauges result for the reporting period are detailed below and complied with Condition 13(b) of the CGCR.

Due to the wet weather during the monitoring period, the dust deposition gauge at AQ-05 overtopped. Therefore, the results are deemed invalid.

AQ-02 near BGGS was tampered with and the funnel was missing / stolen. Therefore, the results are deemed invalid. The DDG was subsequently moved inside the rail corridor to prevent further tampering

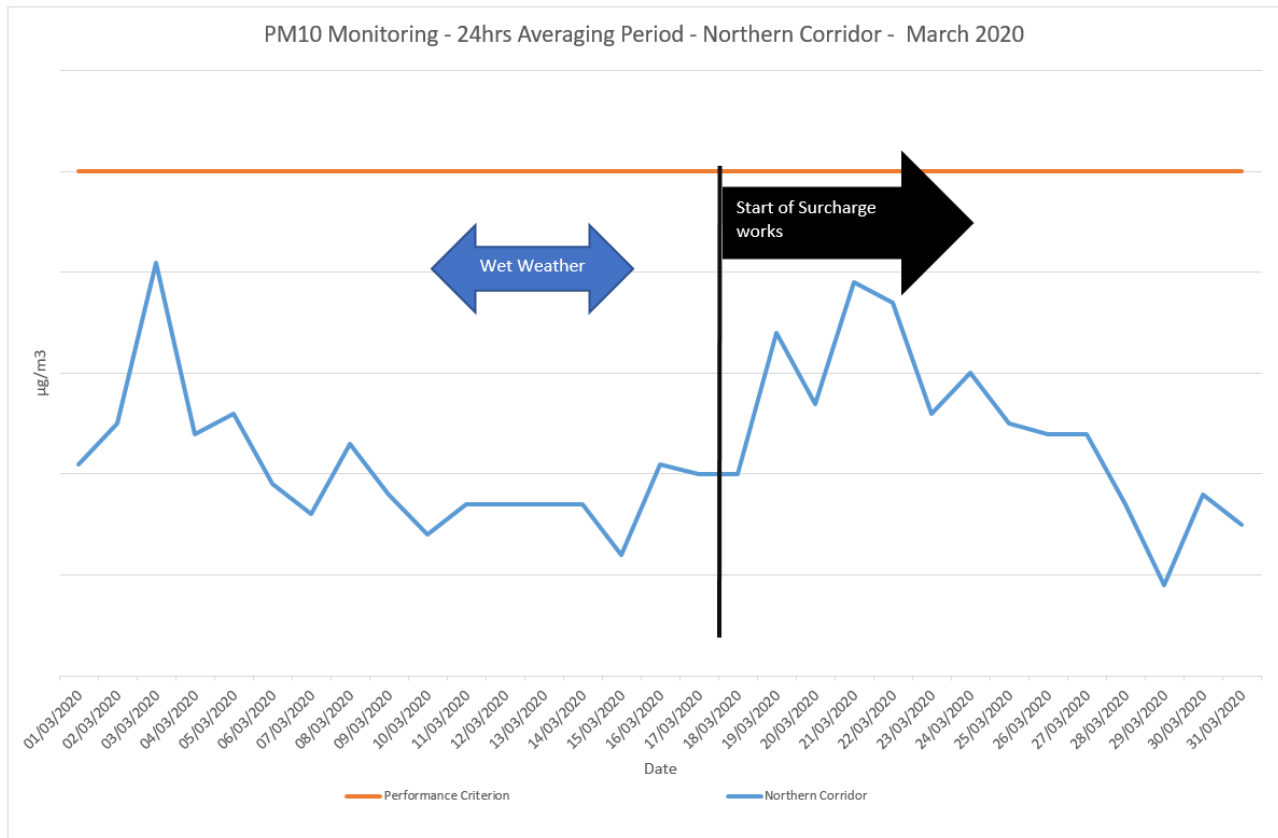
There were no exceedances recorded for the reporting period for PM₁₀ near the northern corridor.

Figure 1: PM10 Monitoring for the Northern Corridor - April 20 Results
