Cross River Rail Project

Monthly Environmental Report

April 2020

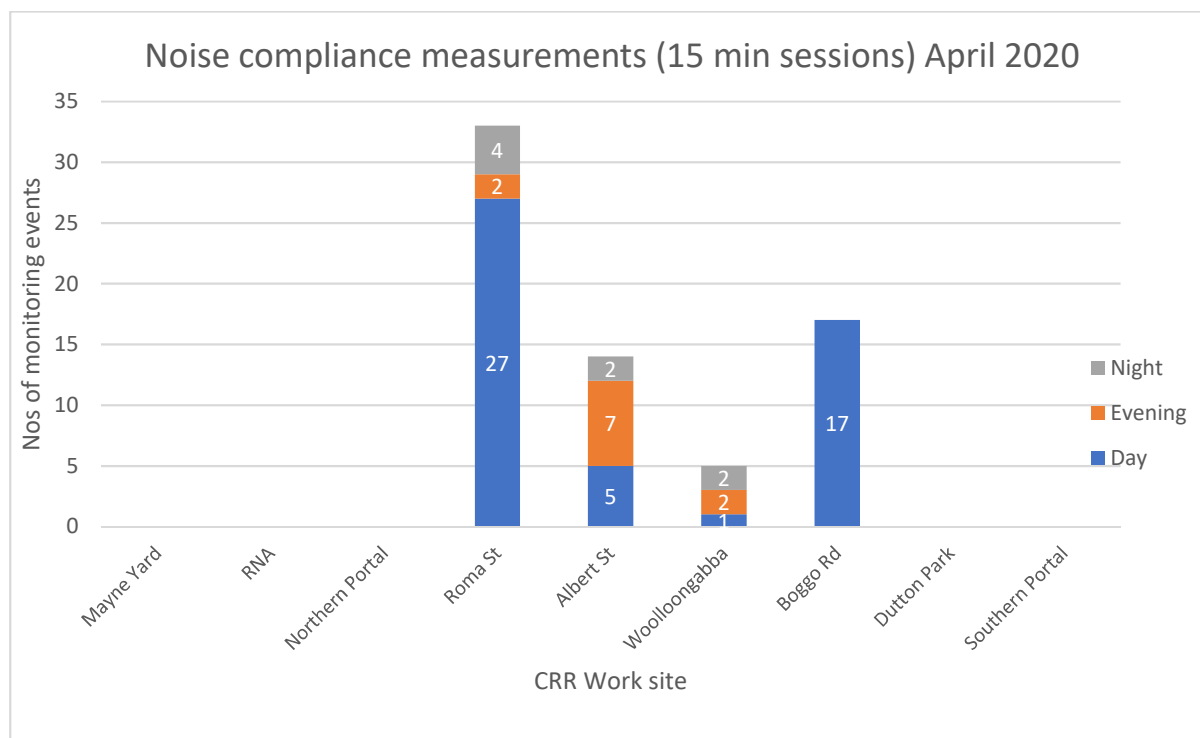
TSD undertook noise monitoring on 69 occasions during April as summarised in the graph below and detailed in **Appendix B**. Compliance monitoring was completed at the Albert Street, Boggo Road, Roma

Street and Woolloongabba worksites as well as Dutton Park Station. It should be noted that the noise goals have been nominated as internal levels. Where internal monitoring has not been possible for the contractors, they have undertaken external monitoring at nominated locations pending their work activities. The contractors noise consultants have then nominated suitable façade attenuation corrections, considering receiver property type, to determine compliance against the project’s noise goals and to provide further calibration of the completed modelled predictions. The contractors have reported that the project noise goals have been met during this reporting month.

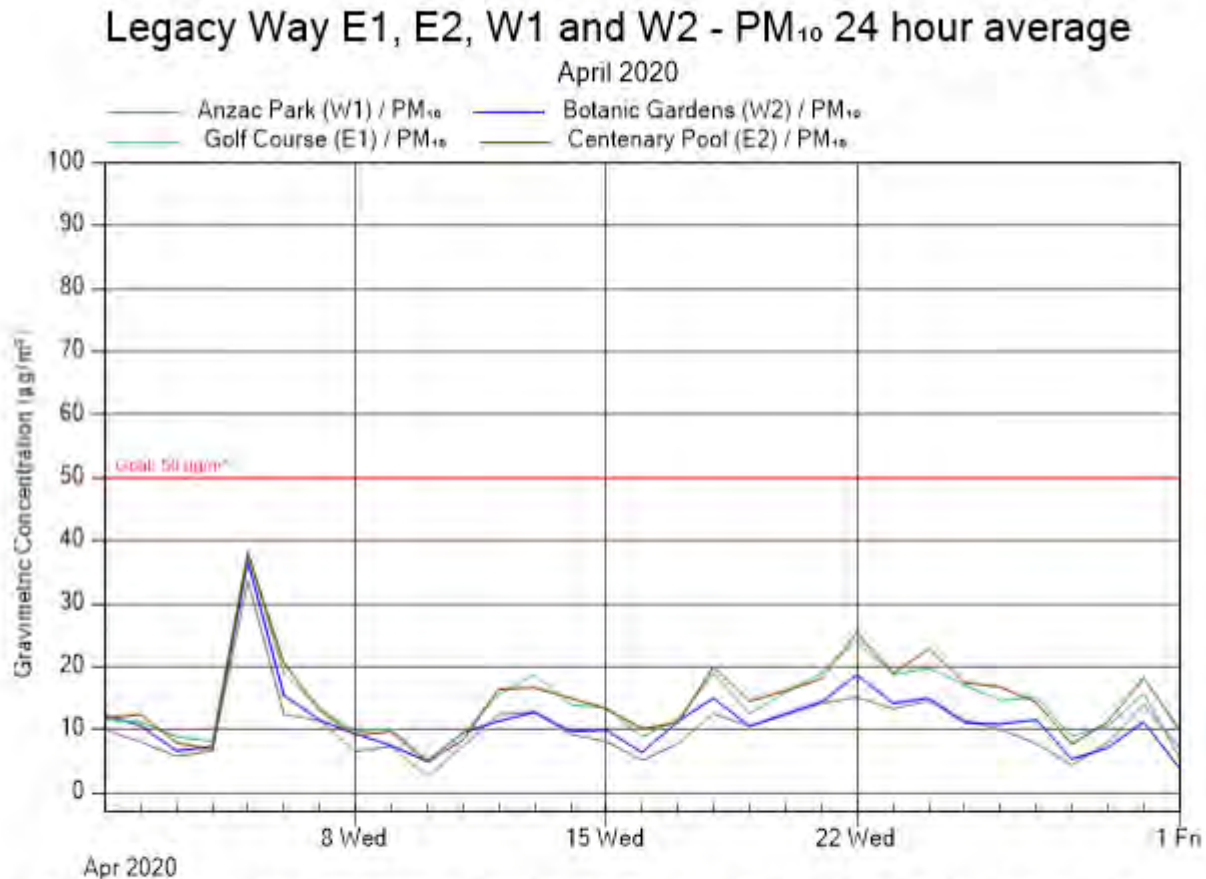
Figure 5: Transurban QLD Legacy Way (E1, E2, W1 and W2) - PM₁₀ graph for April 2020

There were no exceedances recorded for the reporting period for PM₁₀ near the northern corridor.

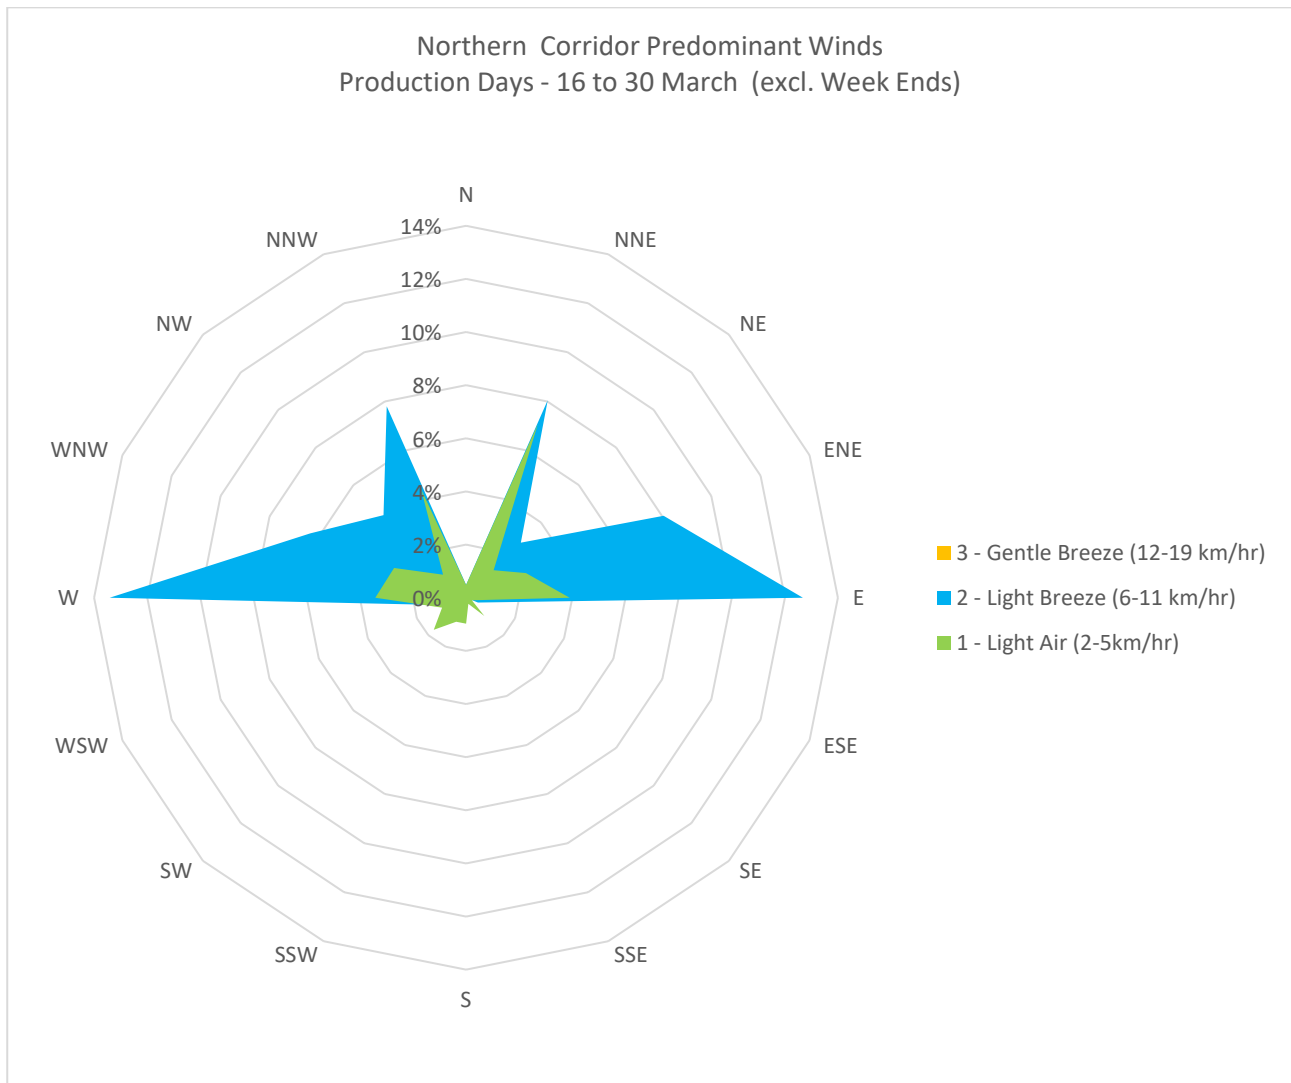
Plate 1: Prevalent Wind Conditions

- The prevalent wind conditions between 16 March and 30 March 2020 are presented in Plate 1 and summarised on Figure 5.
 - The winds were predominantly from the North-Eastern quadrant in the mornings, meaning AQ-02 dust deposition gauge was Upwind of the earthworks.
 - The winds were predominantly from the North Western quadrant in the afternoons meaning
 - AQ-02 dust deposition gauge was downwind of the haulage but not from the earthworks
 - AQ-03 dust deposition gauge was downwind of the earthworks
 - All the winds were deemed a light breeze under the Beaufort Scale.

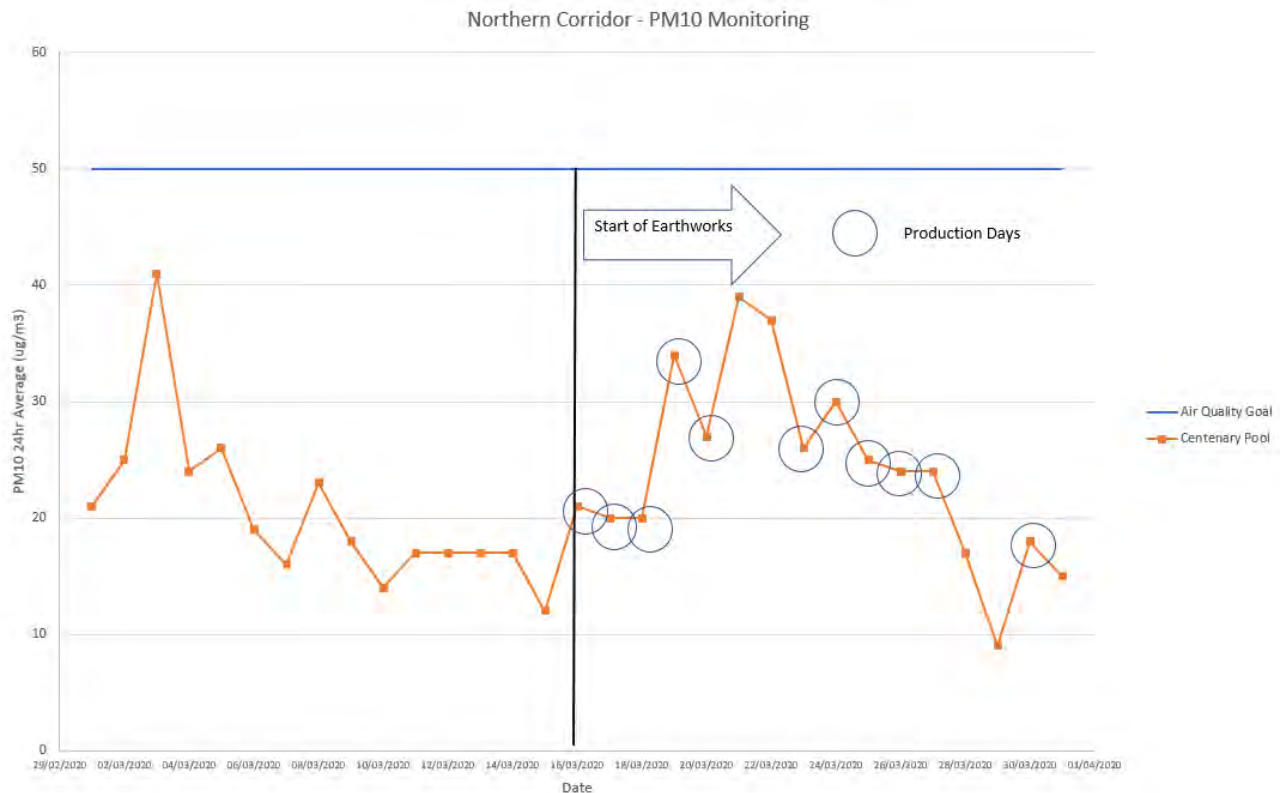
Figure 6: PM10 Results

- Field observations for visible dust during routine surveillance did not record visible dust beyond the project boundaries
- There were nil complaints related to air quality within the Northern Corridor Air Shed during the monitoring period.
- Other available data were
 - The results from the dust deposition gauge AQ-02, the closest to the works and typically downwind of the earthworks in the afternoons, did not exceed the Deposited Dust Air Quality Goal (120 mg/m²/day) with a reading of 47 mg/m²/day.
 - There was no recorded exceedance of the daily PM₁₀ Air Quality Goal during the days of earthworks.
 - The highest PM₁₀ results were recorded when no earthworks activities were being undertaken. The results have been reproduced below in Figure 6.

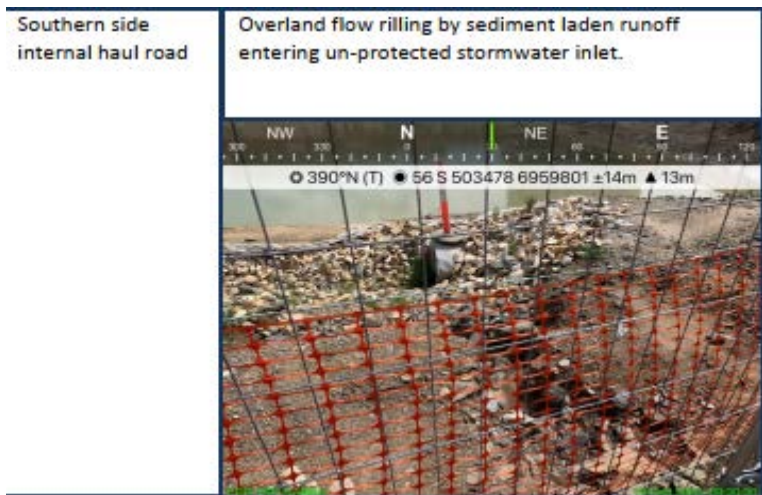
Circumstances under which the non-compliance event occurred (include activity being undertaken, predictive modelling, monitoring etc)	<p>The Woolloongabba worksite has been undergoing regular change in type of groundcover, landform, gradients and site drainage as a result of ongoing civil works within the site. During a site inspection completed by the Environmental Monitor on 19/02/202, he observed through site scouring, that overland flow had left the site through a damaged erosion and sediment control (earth-bund) and entered into a stormwater inlet. Refer to photos below captured on the day of the inspection which formed part of the Environmental Monitor Inspection Record (19/02/2020).</p> <p>19 February 2020 - Environmental Monitor Inspection Report.</p> <div data-bbox="533 1554 1299 2047" data-label="Image">

NCE Ref	CRRDA-NCE-TSD -001	NCE Ref (DA)	CRRDA-002
Root cause of non-compliance	<ul style="list-style-type: none"> The erosion and sediment controls not properly maintained which allowed site water to travel to open drain. The ESC design drawing had not captured all latest site conditions and had not nominated an erosion and sediment control for this location within the worksite. 		
Description of environmental effects and impacts	Site water (unknown quality) entered stormwater inlet on site during a rain event breaking through bunding that wasn't repaired following the disturbance from plant and equipment moving along the haul road.		
Was sampling or monitoring performed in relation to this event? (if so attach results)	No. Visual observation by the Environmental Monitor only.		
Actions already undertaken to mitigation environmental effects of this NCE	Update of ESC design drawing to reflect site condition and inclusion of additional erosion and sediment control for this location, i.e. earth-bund.

Additional actions to be undertaken (and timeframes for completion)	<p>The Delivery Authority will continue to work with the Contractor to seek the following outcomes:</p> <ul style="list-style-type: none"> Site Erosion and Sediment Control design to be reviewed and updated on an ongoing basis to ensure all changes to site conditions have been captured and suitable erosion and sediment controls nominated. Site supervisor to be fully briefed on the Erosion and Sediment Control Plan and ESC design. Site supervisor to perform daily checks of vulnerable areas for ESC maintenance (i.e. especially around stormwater drains) and ensure the ESC design is implemented. <p>Completed actions by 29.05.2020</p> <ul style="list-style-type: none"> Provision of Erosion and Sediment Control Plan (ESCP) which reflects the current site conditions and has been certified by a Certified Professional in Erosion and Sediment Control (CPESC). Confirmation has been received that the nominated erosion and sediment controls are implemented on site.

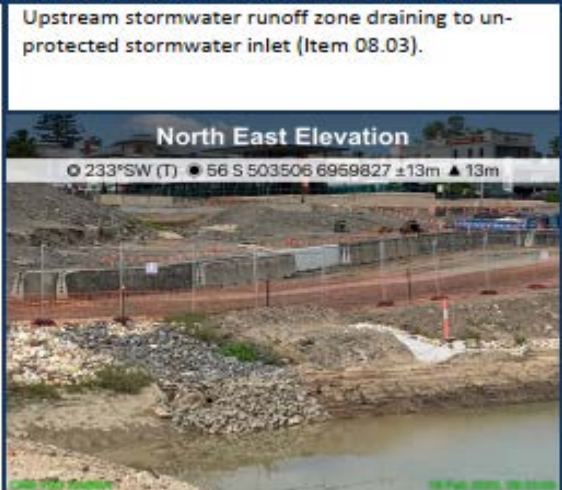
</div> <div> <p>Southern catchment above sediment basin.</p>

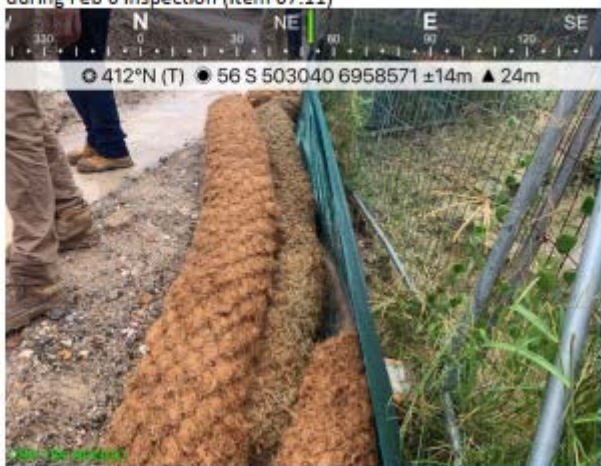
NCE Ref	CRRDA-NCE-TSD -002	NCE Ref (DA)	CRRDA-003
	<p>BOGGO</p>

NCE Ref	CRRDA-NCE-TSD -002	NCE Ref (DA)	CRRDA-003
	BOGGO	Stormwater drain not installed as per ESCP. Dimensions are not as described within additional design detail (email CK 11 Feb). A clearly defined channel is not evident, it is not clear how this matches the as-built channel base of 1.5m. Sed fence damaged.	 
	BOGGO	QR corridor access road across main drainage channel, without adequate boundary ESC measures. The main drainage channel was occluded with potential to cause over-topping and escape of stormwater past internal ESC controls.

<p>Boundary perimeter sediment fence requires maintenance, visible gap allowing stormwater release. This item was observed during Feb 6 inspection (Item 07.11)</p>		
	<p>As part of the investigation into the failing of the erosion and sediment controls on the site a number of minor errors in the RUSLE calculations (such as gradient of the site) were also identified which led to incorrect outputs and nomination of controls. These design calculations have been revised and included in the next ESC design drawings.</p>		
Consultation with DAP's (if applicable)	Not applicable.		
Description of the non-compliance event	<p>This event has resulted in non-compliance with the following CG imposed conditions:</p> <p>Activities on site relating to erosion and sediment control are non-compliant with the following:</p> <ul style="list-style-type: none"> Imposed Condition 4 – Construction Environmental Management Plan: Site ESC controls have been not been implemented in accordance with the CEMP for the duration of works.

Proposed actions to prevent reoccurrence of the NCE (include responsibility and timeframes)	<p>Preventative Actions</p> <ul style="list-style-type: none"> • The Delivery Authority will encourage the Contractor to carry out Lessons Learned toolbox talks to other Environmental Advisors and Site Supervisors across the project worksites and to include in daily site briefings, especially during wet weather. 		
Report completed by	The Delivery Authority with advice from the Environment Monitor		
Completion statement	Erosion and Sediment Control plan finalised with nominated sediment controls implemented. NCE closed.
