Cross River Rail Project

Monthly Environmental Report

June 2020

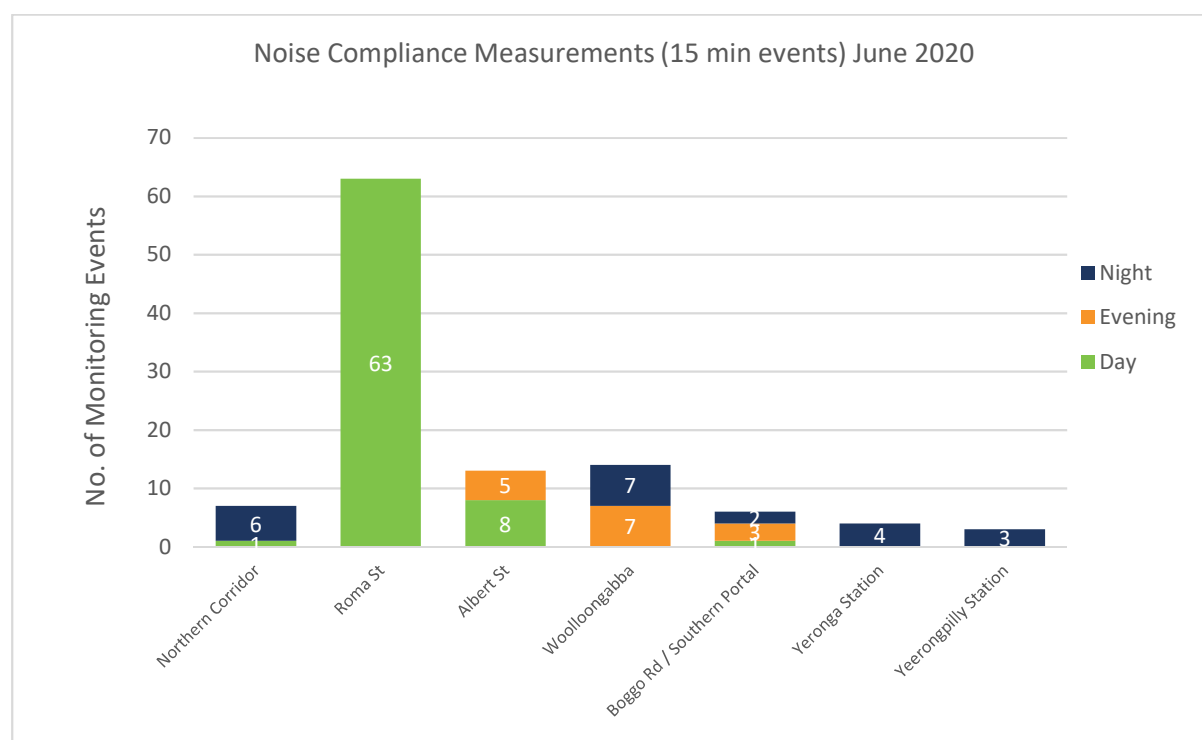
In the Central area noise monitoring was undertaken on 97 occasions during the month as summarised in the graph below and detailed in **Appendix B**. Where internal monitoring was not possible for the contractors, they have undertaken external monitoring at nominated locations. The contractors noise consultants have then nominated suitable façade attenuation corrections, considering receiver property type, to determine compliance against the project's noise goals and to provide further calibration of the completed modelled predictions. The contractors have reported that the project noise goals have been met during this reporting month. A breakdown of the monitoring events by time of day and location is shown below.

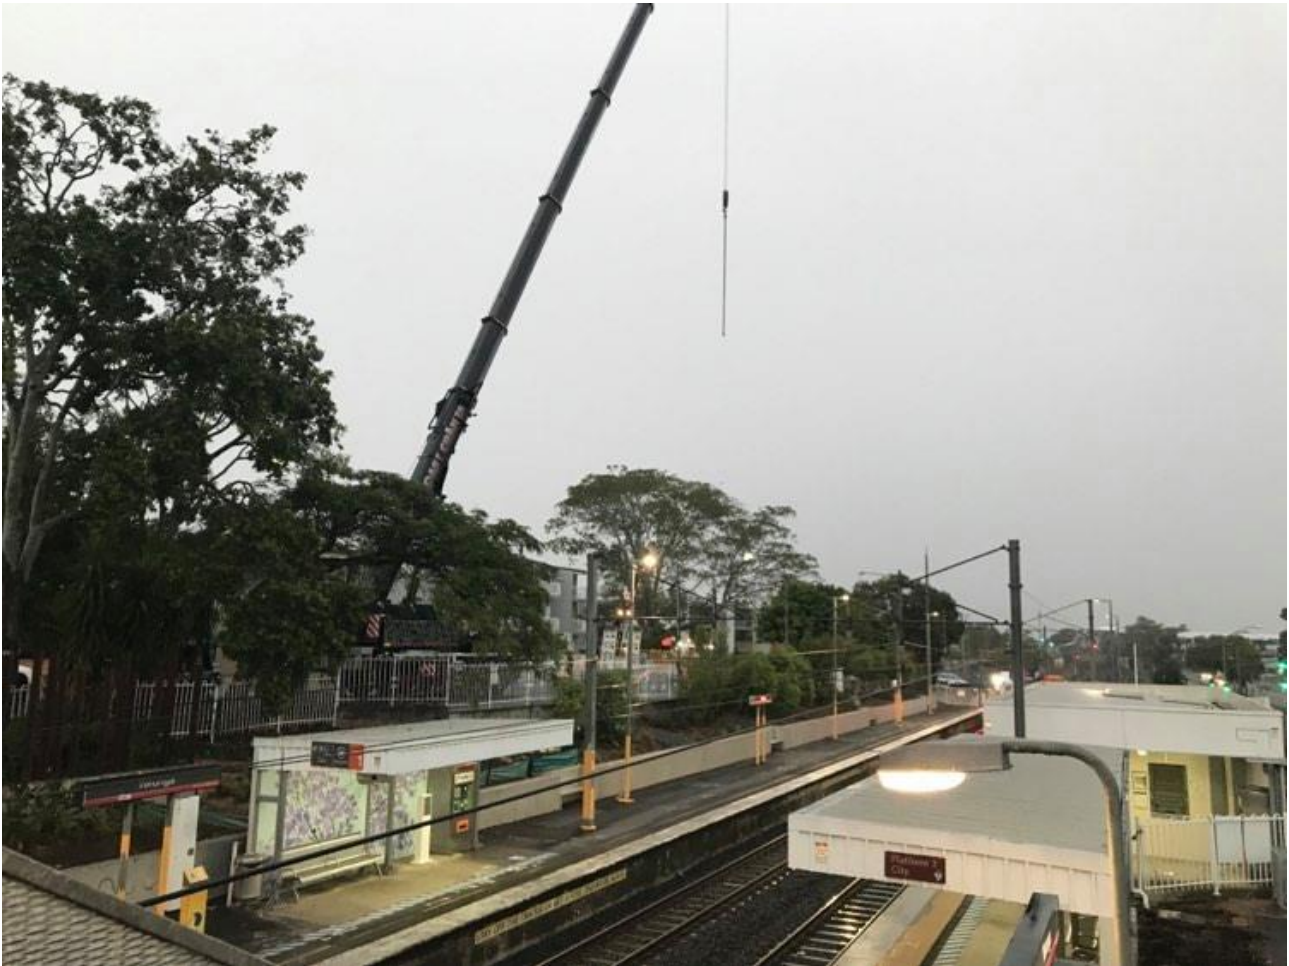
Figure 1: Crane set up for OHLE portal installation was completed without community complaints and exceedances of out of works noise limits

Monitoring of crane set up works associated with the OHLE portal installation at Yeronga Station was undertaken as close as possible to the nearest DAP (8 Lake Street, multistorey modern build townhouses complex), approximately 5m from façade of the closest townhouse to the works. The measured LA₁₀ and Laeq readings were compliant with the imposed conditions for works outside of standard working hours.

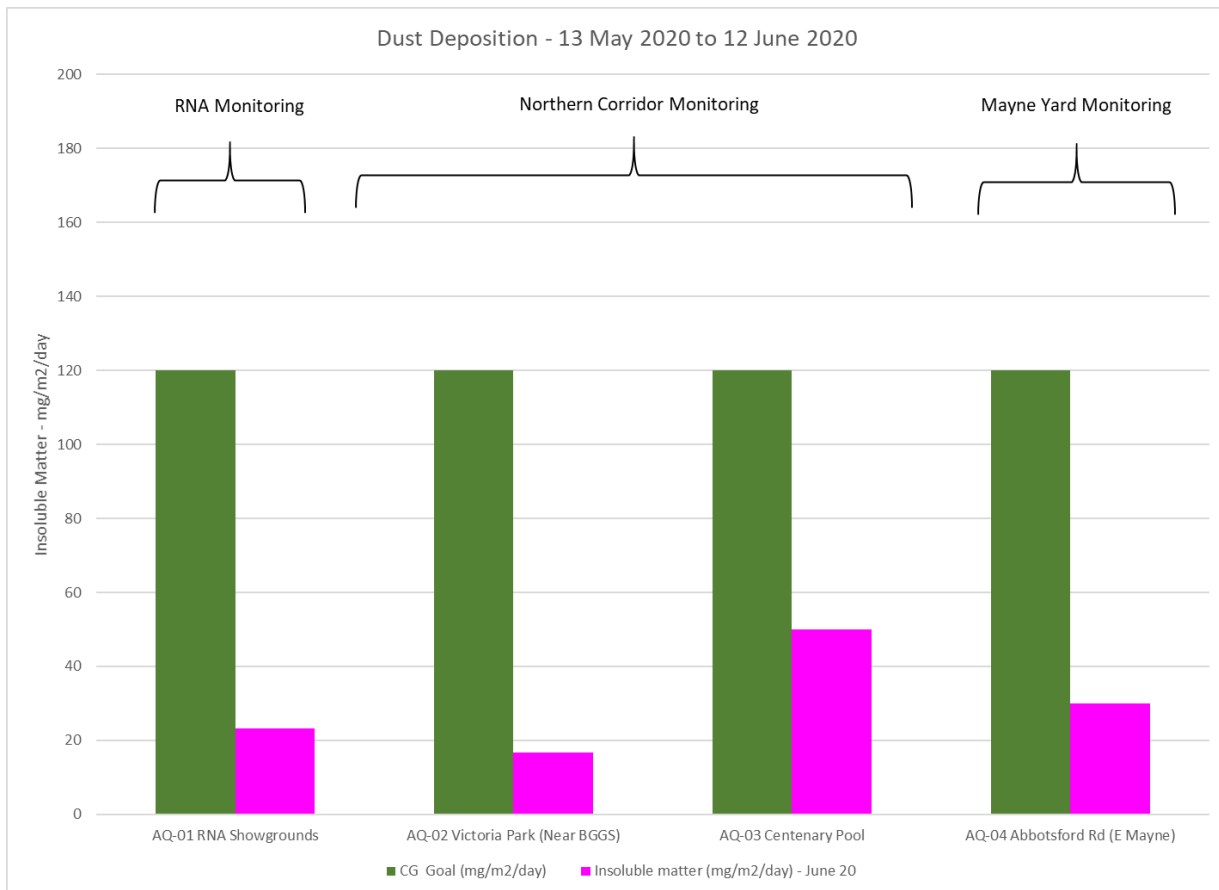
Figure 2: Air Quality Monitoring (Deposited Dust) – 13 May to 12 June 2020 Results

The dust deposition gauges result for the reporting period are detailed below and complied with Condition 13(b) of the CGCR.

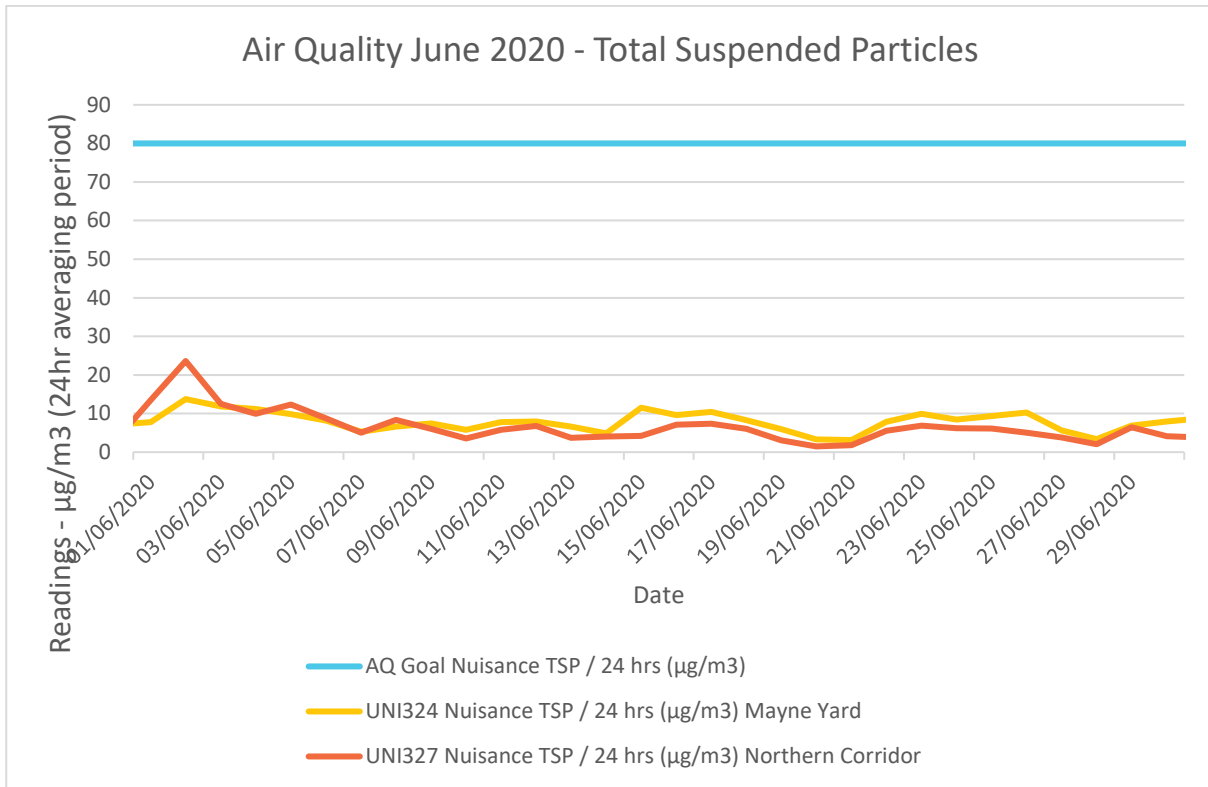
Figure 4: Air Quality Monitoring (TSP) - June 2020 Results

TSP is one of the indicators for which the Coordinator General has imposed a goal of 80 µg/m³ (over an averaging period of 24 hours) the project must aim to achieve under Imposed Condition 13(a).

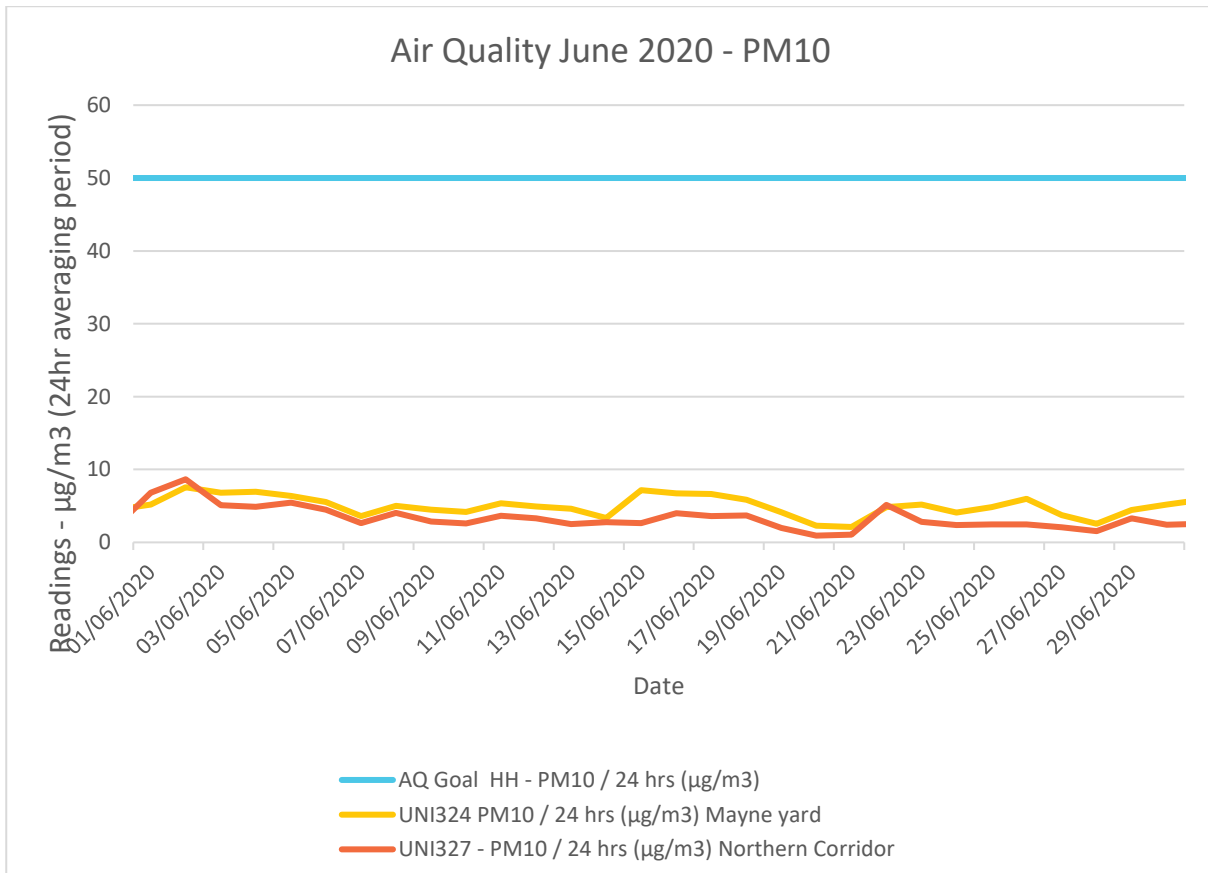
Figure 5: Air Quality Monitoring (PM10) - June 2020 Results

PM₁₀ is one of the indicators for which the Coordinator General has imposed a goal of 50 µg/m³ (over an averaging period of 24 hours) the project must aim to achieve under Imposed Condition 13(a).

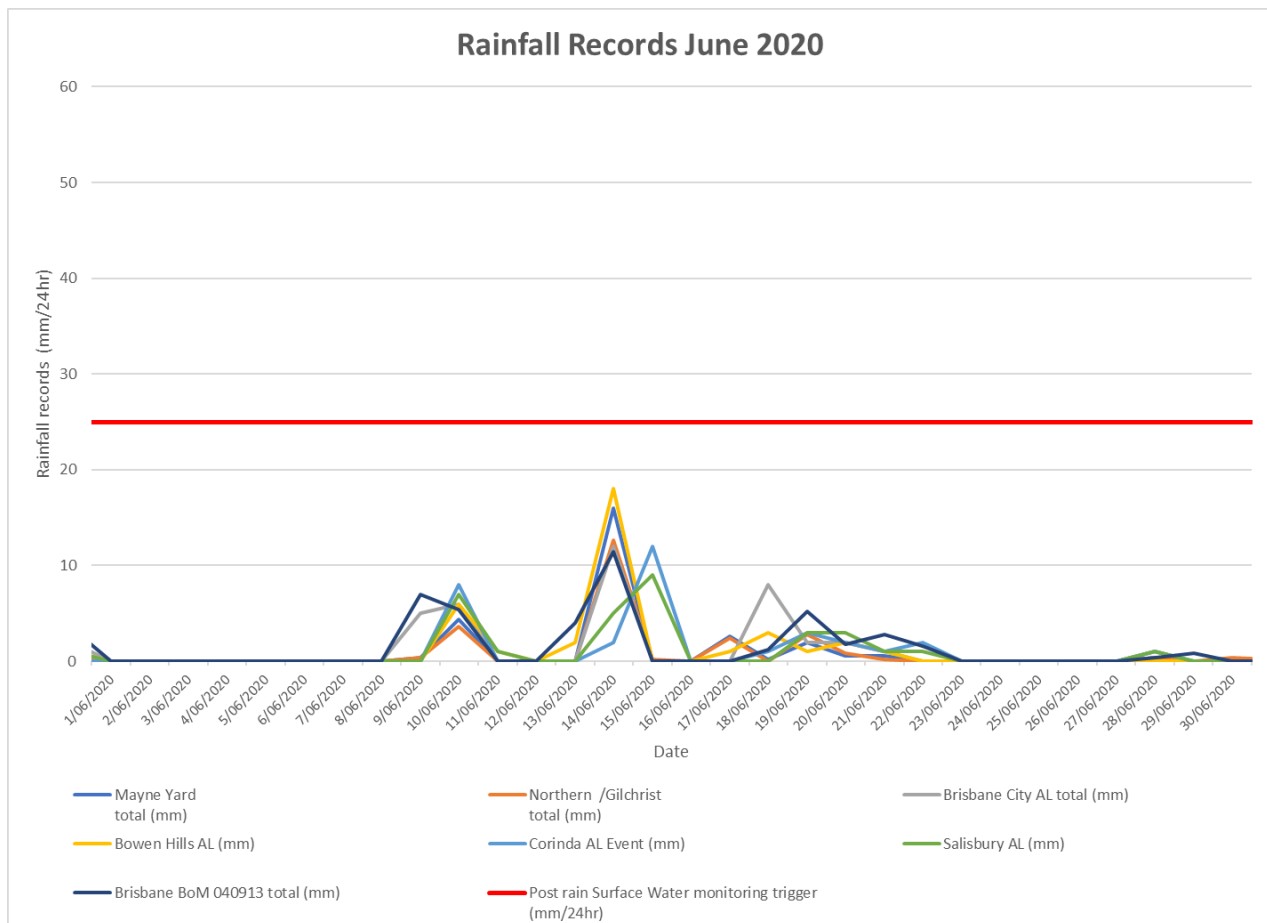
Figure 3: Rainfall - June 2020 Results

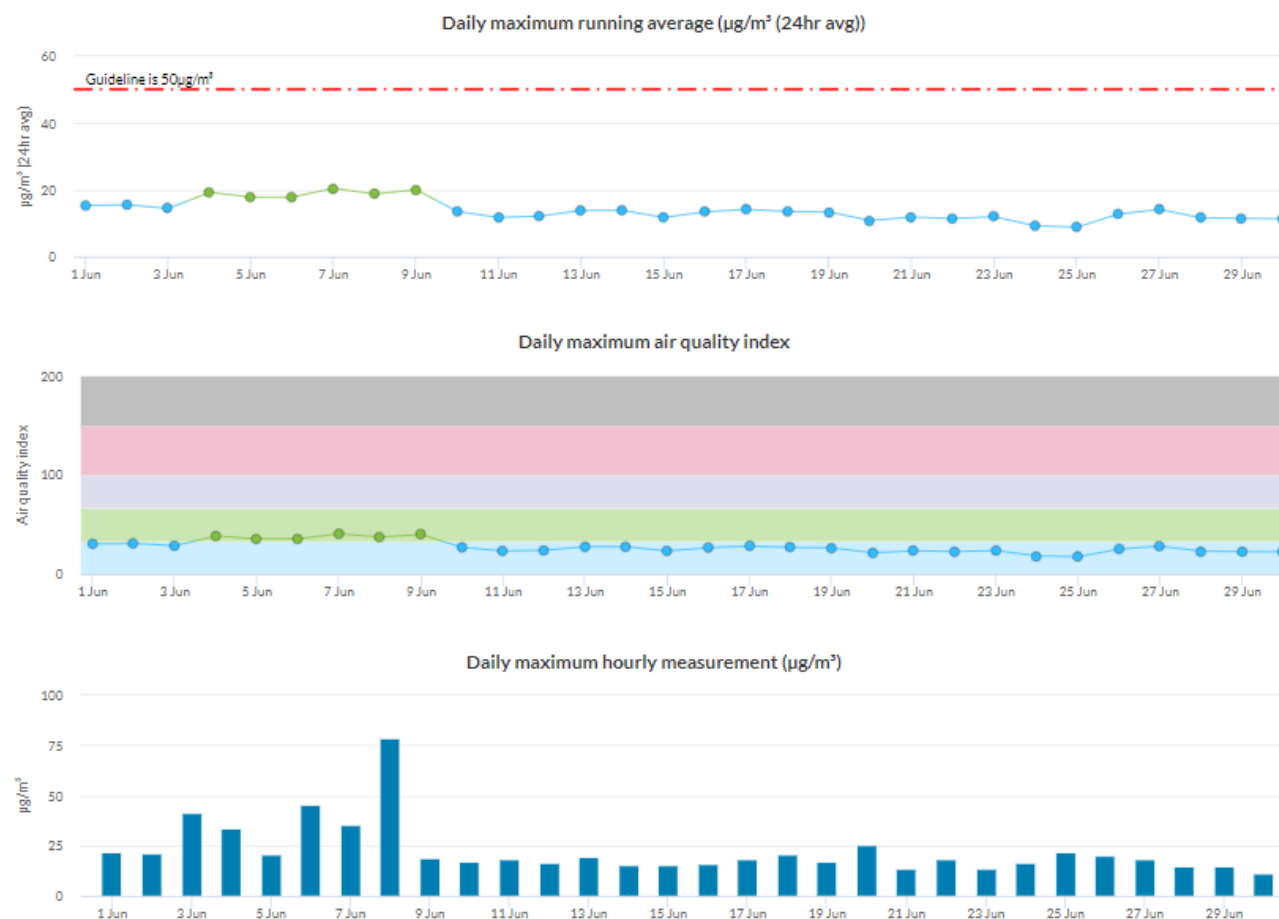
The guideline for Particle PM₁₀ is 50 µg/m³ (24hr avg).

Figure 1: Brisbane CBD – DES Station - PM₁₀ graph for June 2020 (reproduction from the DES website accessed June 2020)

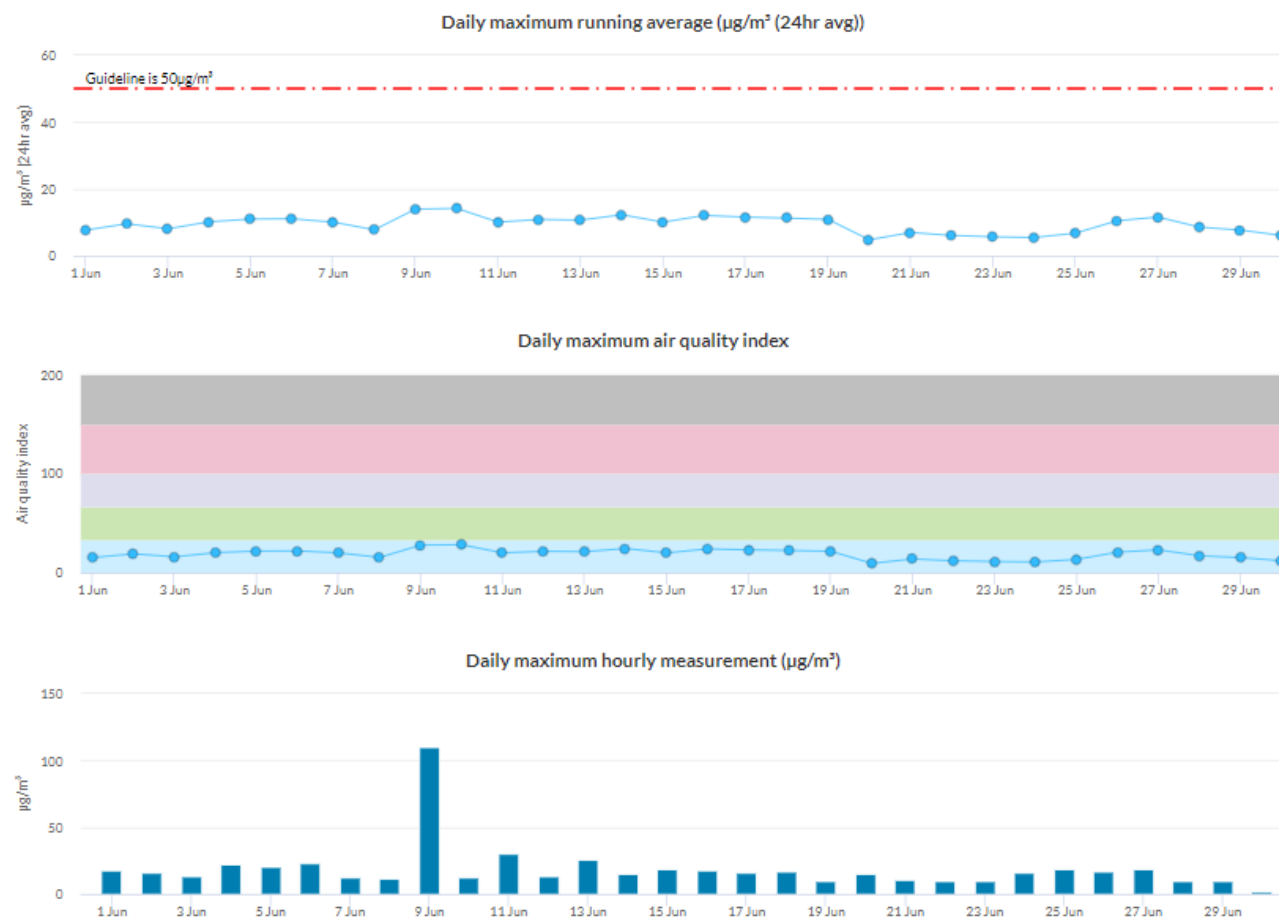
The guideline for Particle PM₁₀ is 50 µg/m³ (24hr avg).

Figure 2: South Brisbane – DES Station - PM₁₀ graph for June 2020 (reproduction from the DES website accessed June 2020)

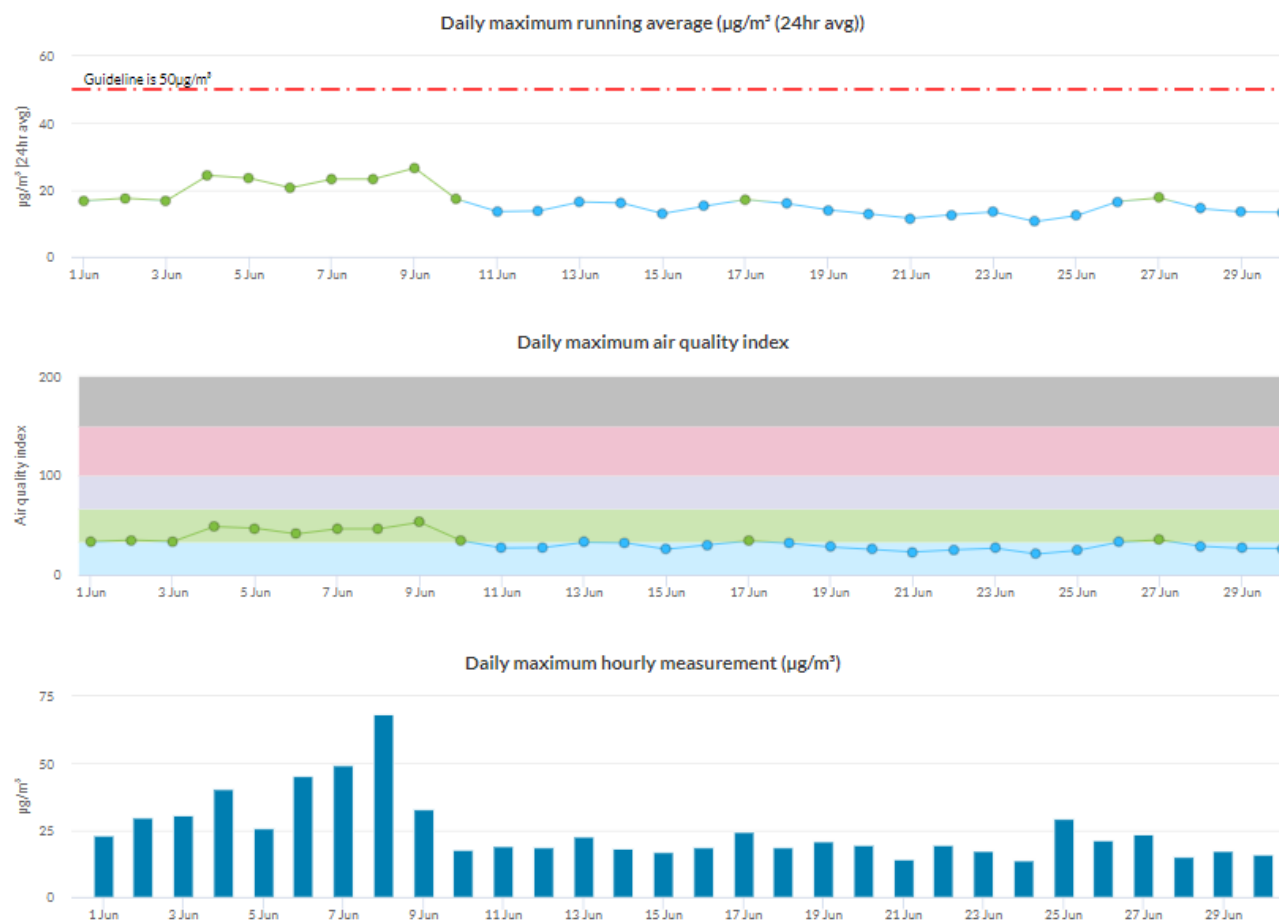
The guideline for Particle PM₁₀ is 50µg/m³ (24hr avg).

Figure 3: Woolloongabba – DES Station - PM₁₀ graph for June 2020 (reproduction from the DES website accessed June 2020)
