Cross River Rail Project

Monthly Environmental Report

April 2021

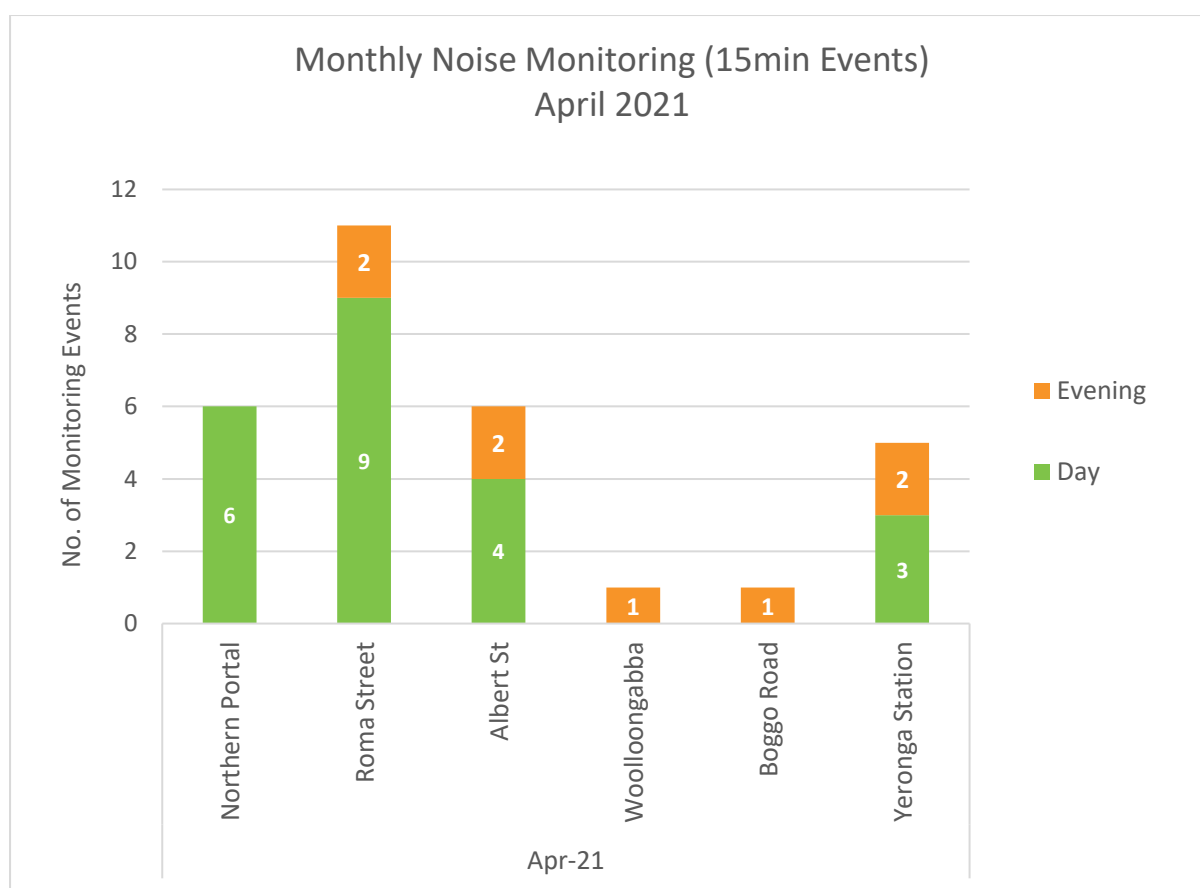
A summary of noise monitoring events for the month is provided in the chart below.

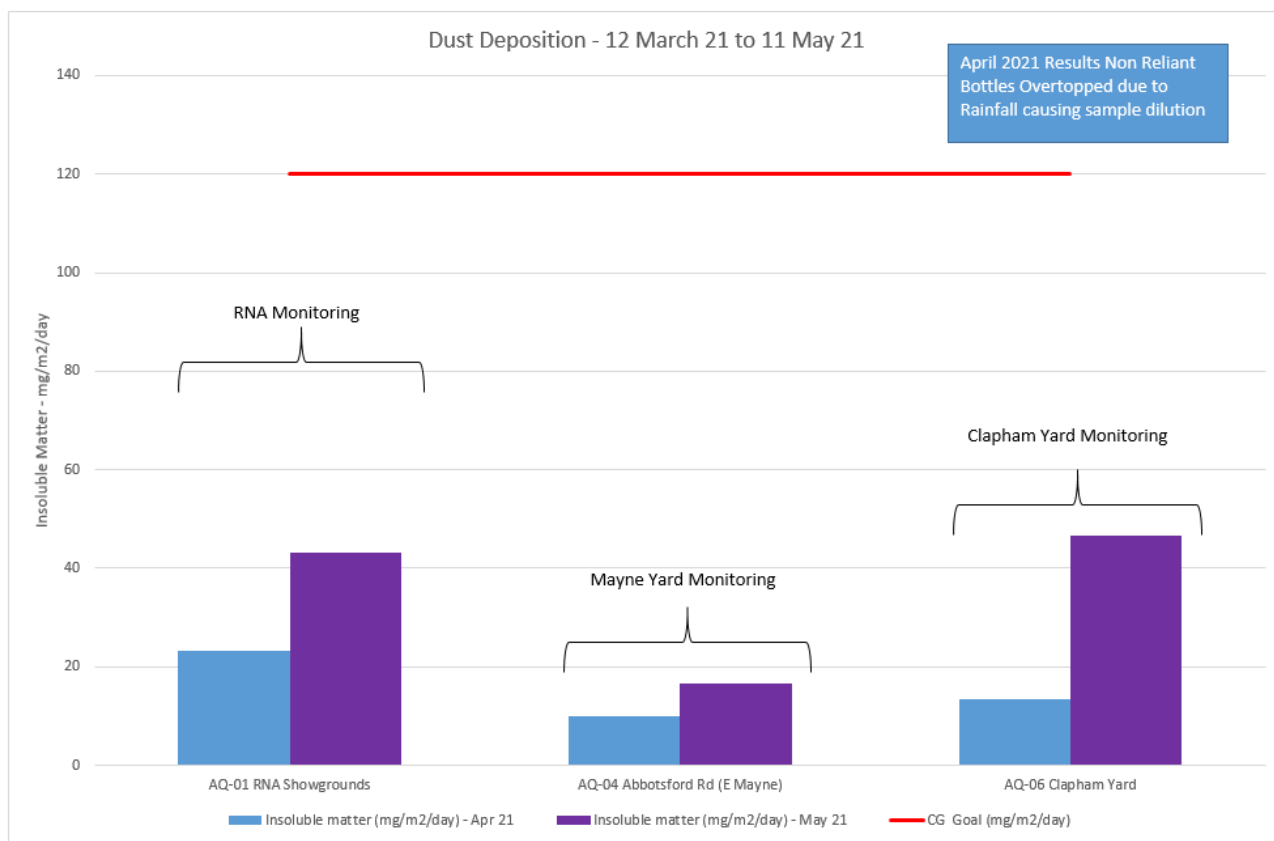
Figure 1 Air Quality Monitoring (Deposited Dust) Results

CGCR Goal (mg/m ² /day)	AQ-01 - RNA Showgrounds (mg/m ² /day)	AQ-04 Abbotsford Rd (E Mayne) (mg/m ² /day)	AQ-06– Clapham yard Showgrounds (mg/m ² /day)
April 2021 results			
120	23	10	13
Total Rainfall during Period	189	189	295
May 2021 results			
120	43	17	47
Total Rainfall during Period	55	55	58

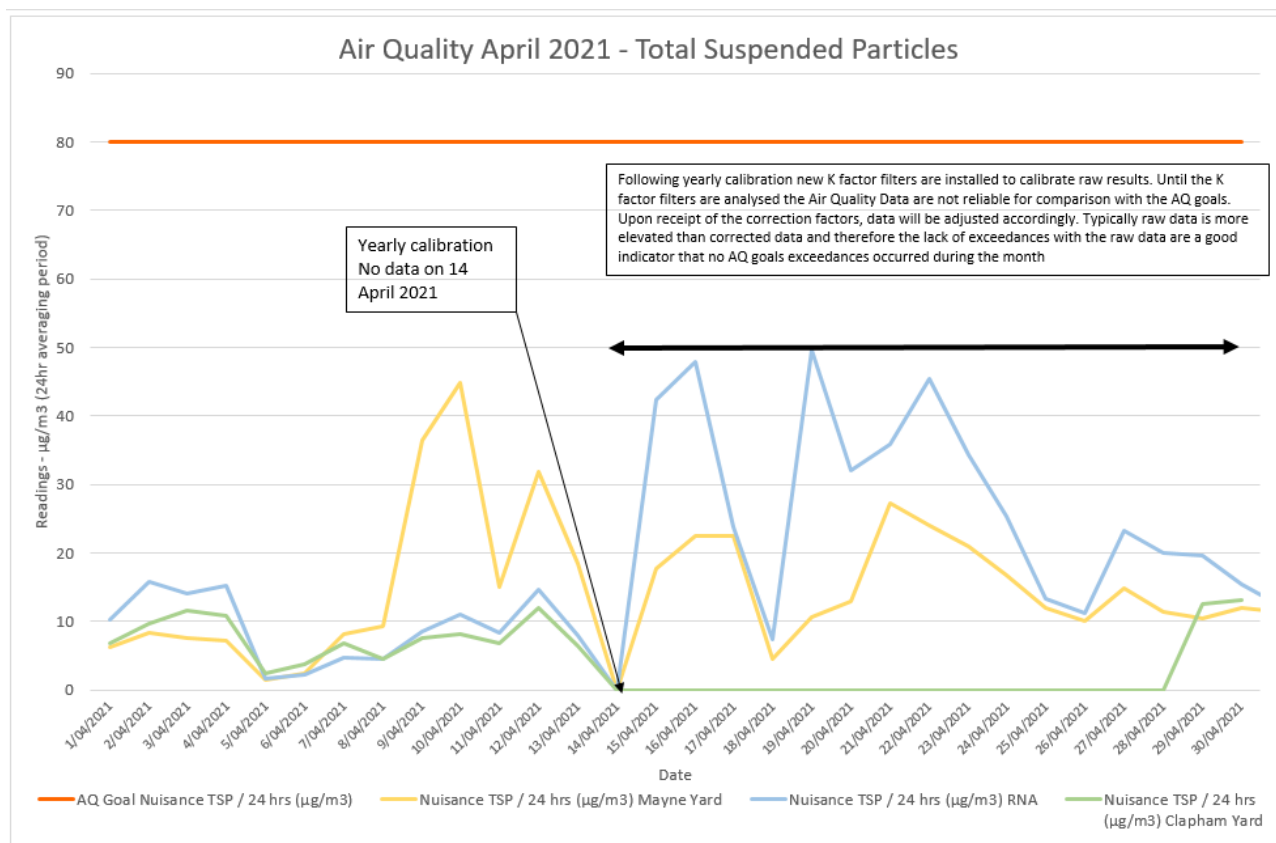
Figure 2 Air Quality Monitoring (TSP) Results

TSP is one of the indicators for which the Coordinator-General has imposed a goal of 80 $\mu\text{g}/\text{m}^3$ (over an averaging period of 24 hours) the project must aim to achieve under Imposed Condition 13(a).

These stations have been set up on site as per AS/NZS 3850 1.1 following consultation with UNITY air quality professionals.

Day	Earthworks quantities (t)	TSP result (nuisance) 24 hrs (µg/m ³)	PM ₁₀ result (health) 24 hrs (µg/m ³)	Compliance Assessment
9 Apr 21	2,772	8	15	No exceedance of the air quality goals
10 Apr 21	2,084	8	16	No exceedance of the air quality goals
12 Apr 21	2,128	12	20	No exceedance of the air quality goals
13 Apr 21	1,104	6	11	No exceedance of the air quality goals
16 Apr 21	696	No data	No data	No exceedance of the air quality goals
27 Apr 21	1036	No data	No data	No exceedance of the air quality goals
28 Apr 21	626	No data	No data	No exceedance of the air quality goals
29 Apr 21	60	13	17	No exceedance of the air quality goals
30 Apr 21	75	13	18	No exceedance of the air quality goals

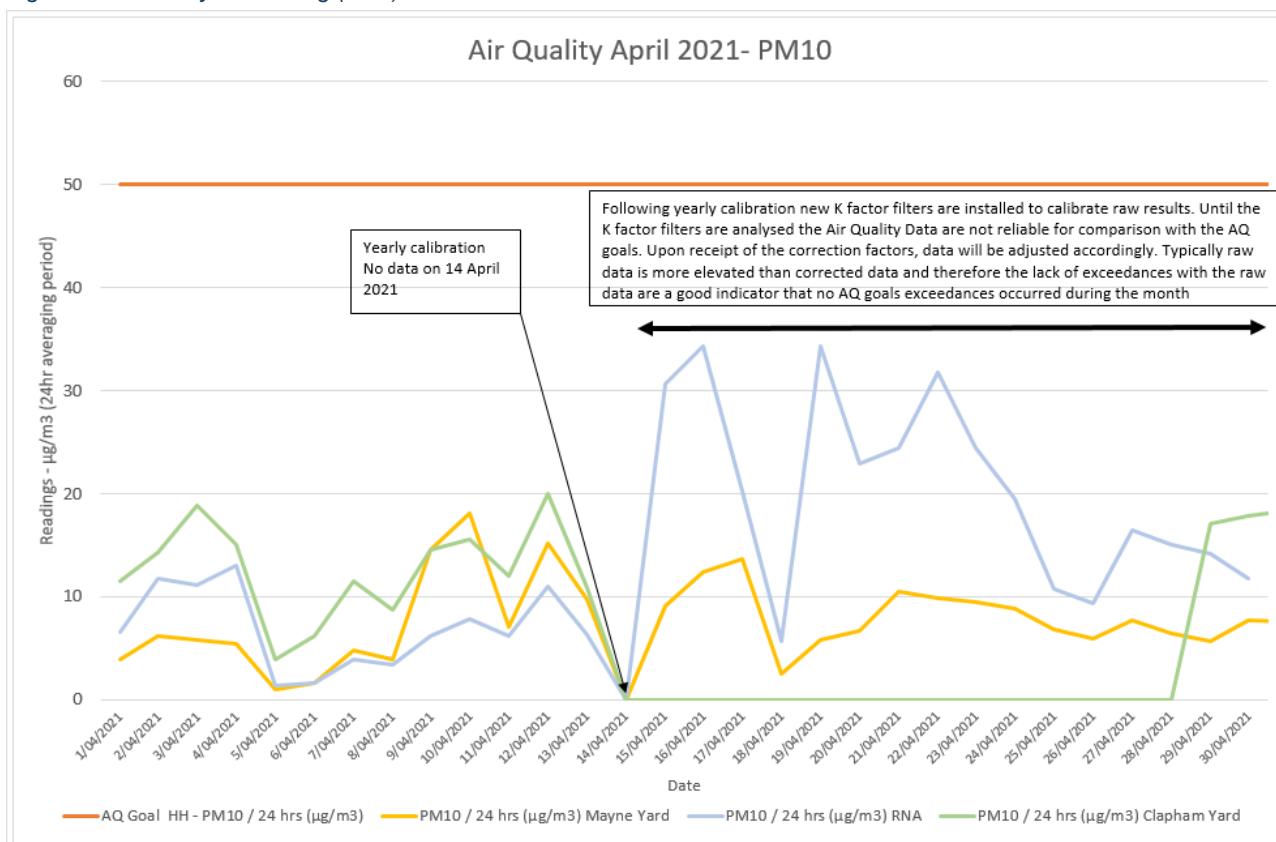
Figure 3 Air Quality Monitoring (PM₁₀) Results

PM_{10} is one of the indicators for which the Coordinator-General has imposed a goal of 50 $\mu\text{g}/\text{m}^3$ (over an averaging period of 24 hours) the project must aim to achieve under Imposed Condition 13(a).

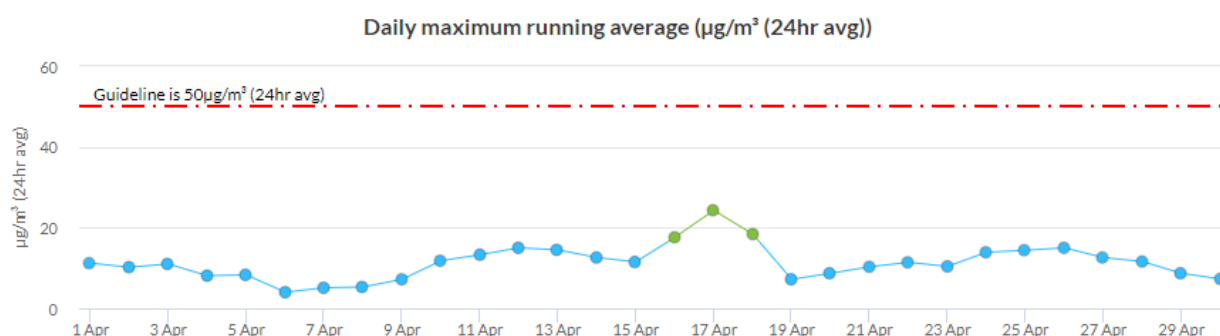
Figure 4: DES Rocklea Air Quality Station Records

The peak earthworks activities for the reporting period occurred between 09 and 13 April 2021. During that peak period there were no recorded exceedance of the PM₁₀ and TSP air quality goals. The PM₁₀ readings at are consistent with the readings at the DES Rocklea Station (reproduced in Figure 4).

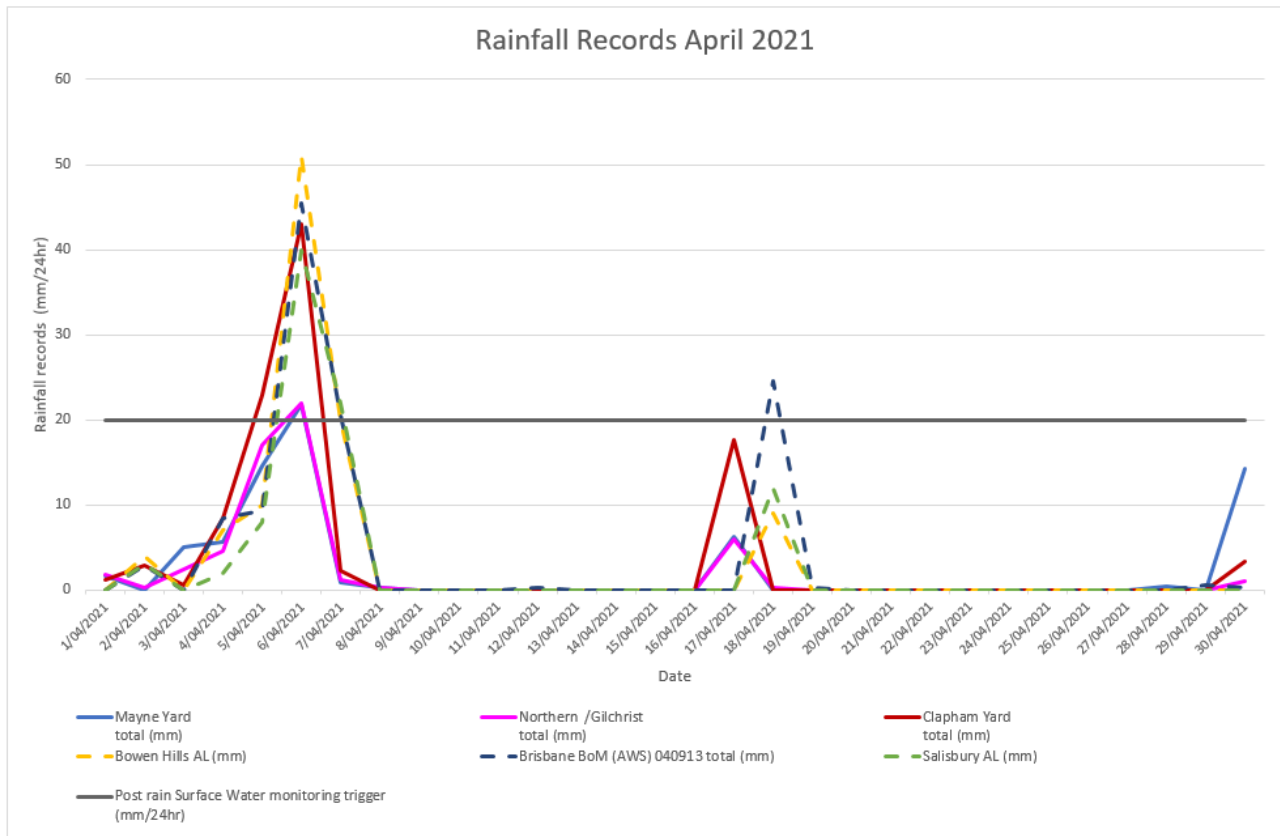
Figure 5 Rainfall Records

Post rainfall monitoring is triggered typically following any rainfall event exceeding 20 to 25 mm over 24 hours, however storm events during the high-risk period of the year (November to March) of lesser amounts but higher intensity may cause run-off which would also trigger post rain monitoring consistent with the C-EMP.

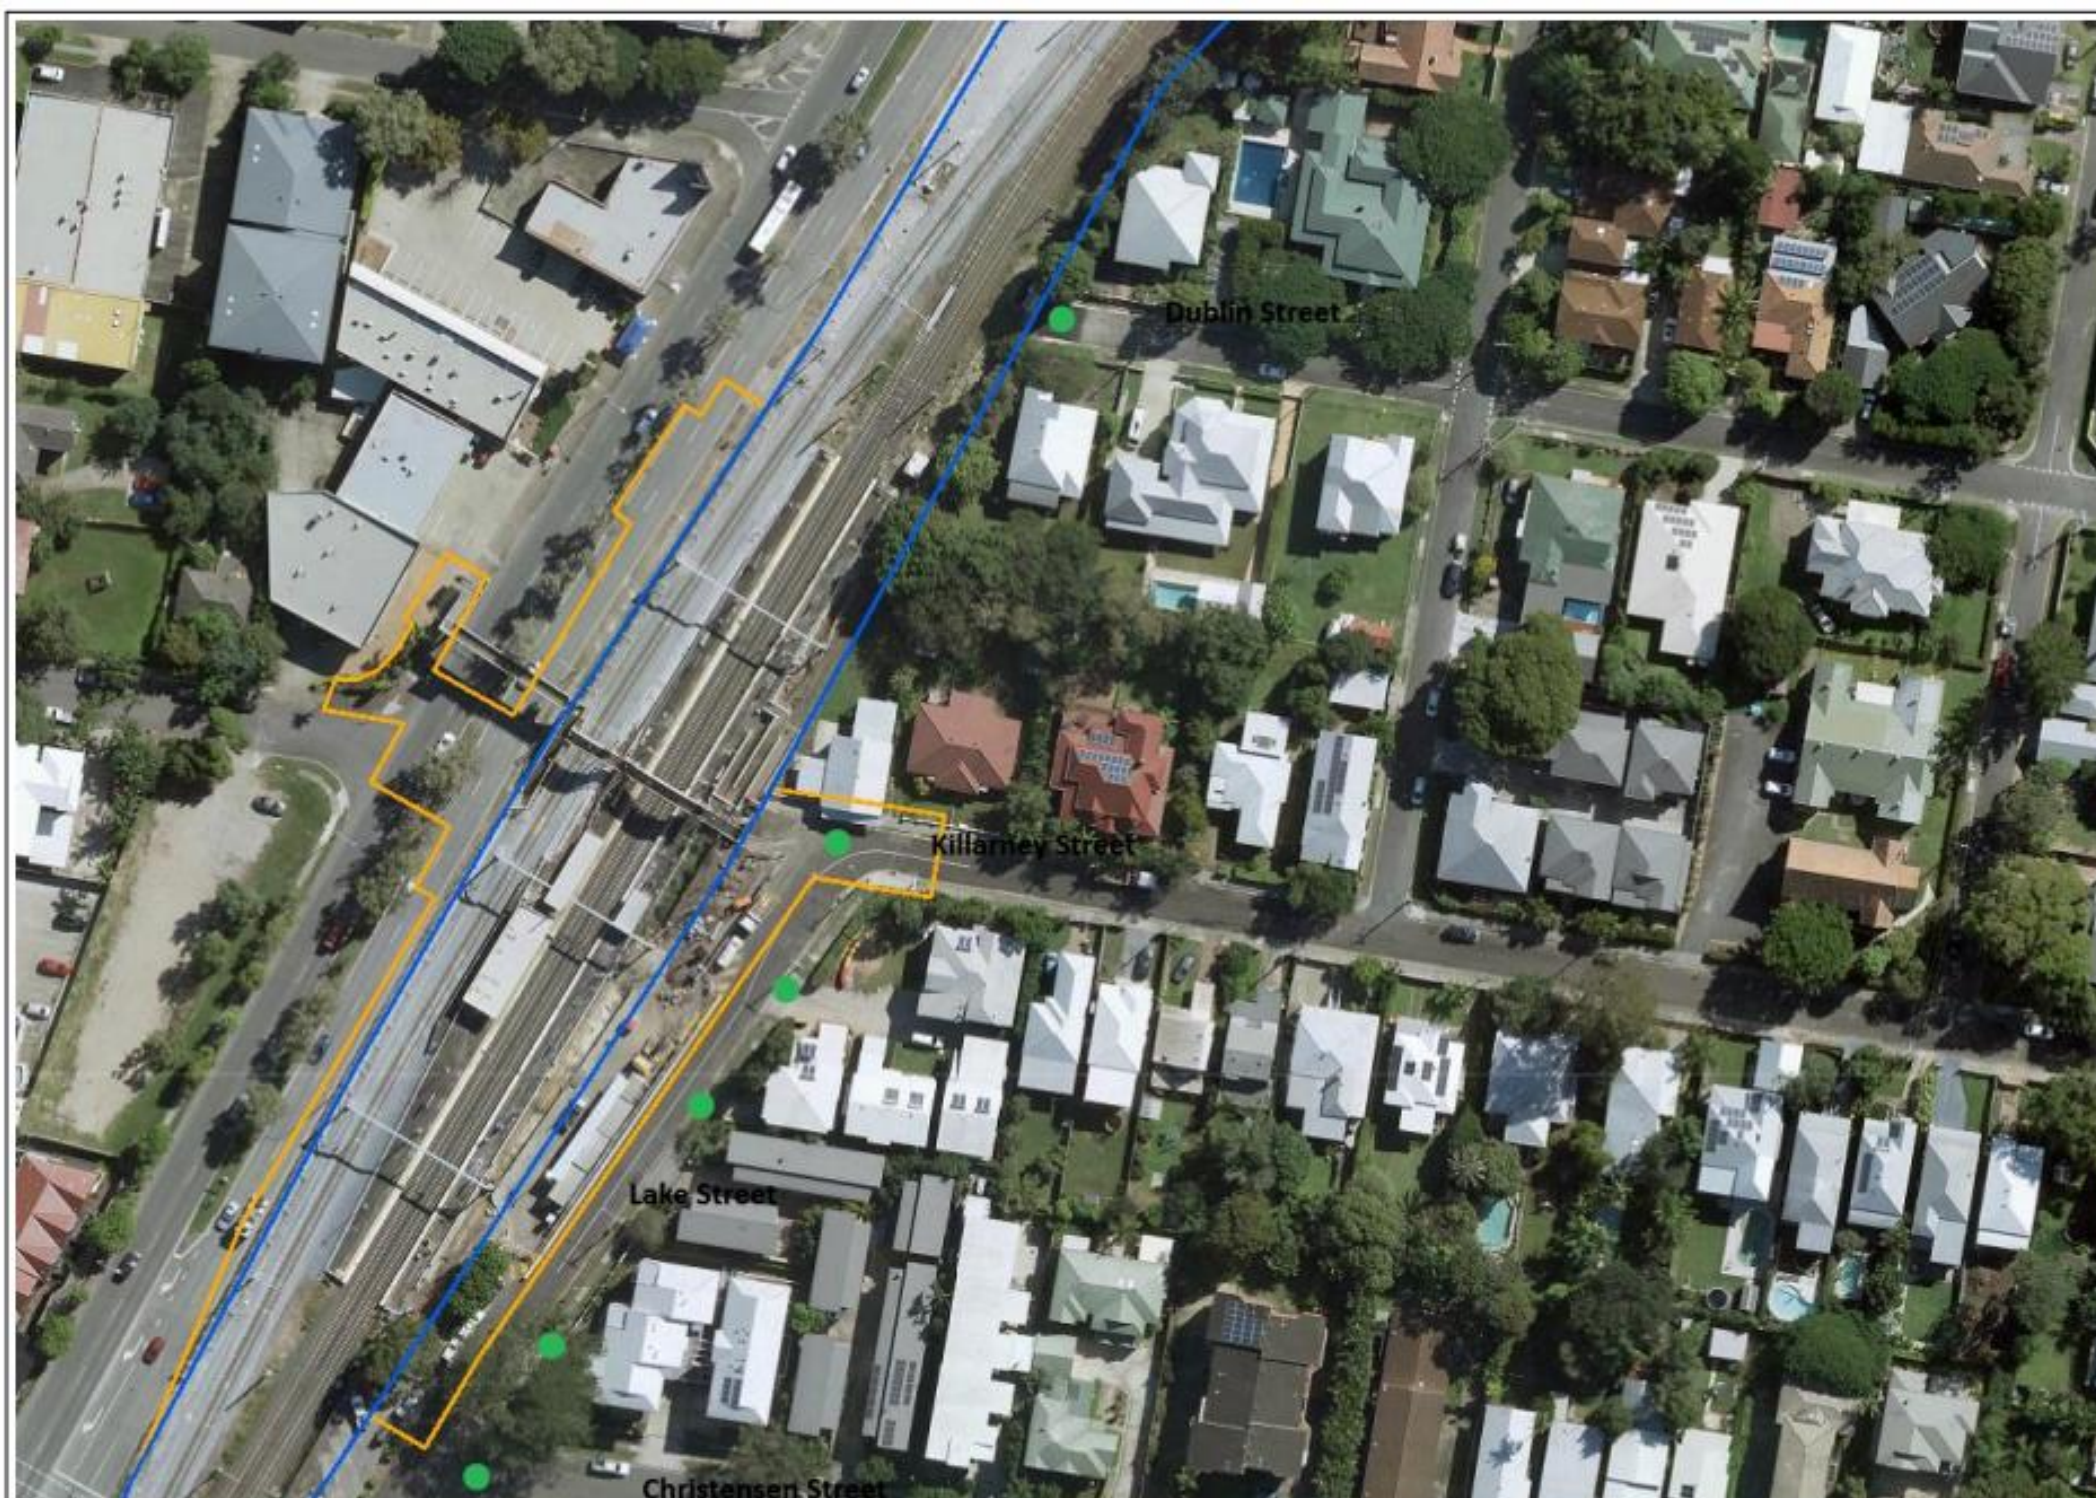
Attachment 2 Monitoring Locations – Noise

A FOR INFORMATION			
Issue	Description	Date	Approved
	Construction Monitoring at Sensitive Places		
Scale 1: 1,000

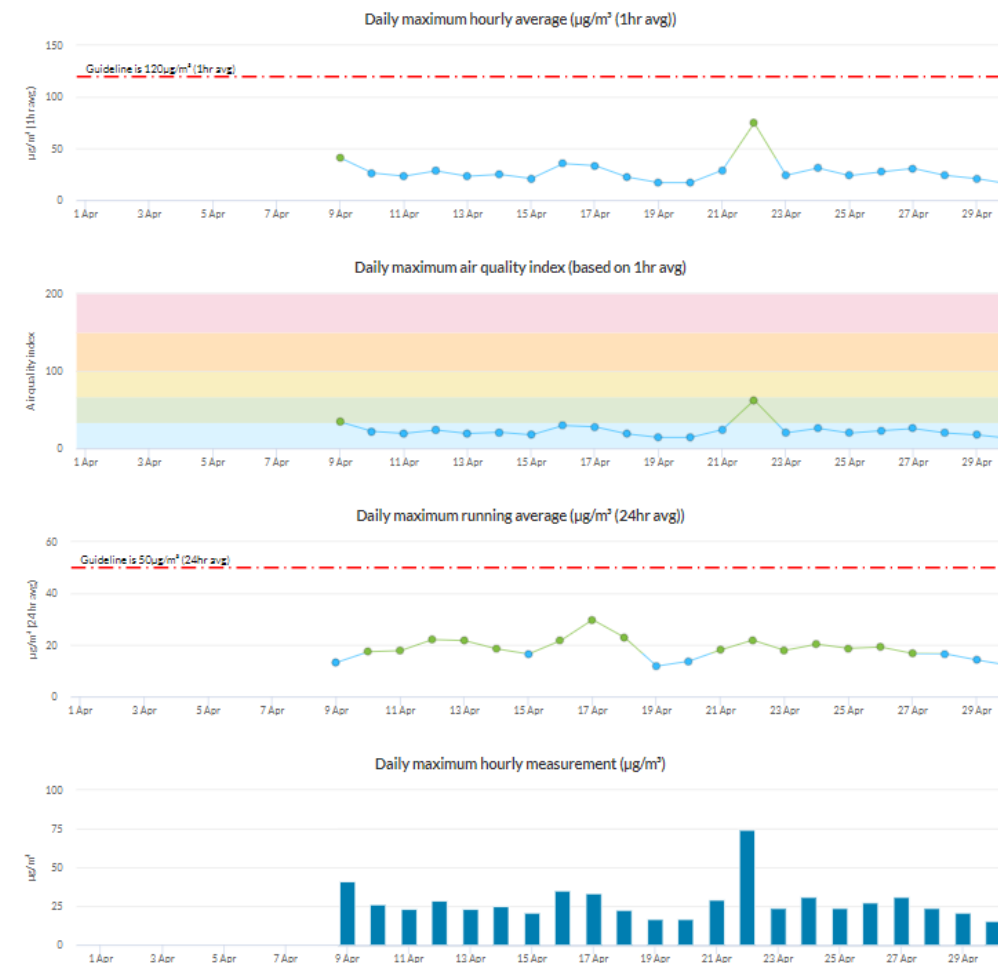
Figure 1: Brisbane CBD – DES Station - PM10 graph for April 2021 (reproduction from the DES website).

The guideline for Particle PM₁₀ is 120µg/m³ (1hr avg) and 50µg/m³ (24hr avg).

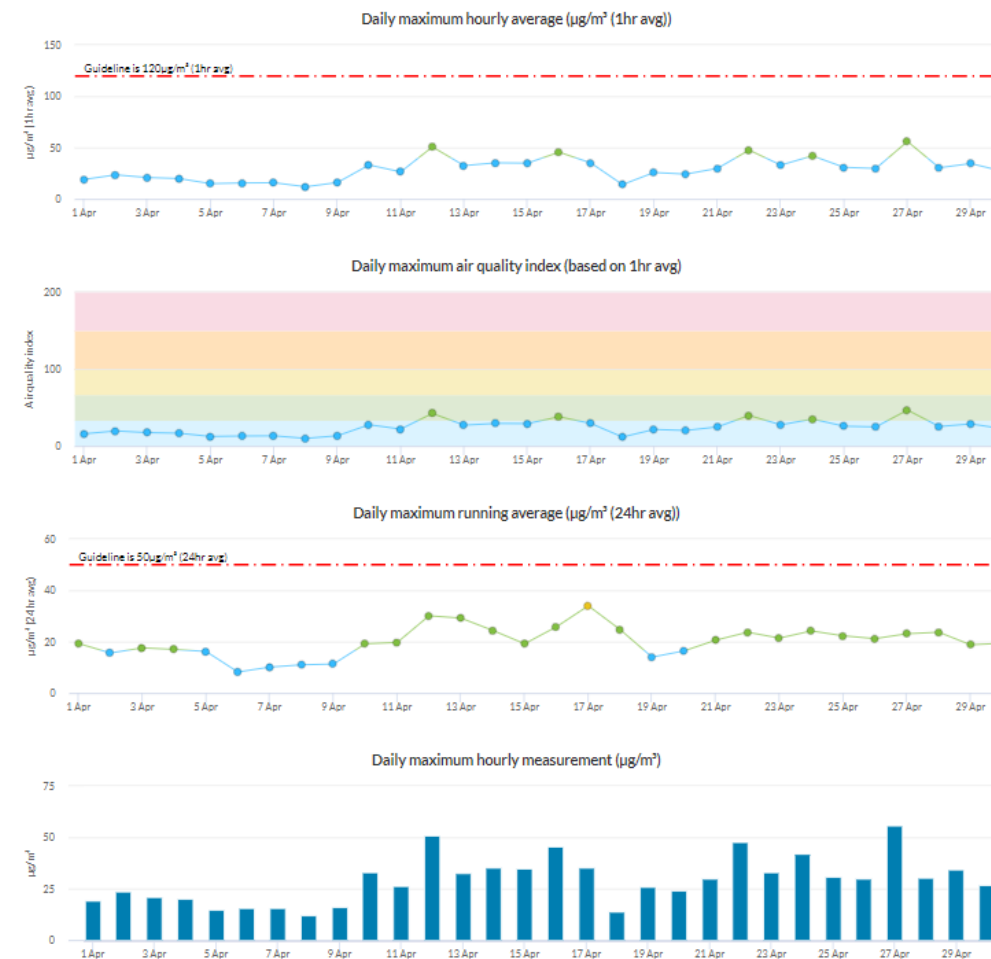
Figure 2: South Brisbane – DES Station - PM₁₀ graph for April 2021 (reproduction from the DES website accessed).

The guideline for Particle PM₁₀ is 120µg/m³ (1hr avg) and 50µg/m³ (24hr avg).

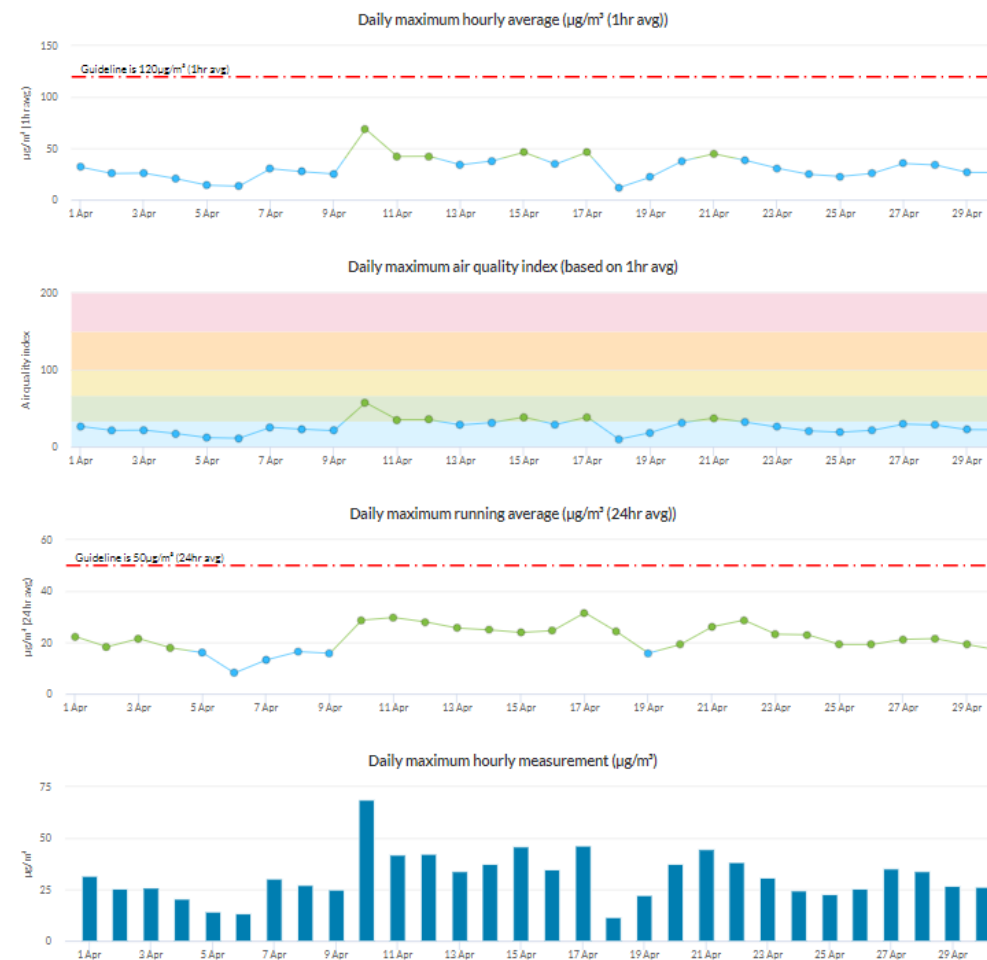
Figure 3: Woolloongabba – DES Station - PM₁₀ graph for April 2021 (reproduction from the DES website).

The guideline for Particle PM₁₀ is 120µg/m³ (1hr avg) and 50µg/m³ (24hr avg).
