Cross River Rail Project

Monthly Environmental Report

May 2021

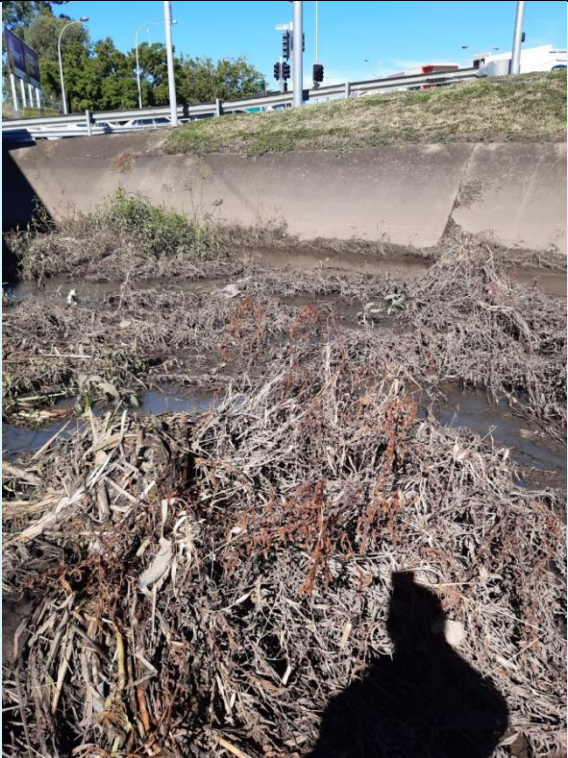
Location	Turbidity in Situ record	Visual Observations	Photograph
Mid-Stream	114 NTU	Brown and murky in colour, large amount of vegetation debris, no odour or sheen

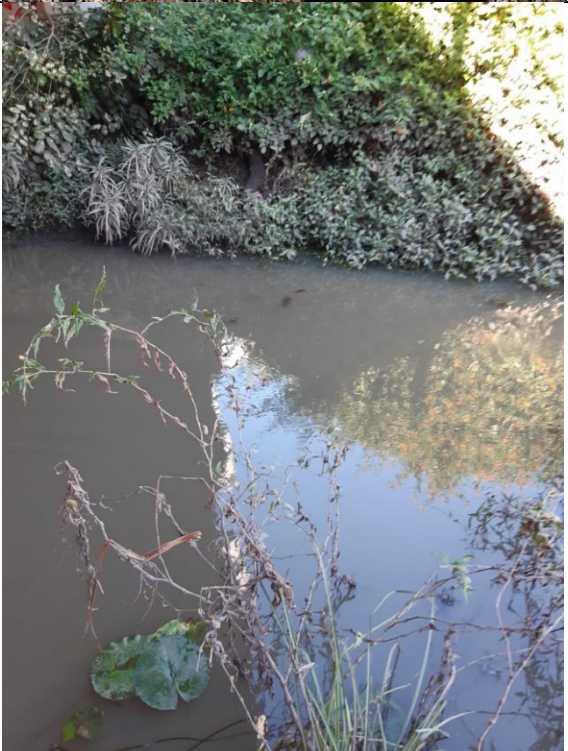
SW08	83 NTU	Brown in colour, vegetation debris, visible turbidity, no odour or sheen

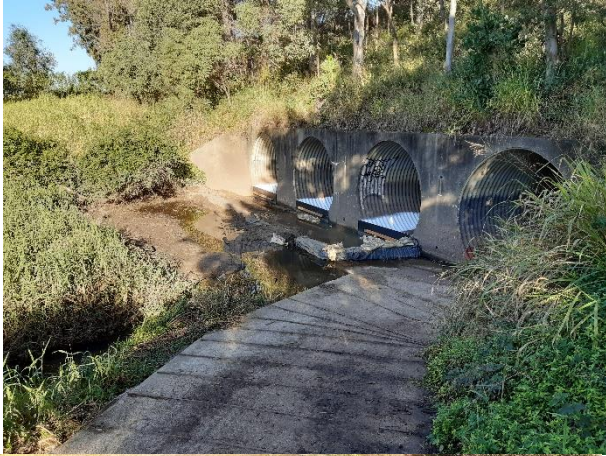
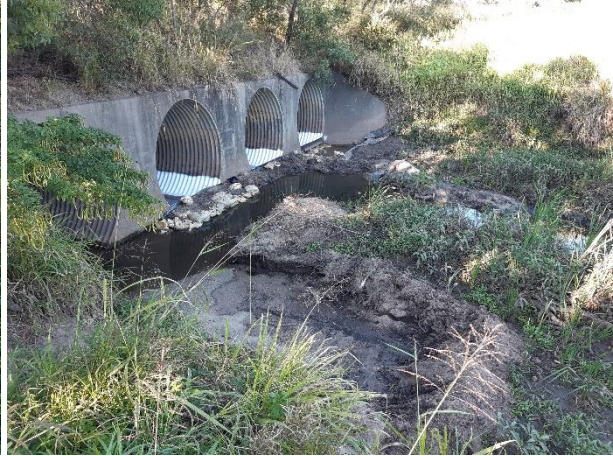
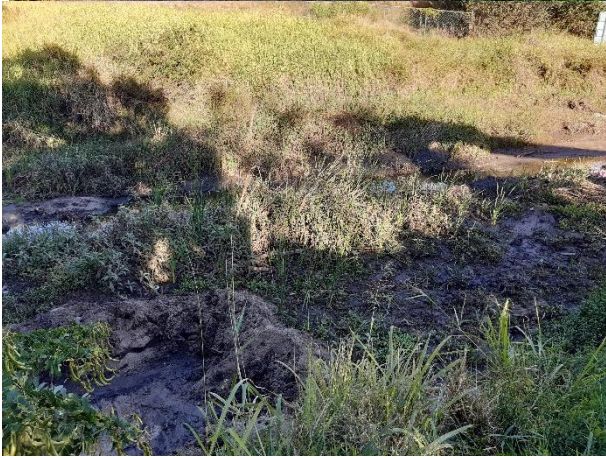
Finally, there is anecdotal evidence of drainage maintenance works and earthworks having occurred recently upstream of SW07 near Muriel Avenue Park (250m upstream of SW-07 adjacent to Rock Water Holes Creek) as presented in the below photographs.

Therefore, the source of the increased turbidity cannot not be reasonably accredited to the Project Works.
Compliance with Imposed Conditions 15 and 18 was met.
