Cross River Rail Project

Monthly Environmental Report

December 2021

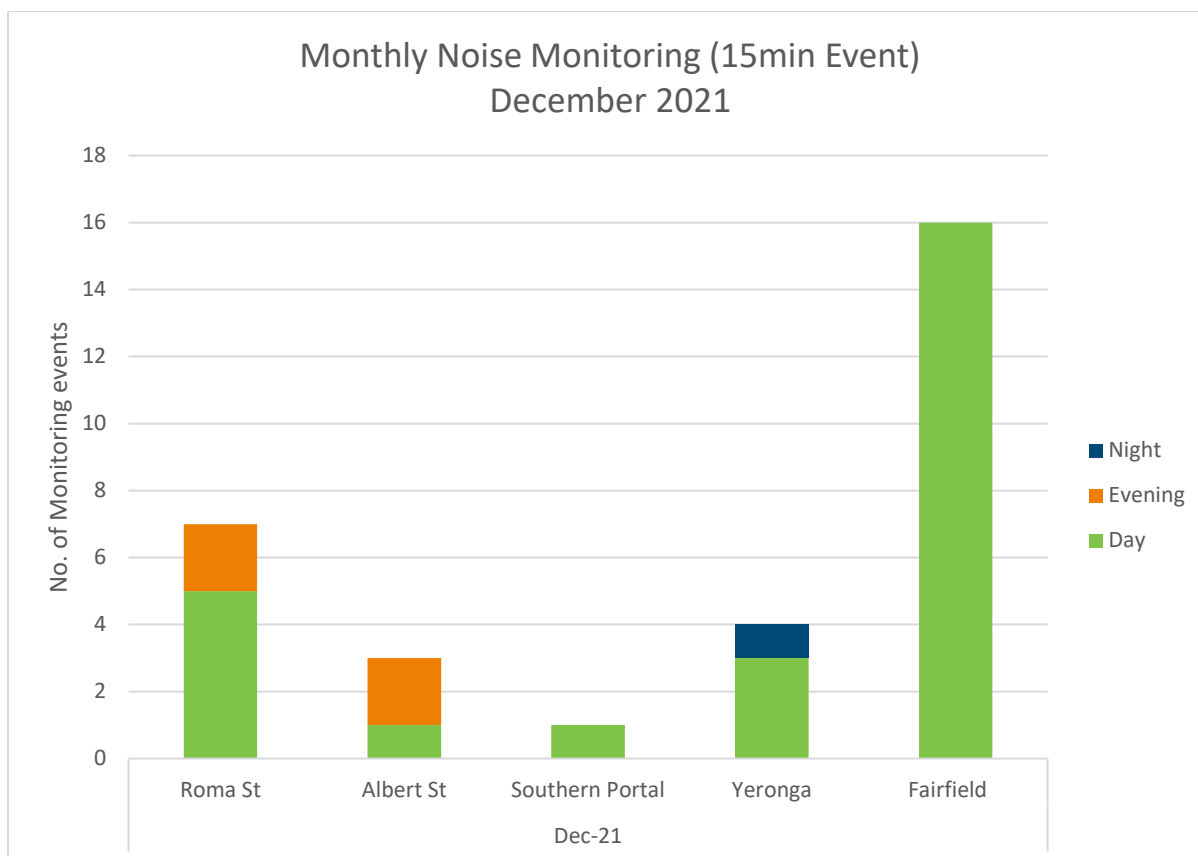
A summary of noise monitoring events for the month is provided in the chart below.

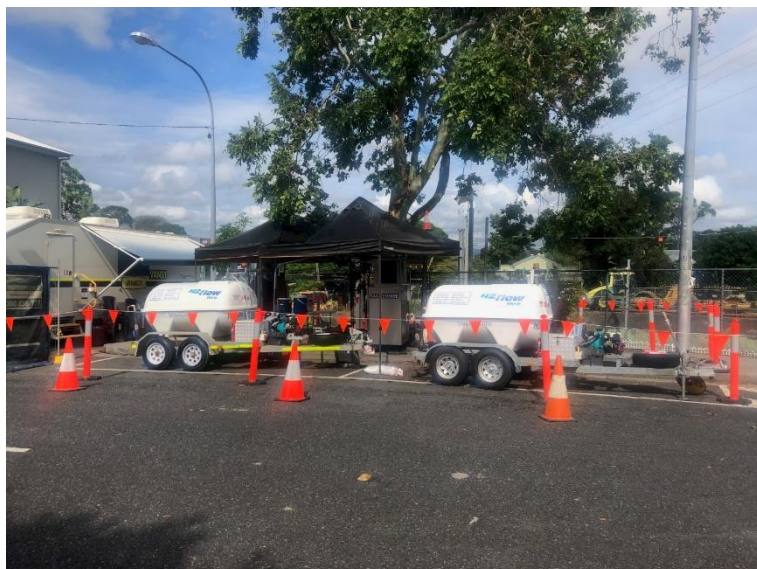
Plate 1: Source of continuous noise before the installation of additional noise blankets

The source of the noise was small two-stroke motors powering mobile water tanks connected to an ice machine for the temporary crib set up near 15 Lagonda Street.

As a response, the Project Team subsequently installed additional portable noise blankets around the mobile water tankers and no further complaints were received regarding this site set up.

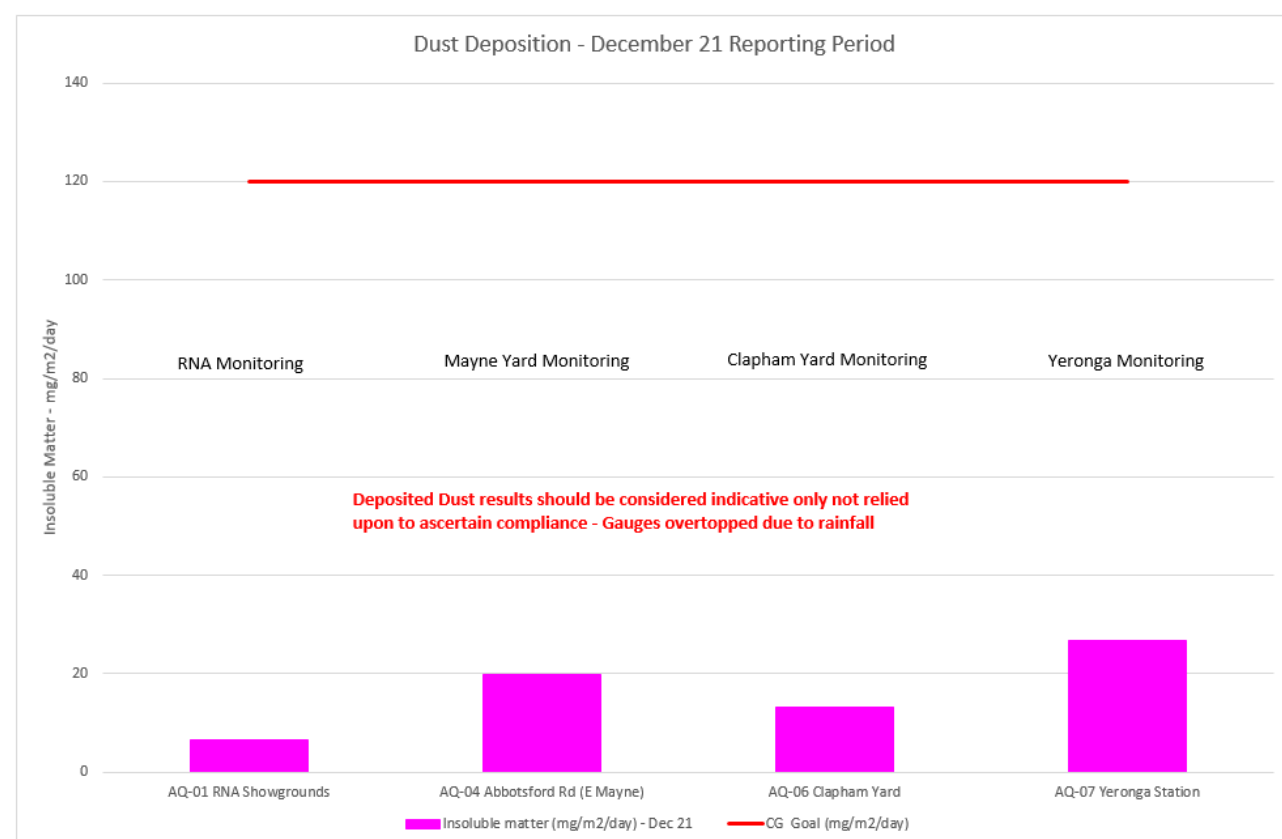
Figure 1 Air Quality Monitoring (Deposited Dust) Results

It is however noted that the results are either invalidated or indicative only as all DDG bottles overtopped due to rainfall. As per AS/NZS 3580.10.1, section 7.42, *where a gauge has overflowed soluble matter cannot be determined*, rendering the soluble matter results invalid.

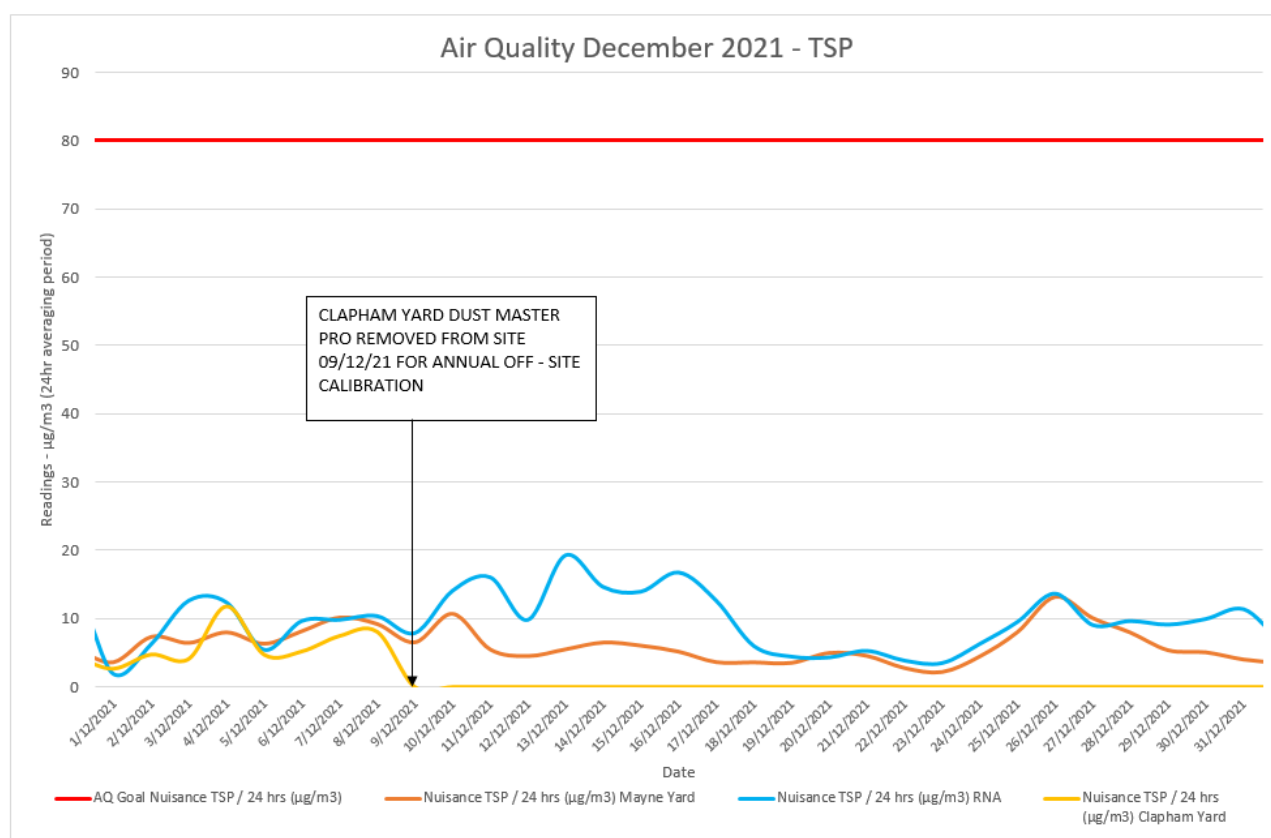
Figure 2 Air Quality Monitoring (TSP) Results

TSP is one of the indicators for which the Coordinator-General has imposed a goal of 80 $\mu\text{g}/\text{m}^3$ (over an averaging period of 24 hours) the project must aim to achieve under Imposed Condition 13(a).

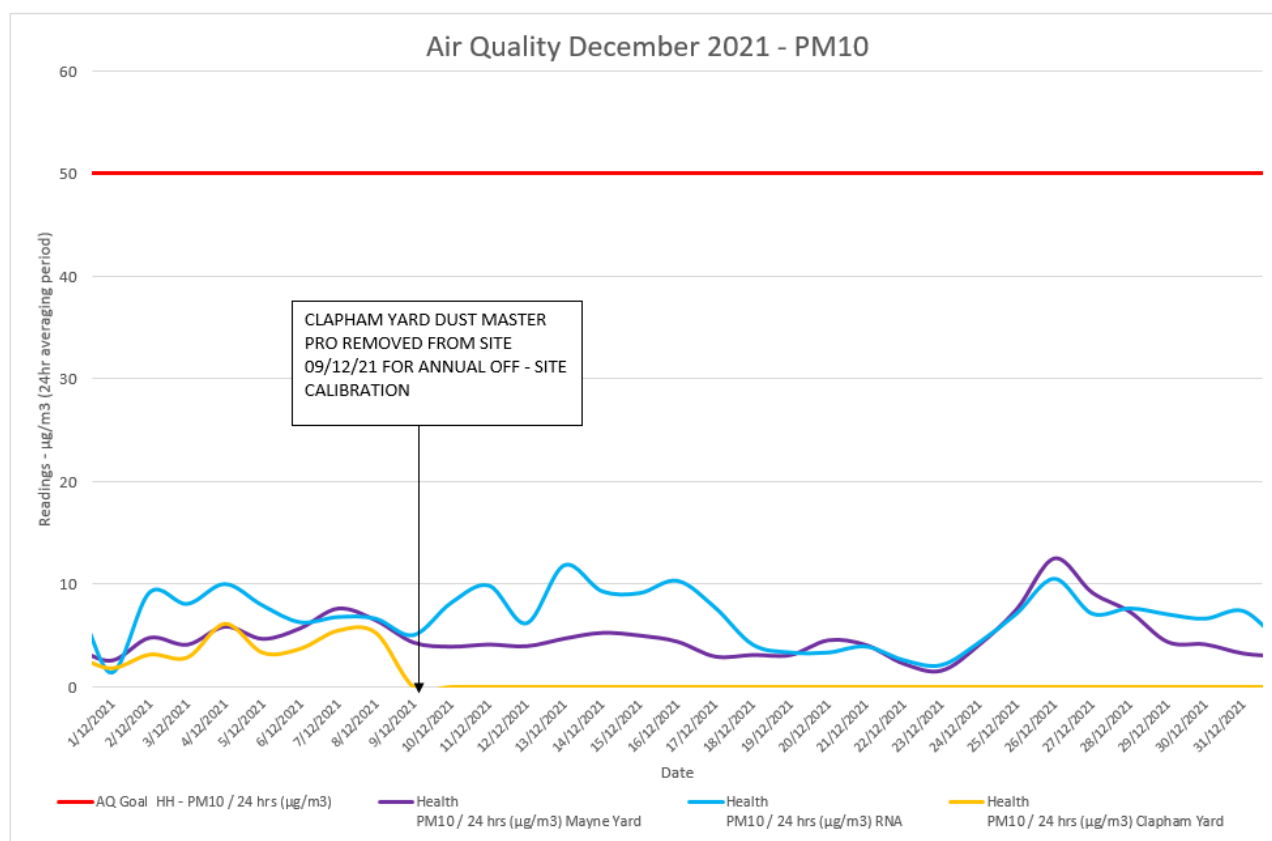
Figure 3 Air Quality Monitoring (PM₁₀) Results

PM_{10} is one of the indicators for which the Coordinator-General has imposed a goal of 50 $\mu\text{g}/\text{m}^3$ (over an averaging period of 24 hours) the project must aim to achieve under Imposed Condition 13(a).

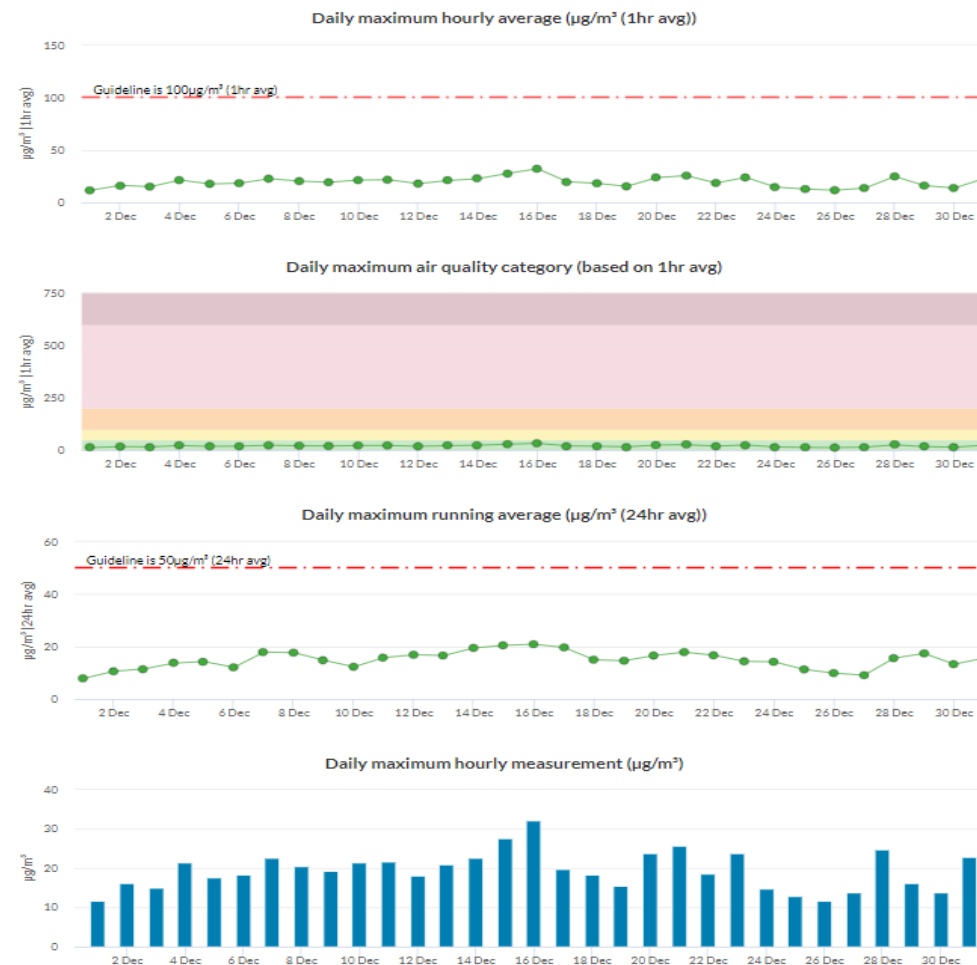
Figure 1: Brisbane CBD – DES Station - PM10 graph for December 2021 (reproduction from the DES website).

The guideline for Particle PM₁₀ is 100µg/m³ (1hr avg) and 50µg/m³ (24hr avg).

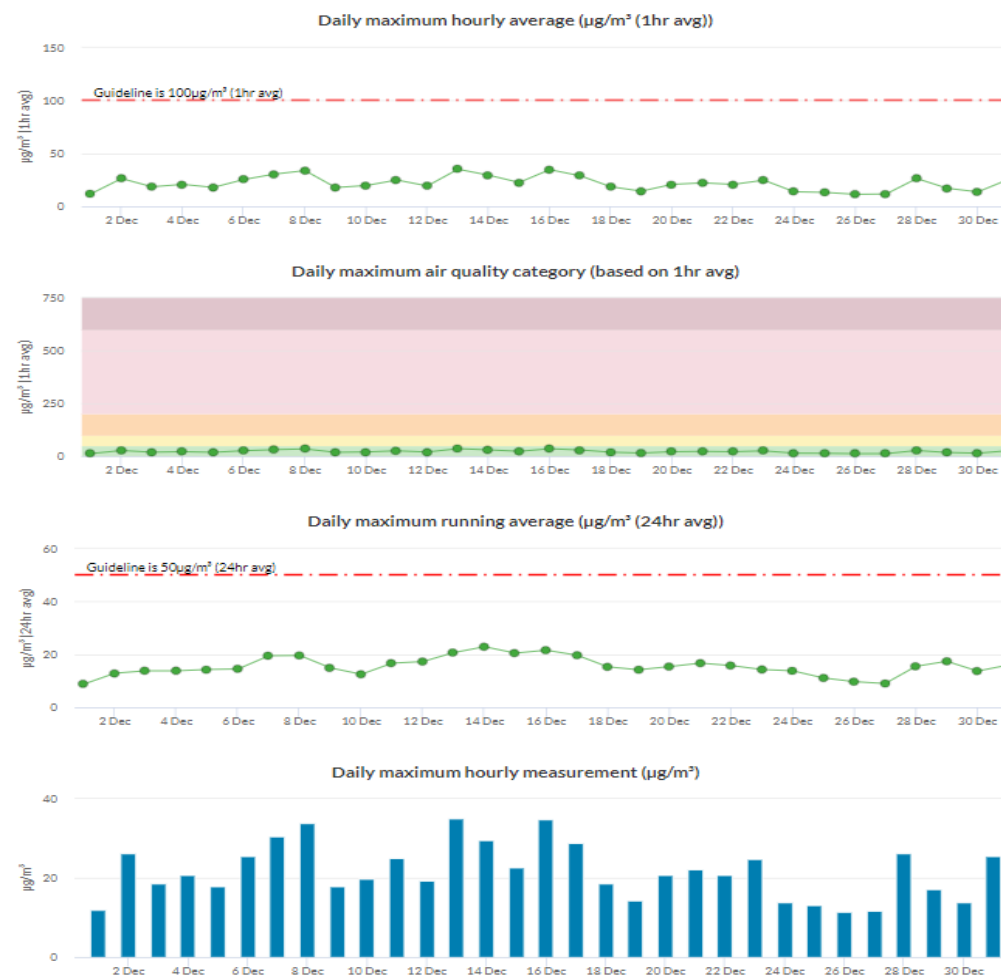
Figure 2: South Brisbane – DES Station - PM10 graph for December 2021 (reproduction from the DES website accessed).

The guideline for Particle PM₁₀ is 100µg/m³ (1hr avg) and 50µg/m³ (24hr avg).

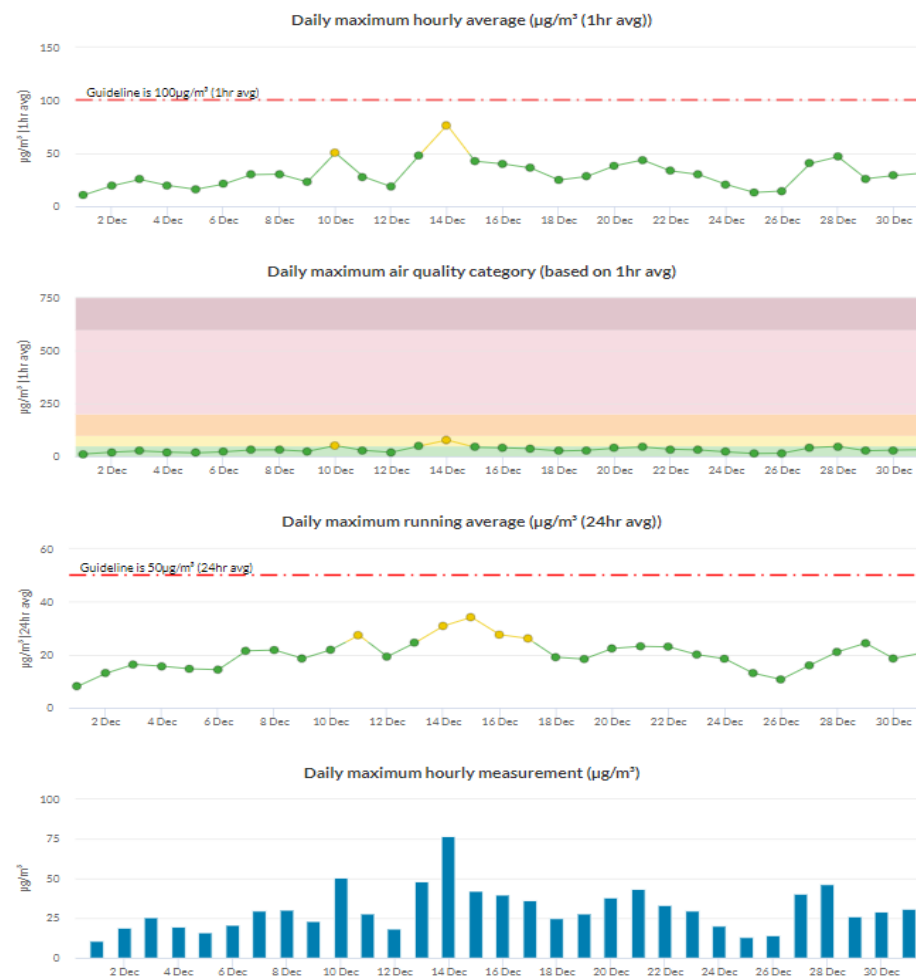
Figure 1: Woolloongabba – DES Station - PM10 graph for December 2021 (reproduction from the DES website).

The guideline for Particle PM₁₀ is 100µg/m³ (1hr avg) and 50µg/m³ (24hr avg).
