Cross River Rail Project

Monthly Environmental Report

September 2022

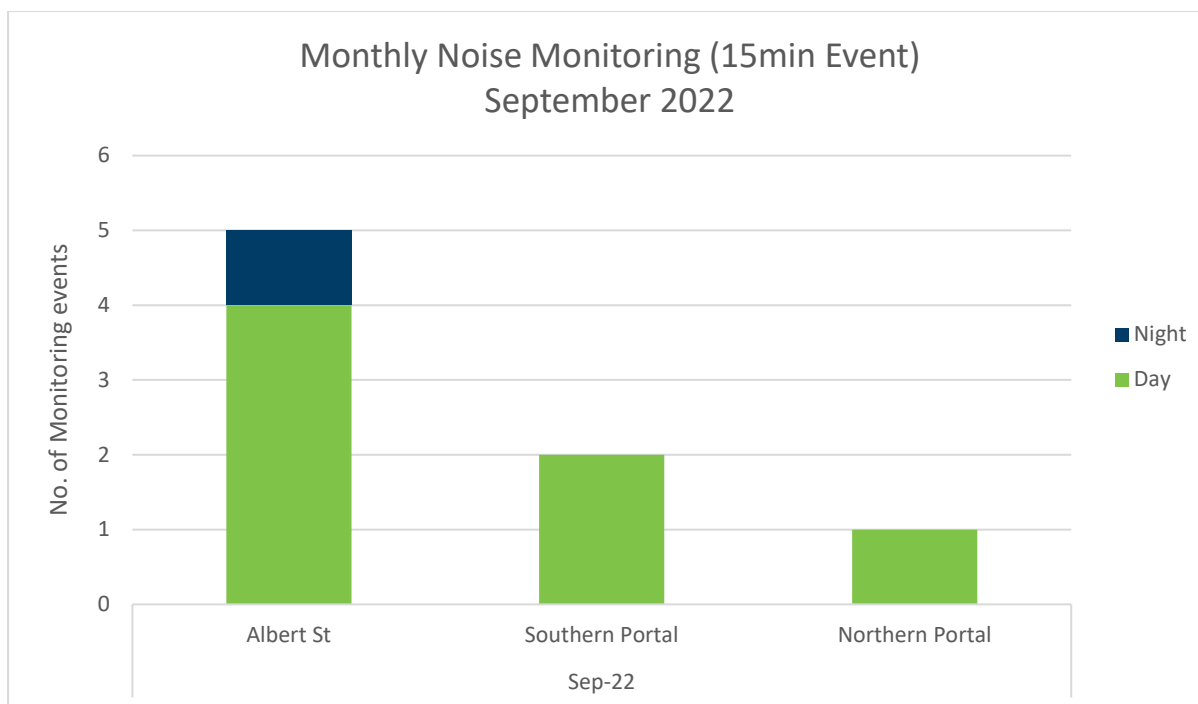
A summary of noise monitoring events for the month is provided in the chart below.

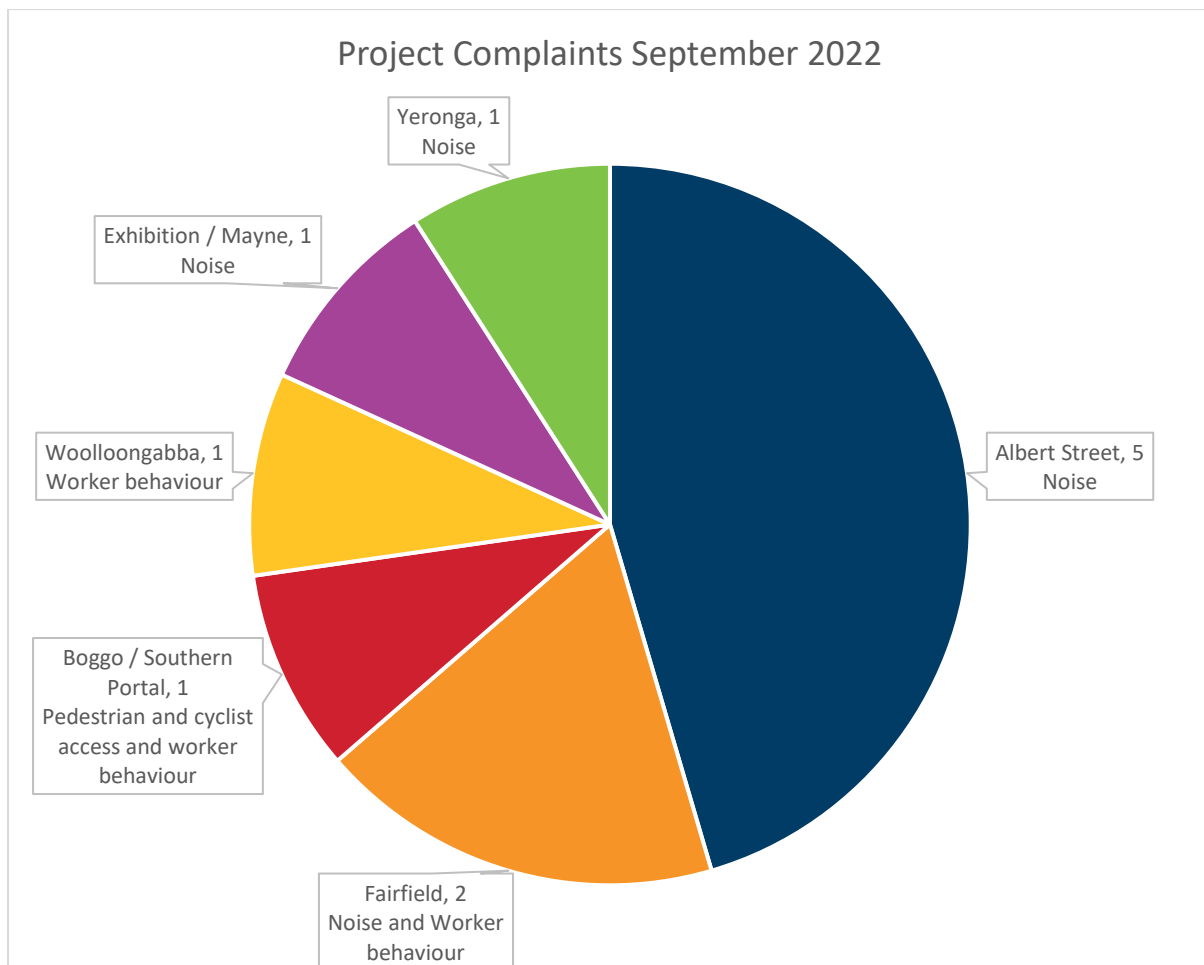
The Project Works complaints summary for the month is provided in the following chart.

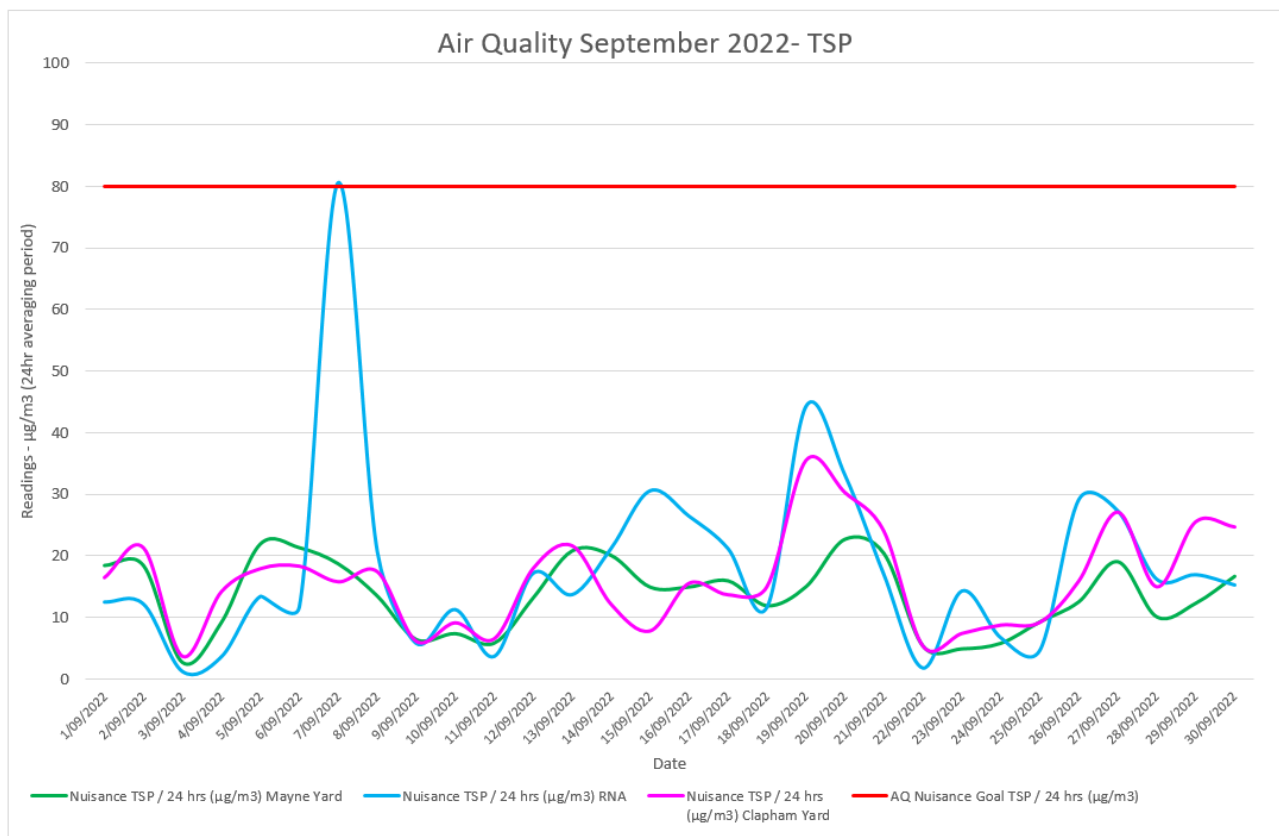
Figure 2 Air Quality Monitoring (TSP) Results

TSP is one of the indicators for which the Coordinator-General has imposed a goal of 80 µg/m³ (over an averaging period of 24 hours) the project must aim to achieve under Imposed Condition 13(a).

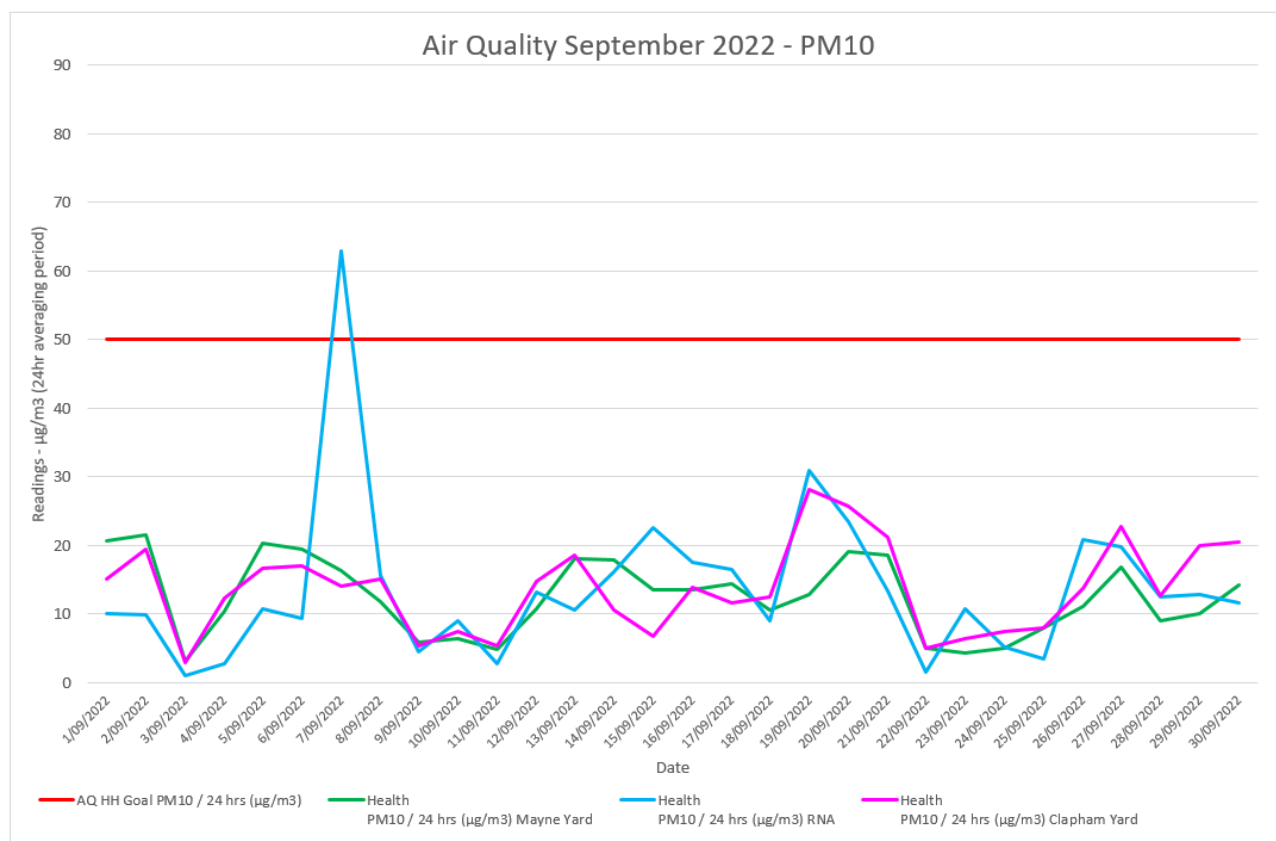
Figure 3 Air Quality Monitoring (PM10) Results

PM10 is one of the indicators for which the Coordinator-General has imposed a goal of 50 µg/m³ (over an averaging period of 24 hours) the project must aim to achieve under Imposed Condition 13(a).

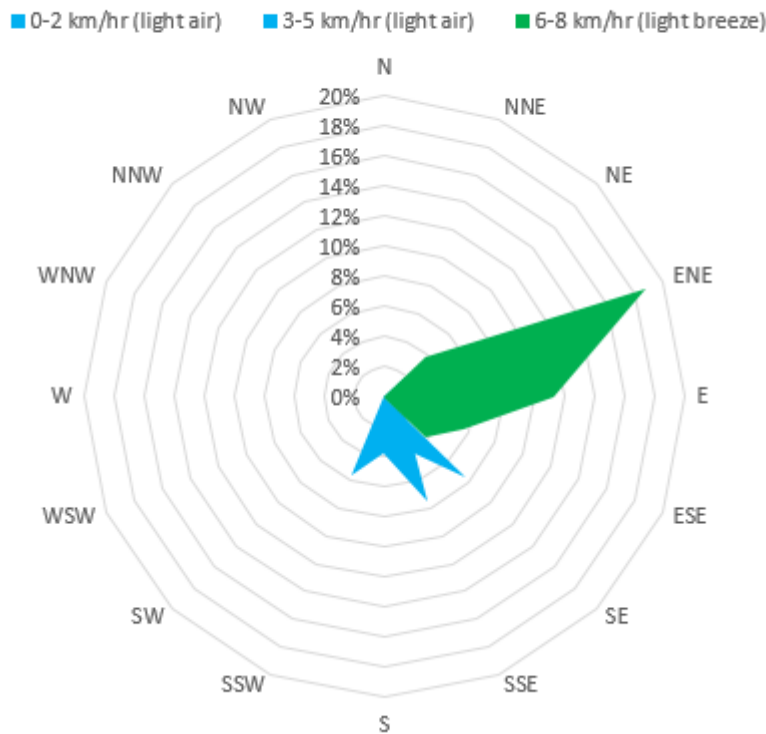
Figure 4 Wind Rose - 07 September 2022

Wind Rose - 07 September 2022 - 24 hours

As shown on the wind rose, the wind conditions were mild. Predominant winds were easterly winds, meaning that the DMP was downwind of the Project Works.

On the afternoon of 07 September 2022 when the highest readings were recorded and therefore contributed to the 24-hr goals exceedances, wind conditions show that high wind speeds reached up to 18 km/hr, which can be classified as a gentle breeze under the Beaufort Scale.

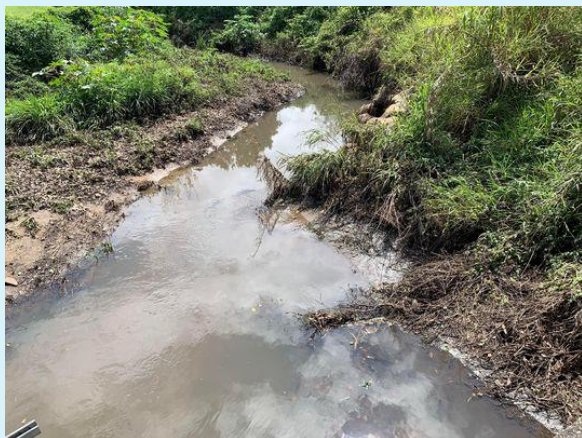
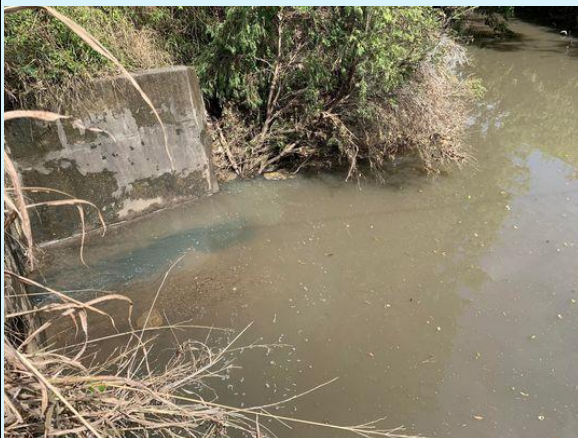
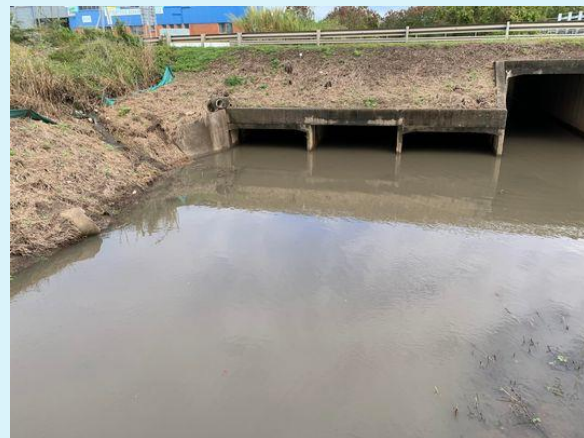
| Date | Location | Event size | Event above Design Criteria | ESC-P designed and regularly maintained by Suitably Qualified Person | ESC measures were installed and maintained to the appropriate standard | ESC measures damaged by the rain event | Evidence of site run off had entered the surface water bodies | Site run off had entered the surface water bodies without going through ESC measures | Presence of external sources of sedimentation | Previous rainfall resulting in increased run-off potential | Flood alert issued | Discernible downstream impact solely attributable to Project Works releases |
|--|---|--|--|--|---|--|---|--|---|--|---|---|
| 23 September 2022 | Clapham Yard Moolabin Creek | Between a 12EY ⁴ and 6EY Micro-bursts of between 4EY and 3EY recorded | Microbursts exceeded the Design Criteria | Yes | Yes | No | No | No | Yes – unknown black plume from midstream outlet | No | No | No – evidence midstream outlet may have impacted water quality downstream |
| SW- 5 – Upstream | | | | | Midstream | | | SW-6 – Downstream | | | | |

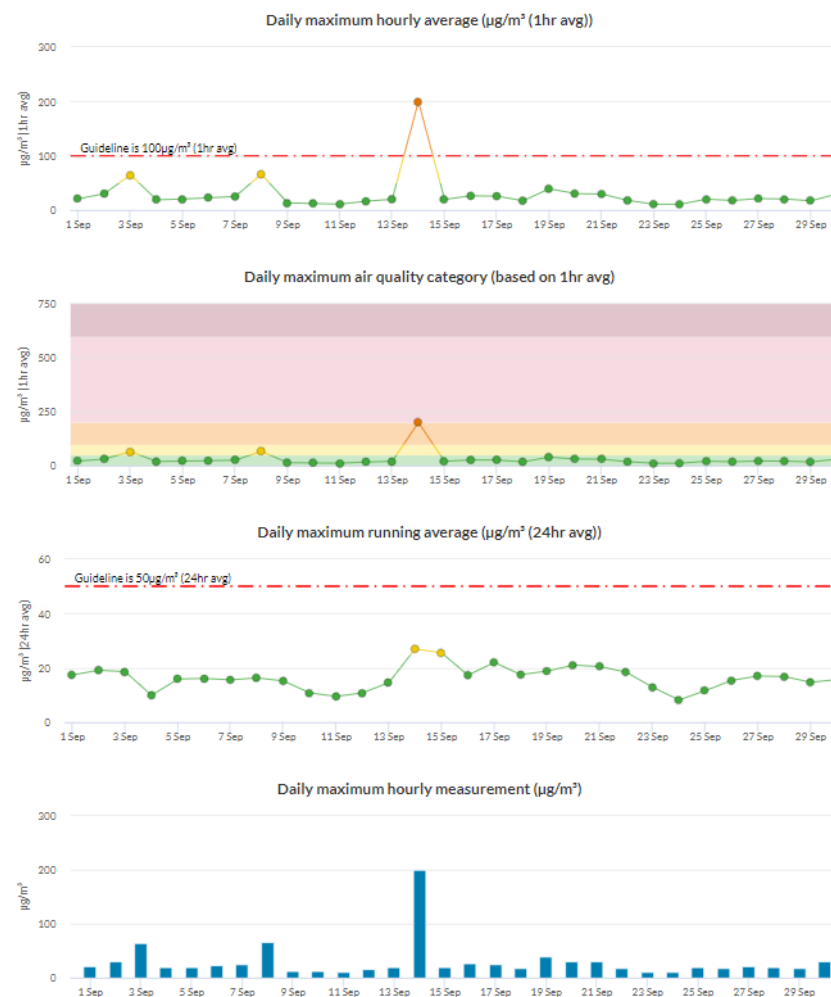
Figure 1: Brisbane CBD – DES Station - PM10 graph for September 2022 (reproduction from the DES website).

The guideline for Particle PM₁₀ is 100µg/m³ (1hr avg) and 50µg/m³ (24hr avg).

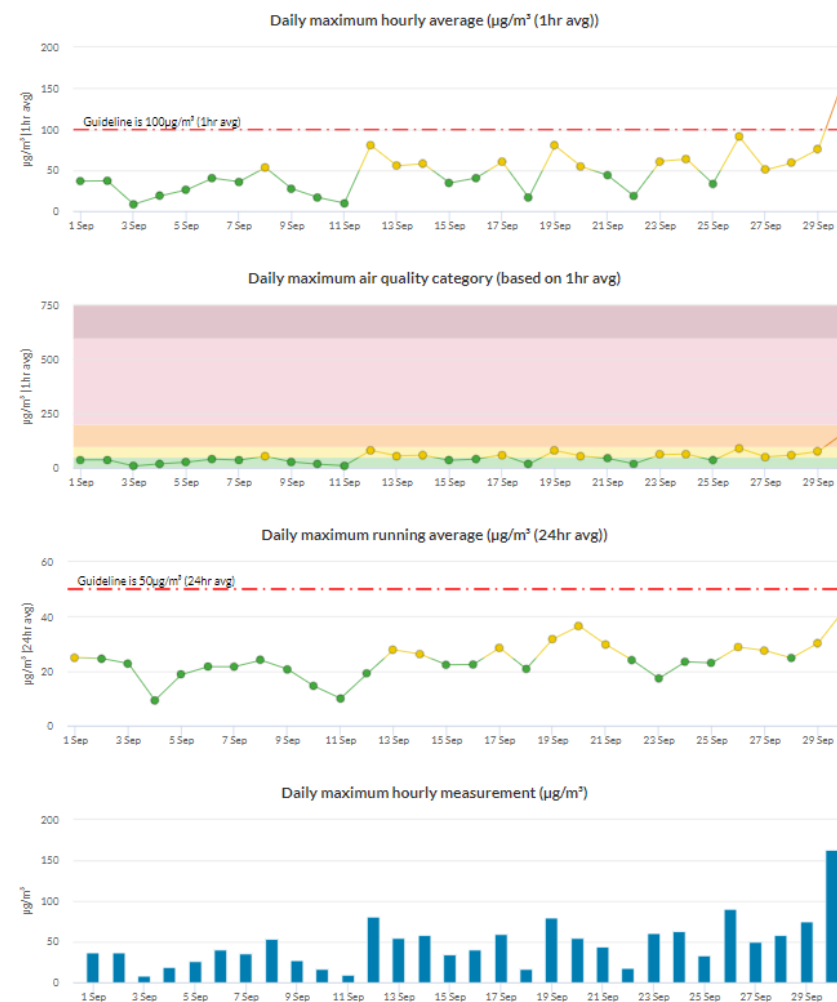
Figure 3: Woolloongabba – DES Station - PM10 graph for September 2022 (reproduction from the DES website).

The guideline for Particle PM₁₀ is 100µg/m³ (1hr avg) and 50µg/m³ (24hr avg).
