Cross River Rail Project

Monthly Environmental Report

November 2022

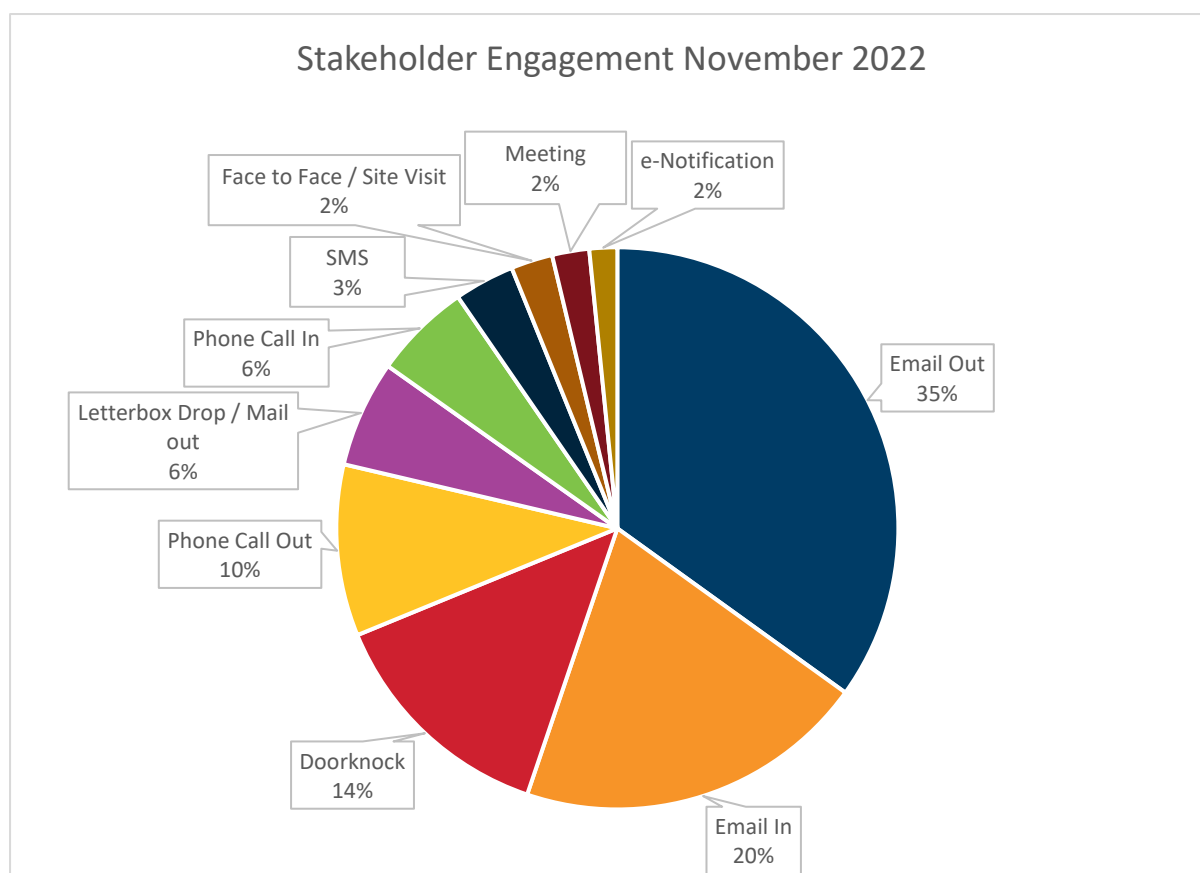
For scheduled out of hours works, community notification was provided, as well as regular project updates. Stakeholder engagement undertaken on the project during the month is summarised in the chart below.

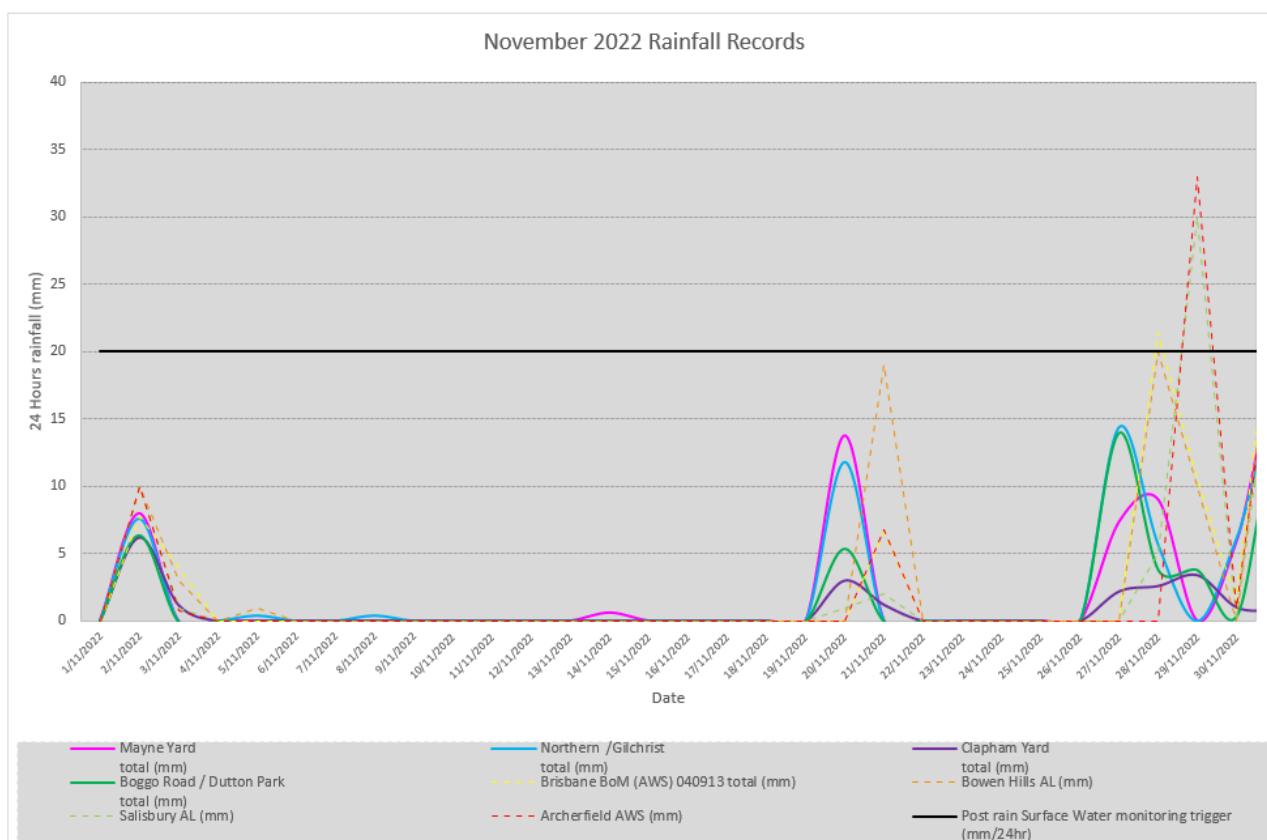
Figure 6: November 2022 Rainfall Records

Post rainfall monitoring is triggered typically following any rainfall event exceeding 20 to 25 mm over 24 hours, however, storm events during the high-risk period of the year (November to March) of lesser amounts but of a higher intensity may cause run-off which would also trigger post-rain monitoring consistent with the C-EMP.
