Cross River Rail Project

Monthly Environmental Report

February 2023

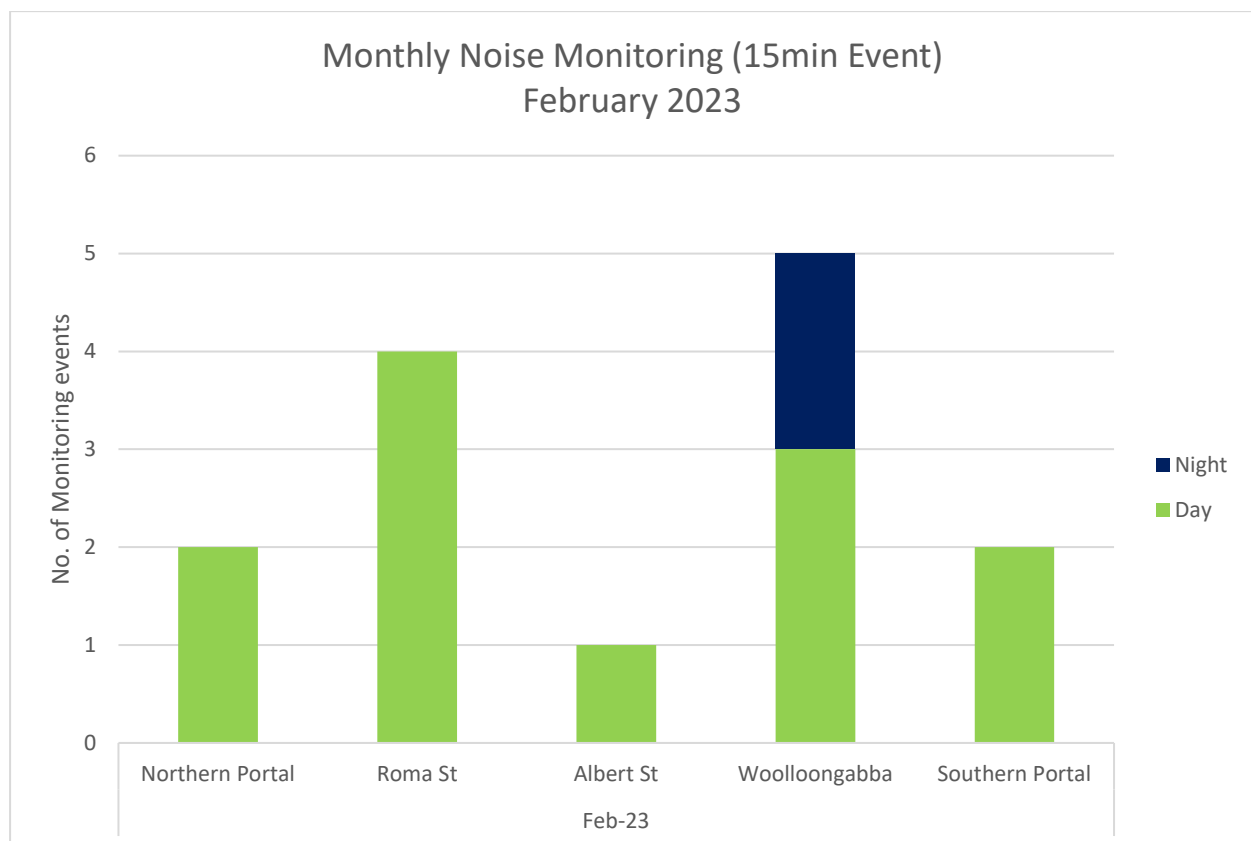
A summary of noise monitoring events for the month is provided in the chart below.

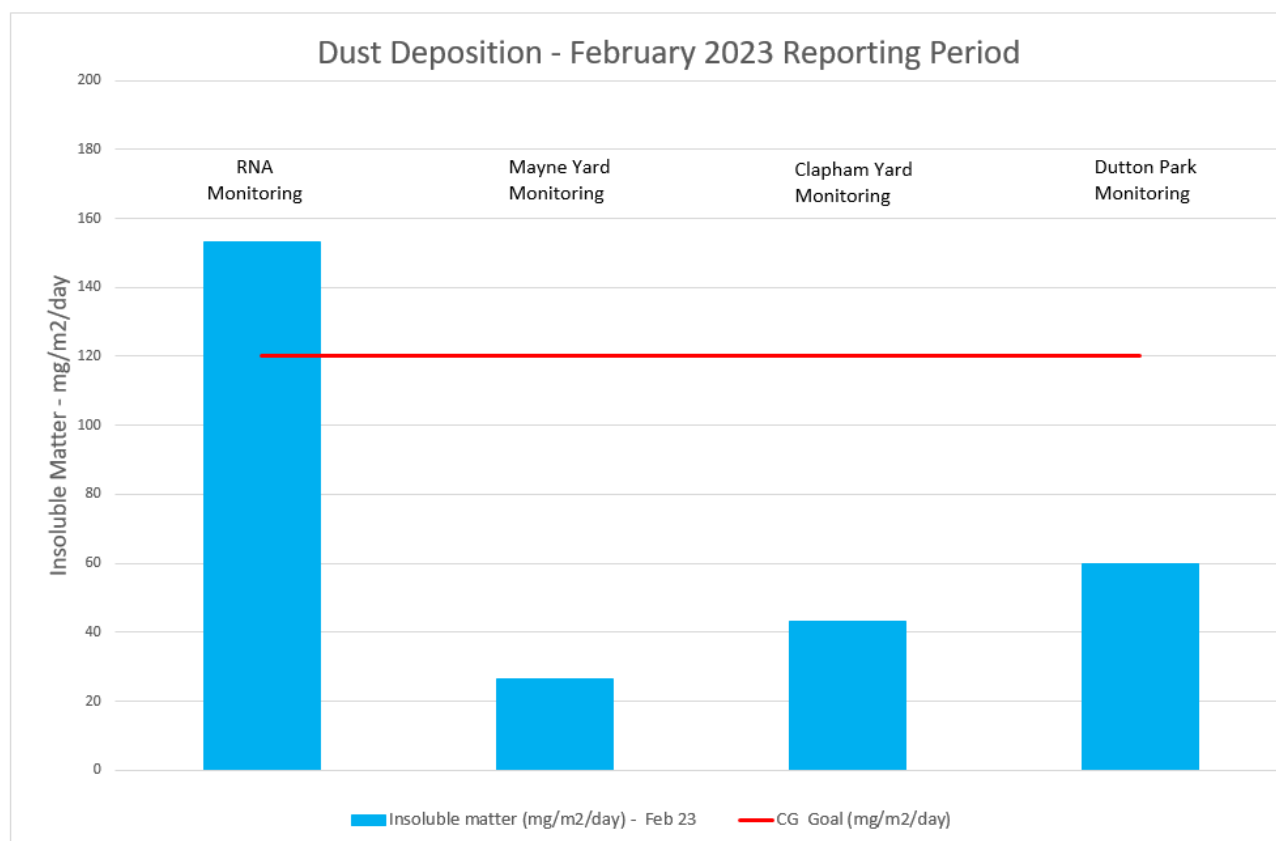
Figure 1 Air Quality Monitoring (Deposited Dust) Results

At the RNA worksite, the measured dust deposition level of 153 mg/m²/day exceeded the goal of 120 mg/m²/day. These elevated levels were primarily due to the dust deposition gauge being relocated much closer to the works, as per recommendation by the Project Certified Air Quality Professional (CAQP) from the vacant block next to the apartments at 6 Tufton Street to the RNA Showgrounds, to mitigate ongoing data loss due to repeated vandalism. The dust deposition gauge was relocated to the fence line, directly above project works which primarily consisted of rock break and cut and fill works associated with Stage 2 demolition works. The scale, duration and intensity of the activities was consistent with the activities reviewed as part of the predictive air quality assessment.

It is noted that the project team continues to actively implement a range of dust mitigation measures at the site. This includes erosion control, dust suppression using water carts, using stabilized access points and utilising the street sweepers as required. There were no complaints from nearby sensitive receptors regarding air quality from the RNA works during the monitoring period. Dust deposition results are detailed in **Appendix A** (Table 7 and Figure 1) and **Appendix B** (Table 4.2).

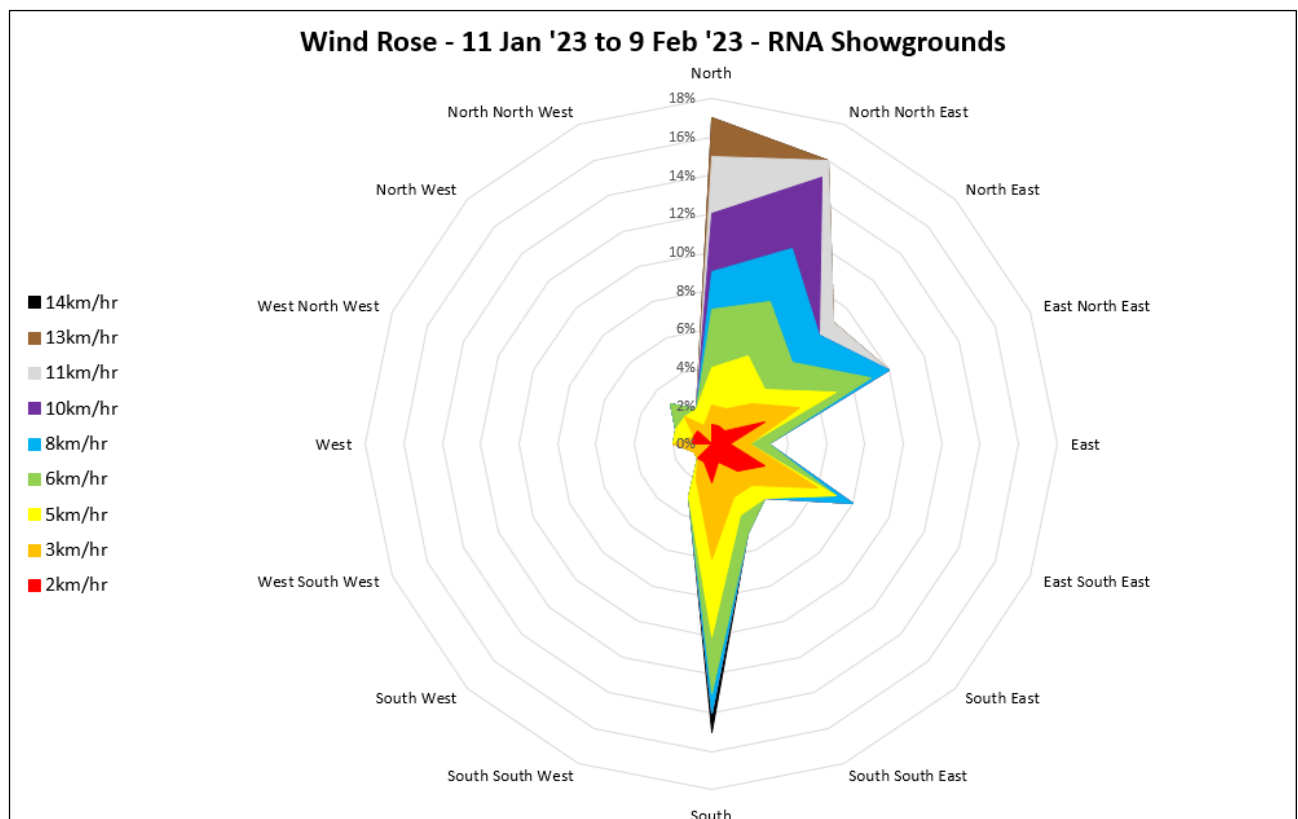
Figure 2 RNA Wind Rose During DDG Measurement Period

A wind rose was completed (refer to Figure 2) to ascertain the predominant winds during the measurement period and whether abnormal wind conditions occurred during the period.

- The DDG was downwind of the Project Works 62% of the time, and
- Wind conditions were light to gentle (according to the Beaufort Scale) during the majority (98%) of the measurement period.

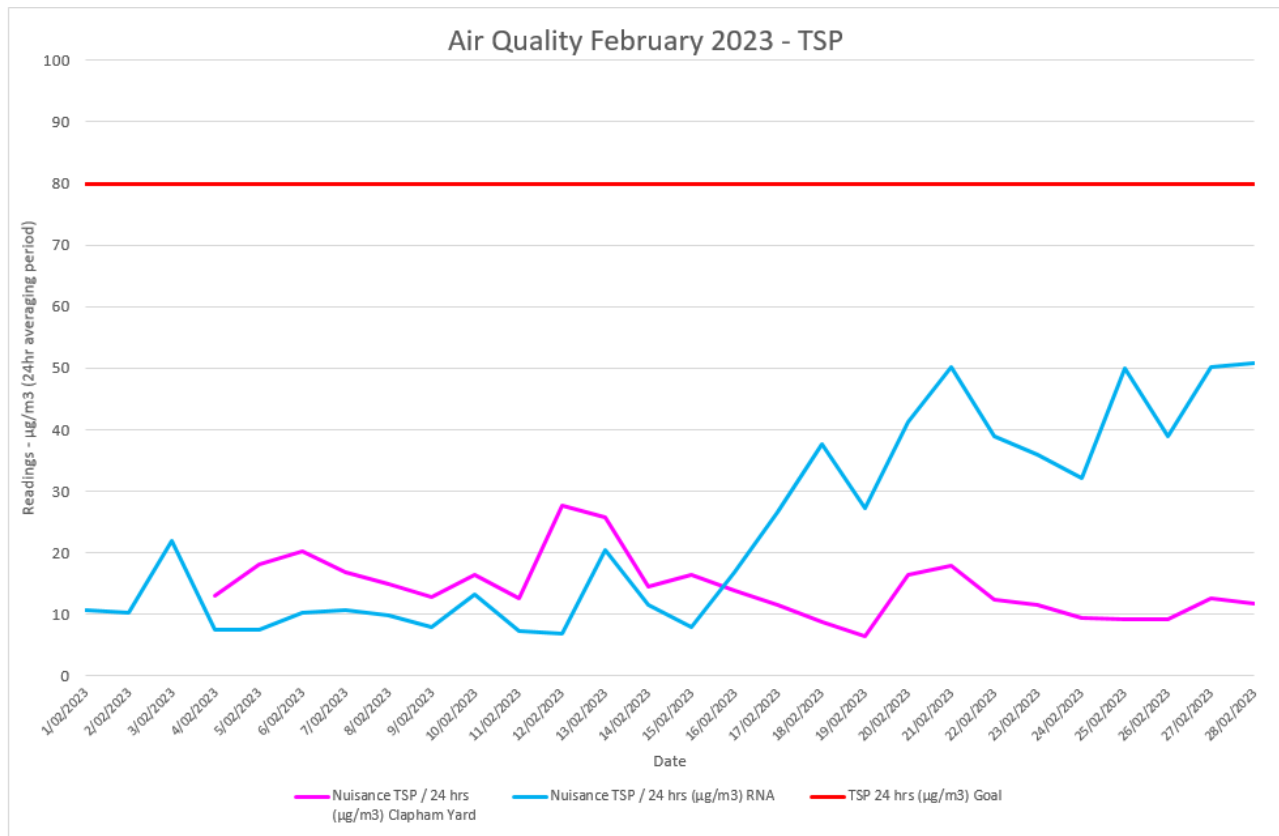
Figure 3 Air Quality Monitoring (TSP) Results

TSP is one of the indicators for which the Coordinator-General has imposed a goal of 80 $\mu\text{g}/\text{m}^3$ (over an averaging period of 24 hours) the project must aim to achieve under Imposed Condition 13(a).

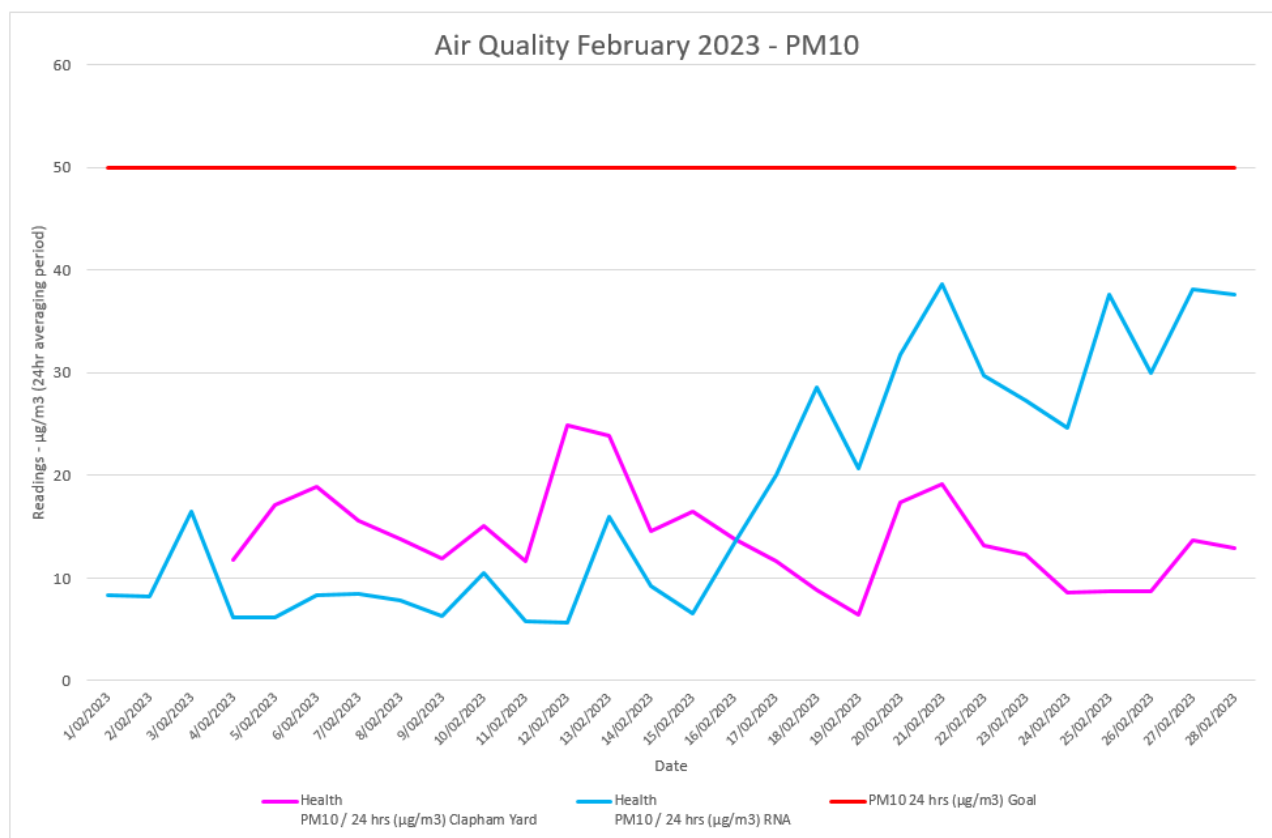
Figure 4 Air Quality Monitoring (PM10) Results

PM_{10} is one of the indicators for which the Coordinator-General has imposed a goal of 50 $\mu\text{g}/\text{m}^3$ (over an averaging period of 24 hours) the project must aim to achieve under Imposed Condition 13(a).

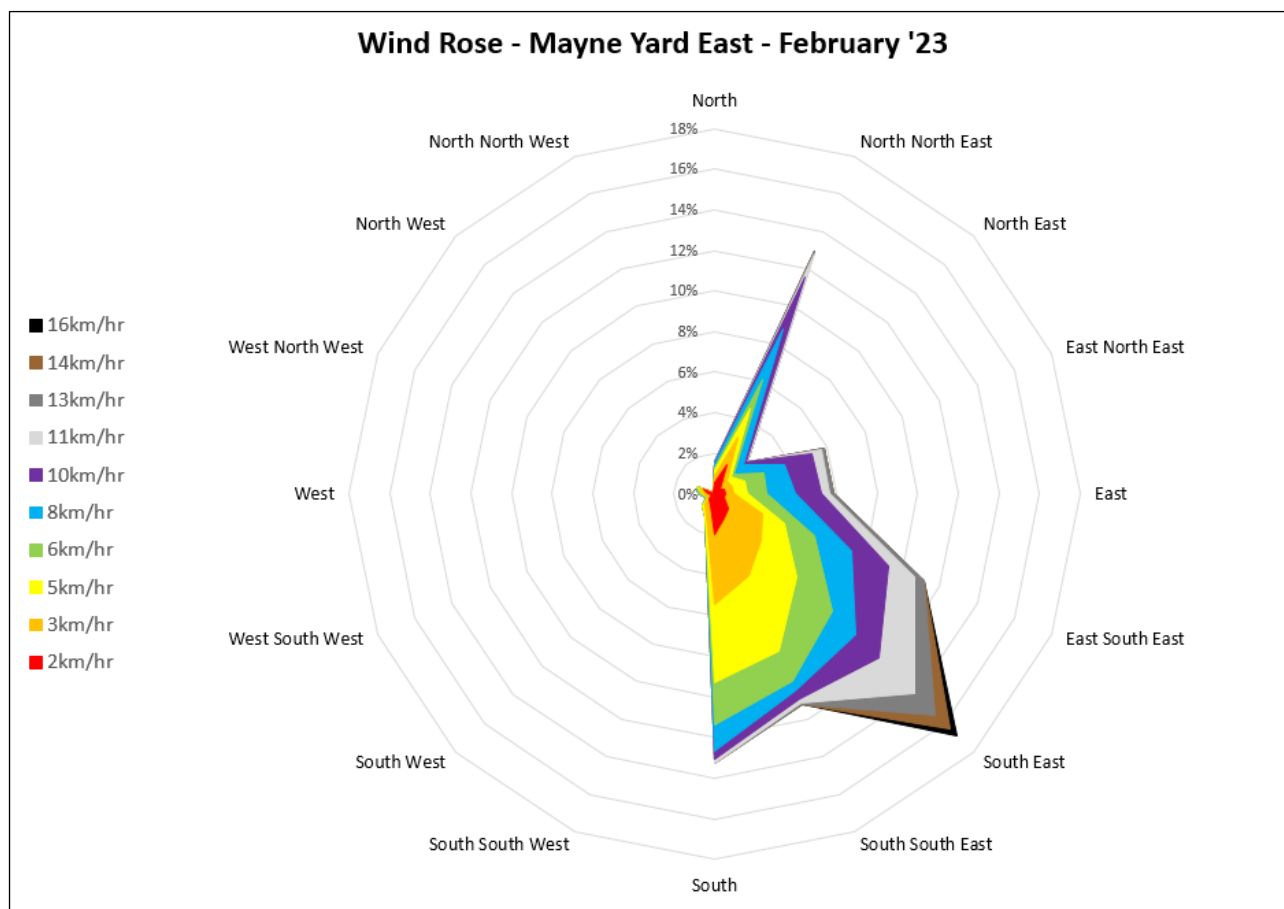
Figure 5 Mayne Yard East February 2023 Wind Rose

As shown in the wind rose below (refer Figure 5) the predominant winds during the reporting period were from a south easterly direction. As a result, any potential dust generated from UNITY works would have

travelled north-west away from the sensitive receptors located east of Mayne Yard East on Abbotsford Road.

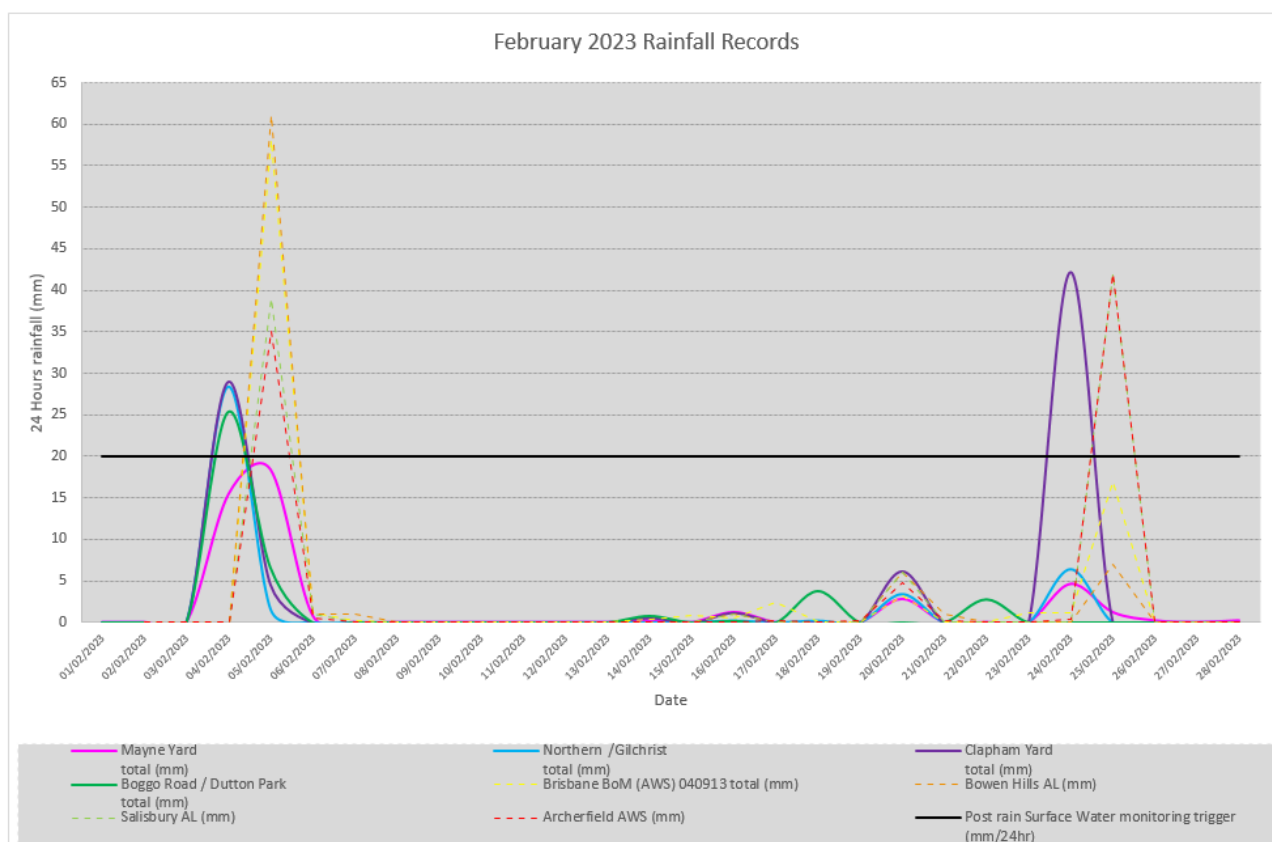
Figure 6 February 2023 Rainfall Records

Post rainfall monitoring is triggered typically following any rainfall event exceeding 20 to 25 mm over 24 hours, however, storm events during the high-risk period of the year (November to March) of lesser amounts but of a higher intensity may cause run-off which would also trigger post-rain monitoring consistent with the C-EMP.

The assessment found that the storm event size was above the design criteria for the controls required for the Mayne Yard and Clapham Yard Works. The entire rainfall event was between 2EY and 1EY with microbursts exceeding 2EY at Mayne Yard and 0.2EY over a 30-minute period at Clapham Yard.

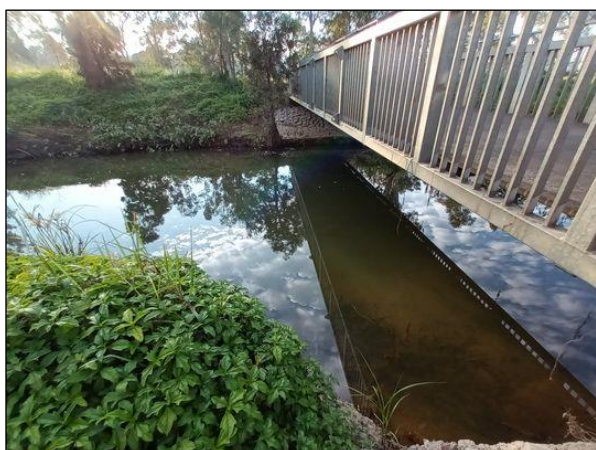
Figure 7 SW-09 27 June 2022

The conditions at SW-09 (Stable Swamp Creek) were not consistent with previous bi-annual monitoring undertaken at this location. The water turbidity was visibly higher than previous monitoring sessions (refer to Figure 7 and Figure 8 below). During monitoring there were no obvious indicators of what activities contributed to the increased turbidity.

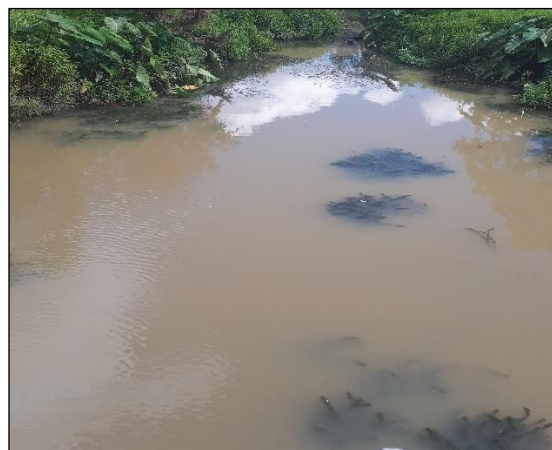
Figure 8 SW-09 10 February 2023

UNITY is not currently undertaking works at sites which discharge to this water body, therefore the increased turbidity cannot be attributed to RIS Works.

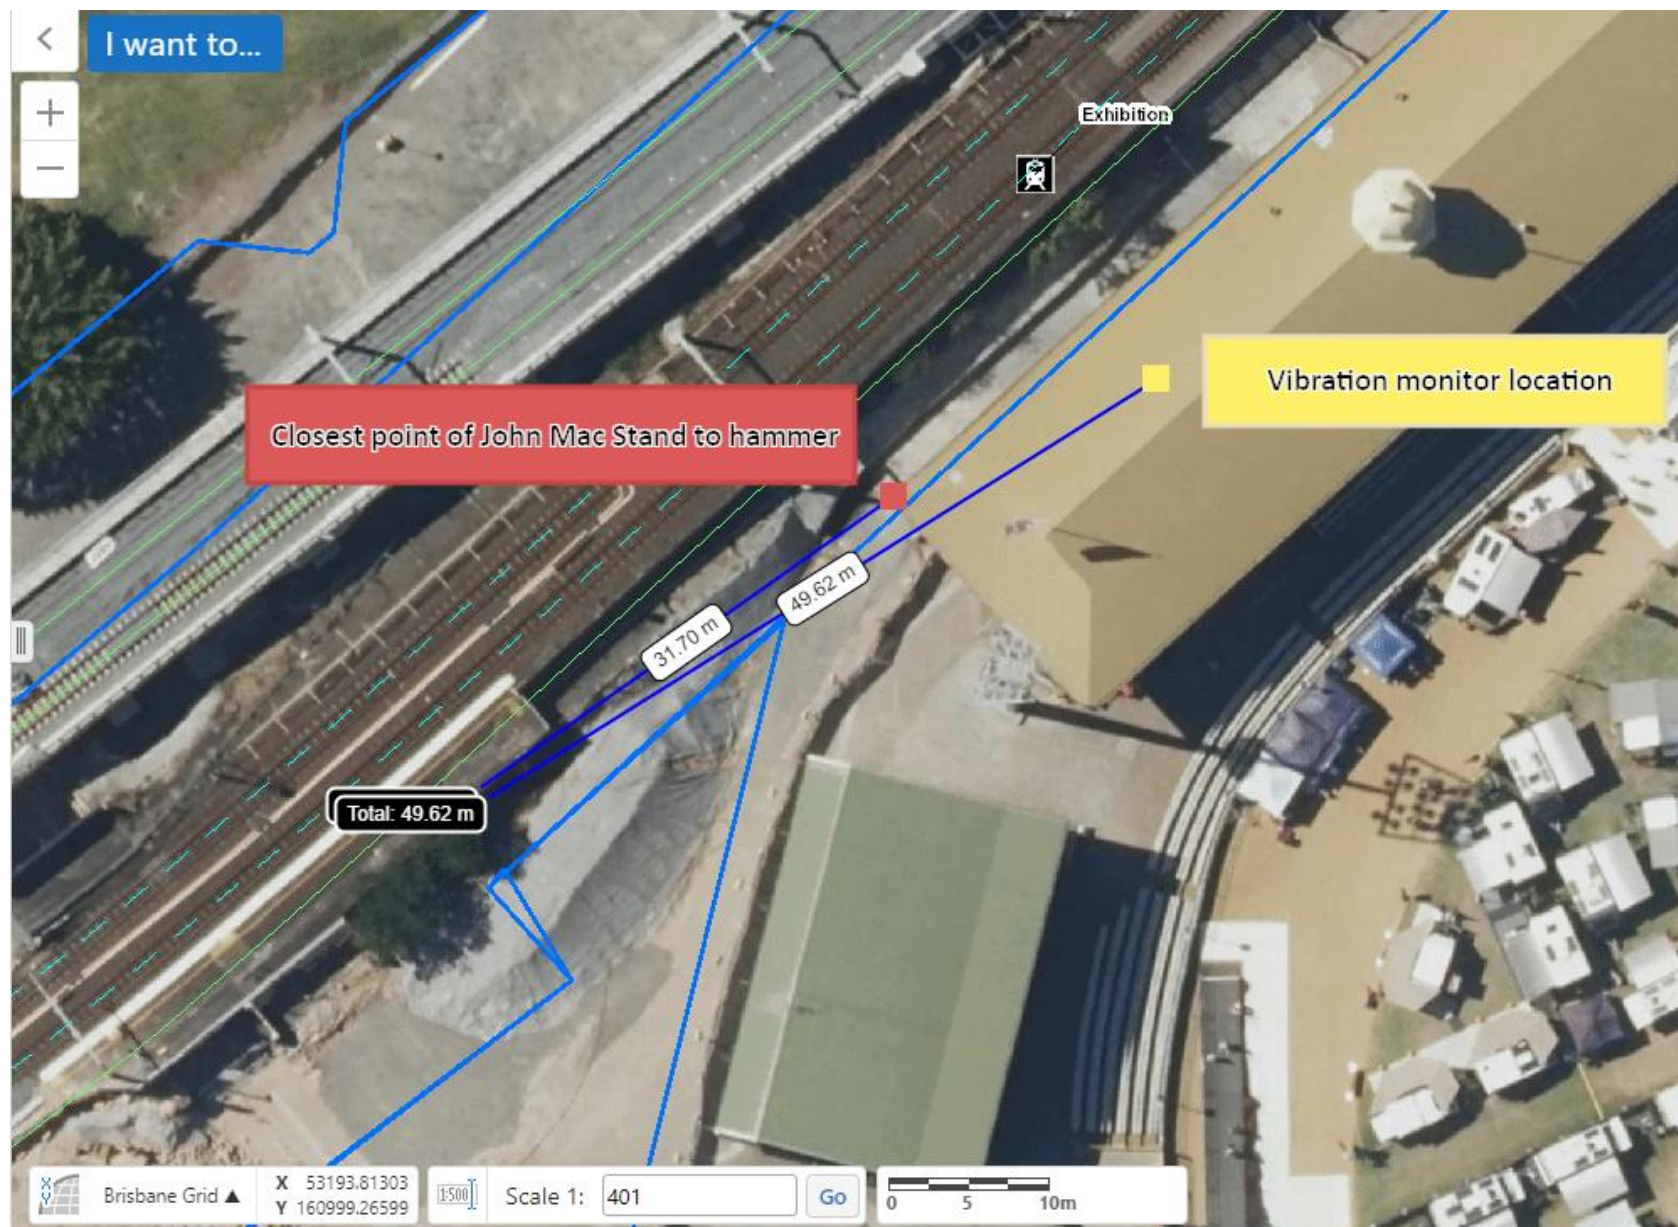
Figure 9 RNA February 2023 Vibration Monitoring

Vibration monitoring during rock breaking works at the RNA Showgrounds was undertaken at the foundation of the State heritage John MacDonald Stand inside a storeroom. This location was selected based on the outcomes of predictive assessments.

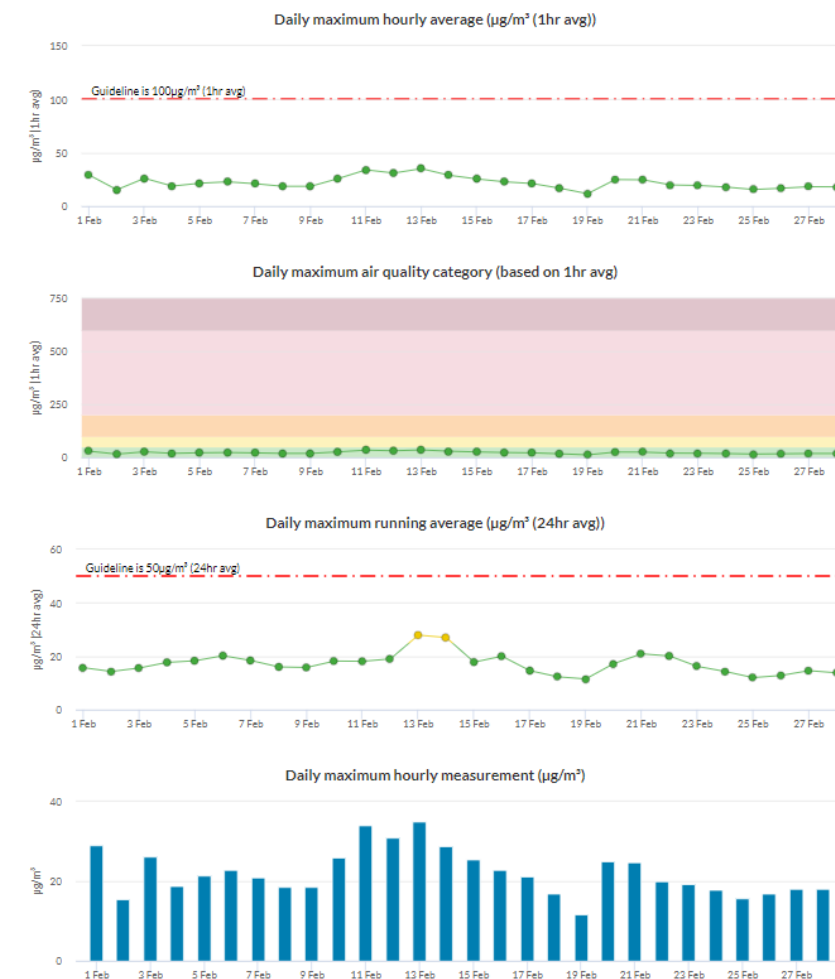
Figure 1: Brisbane CBD – DES Station - PM10 graph for February 2023 (reproduction from the DES website).

The guideline for Particle PM₁₀ is 100µg/m³ (1hr avg) and 50µg/m³ (24hr avg).

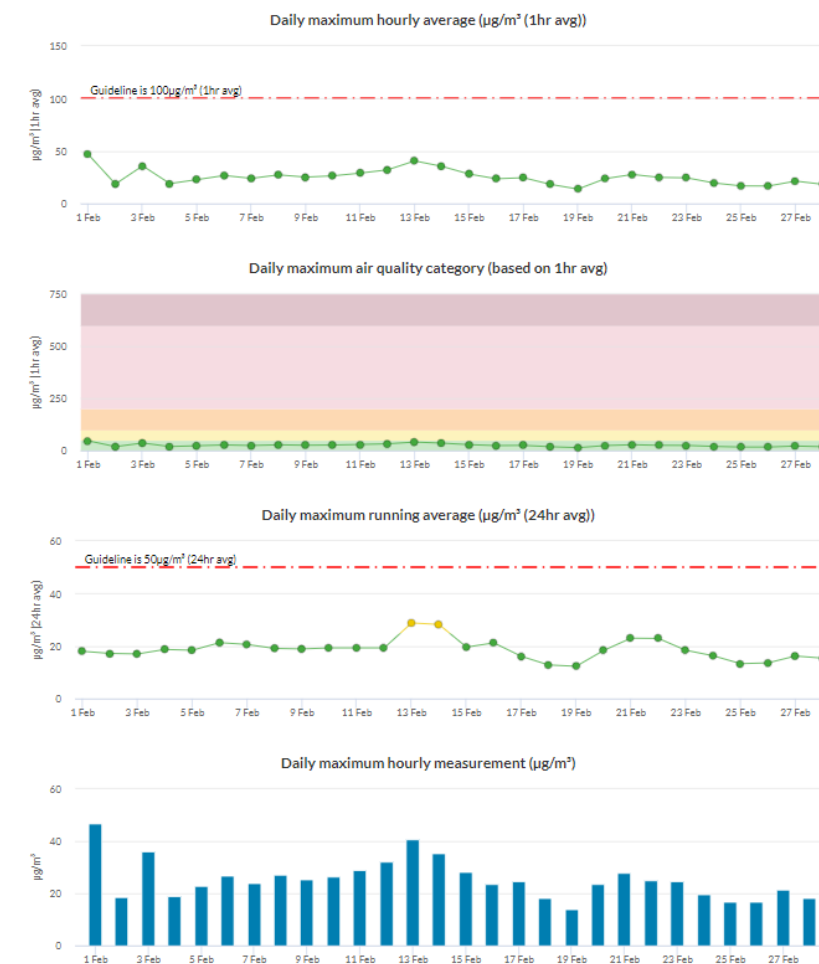
Figure 2: South Brisbane – DES Station - PM10 graph for February 2023 (reproduction from the DES website).

The guideline for Particle PM₁₀ is 100µg/m³ (1hr avg) and 50µg/m³ (24hr avg).
