# Cross River Rail Project

## Monthly Environmental Report

*August 2025*

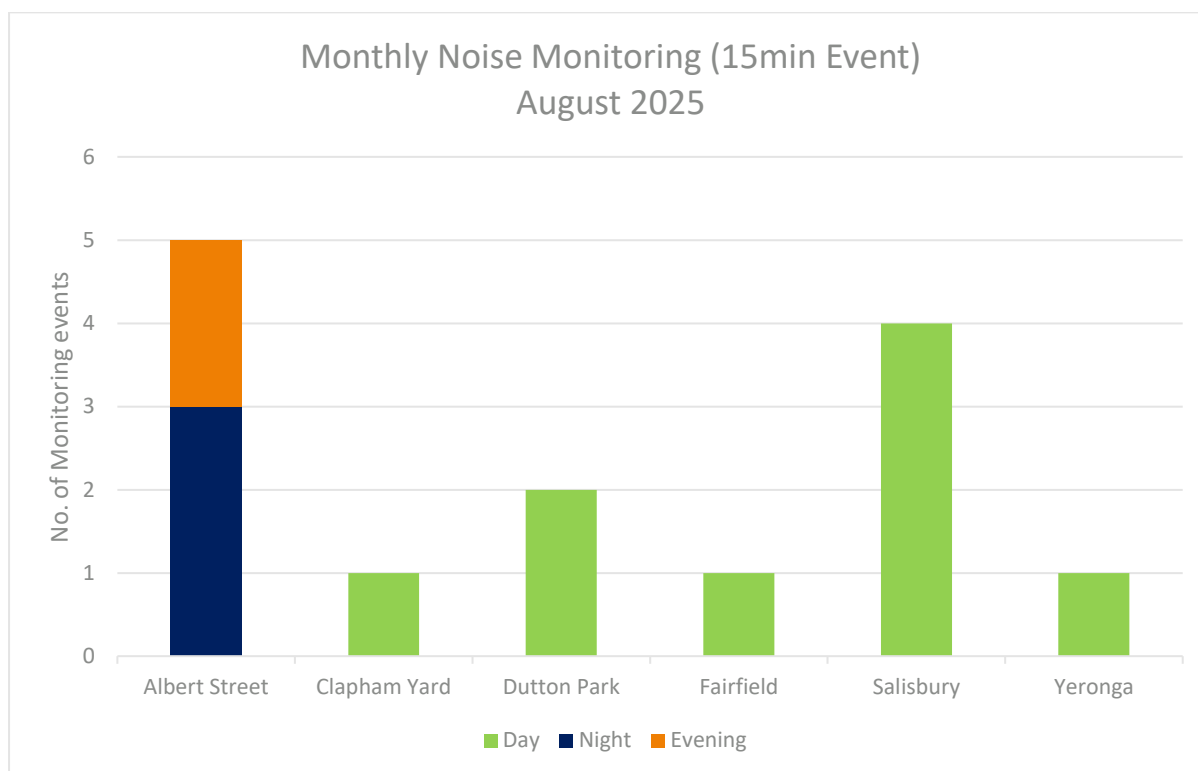
For areas where monitoring was not completed, including the Out of Hours works, potential noise levels have been previously assessed and monitored for similar activities. Subsequently these works and their potential noise levels were deemed consistent with previous monitoring undertaken for the project across the relevant locations. A summary of noise monitoring events for the month is provided in the chart below:

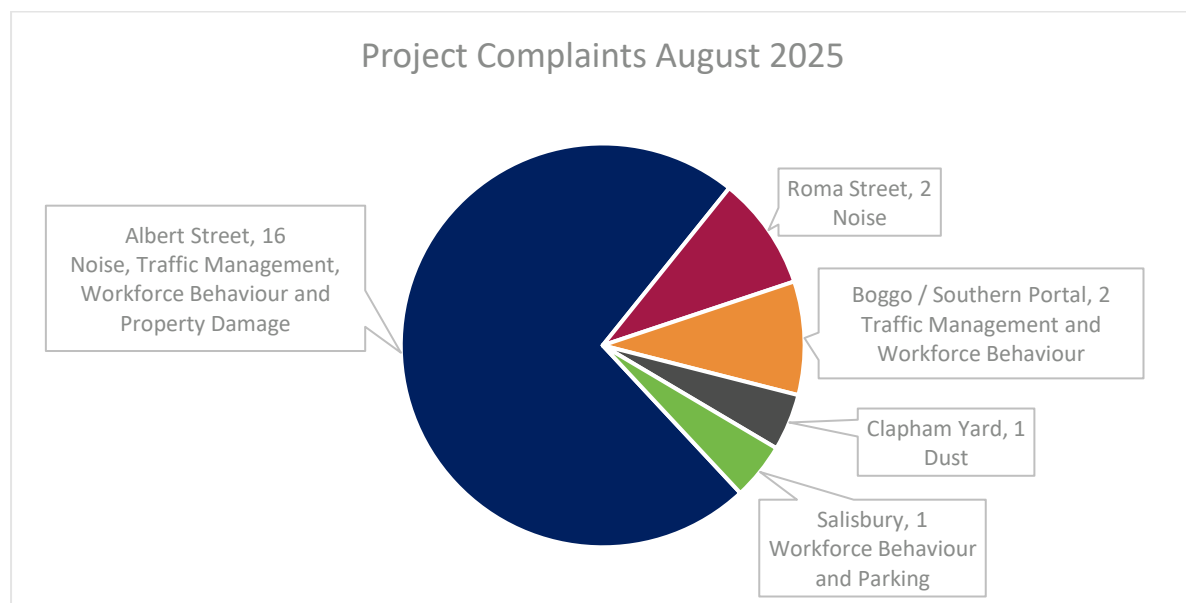
TSD works received twenty-three (23) complaints in August 2025, of which twenty (20) were related to Project Works. These included noise, traffic management, workforce behaviour and property damage (damaged clothing) at Albert Street, traffic management at the Boggo Road precinct and noise and traffic management at Roma Street. The majority of complaints were attributed to night-time green spine works at Albert Street. For further details and a breakdown of complaints, refer to **Appendix B** (Section 5 and Table 10).

The Project Works related complaints summary for the month is provided in the chart below:

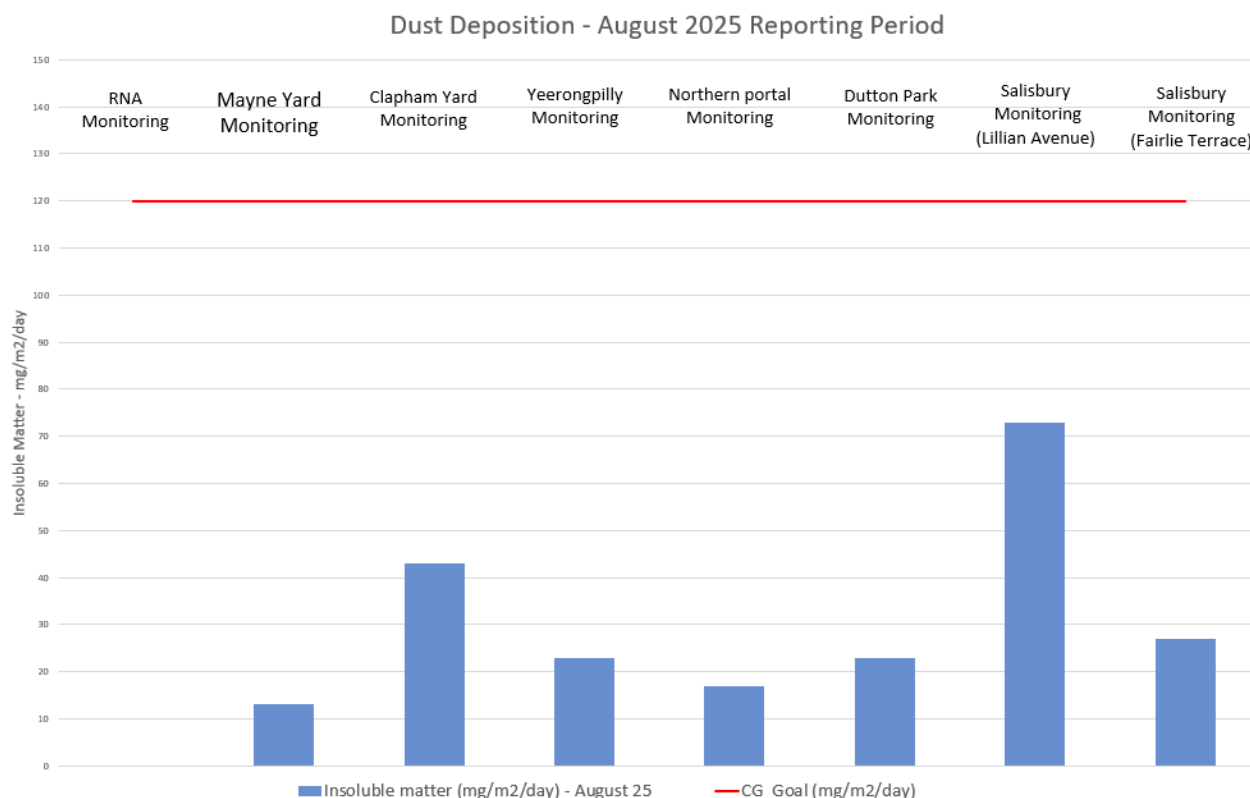
Figure 1: Air Quality Monitoring - Deposited Dust Data

[1]: No sample available for collection. The DDG sampling apparatus was found tampered with and damaged during non-project works related to The Royal Queensland Show (EKKA) event.

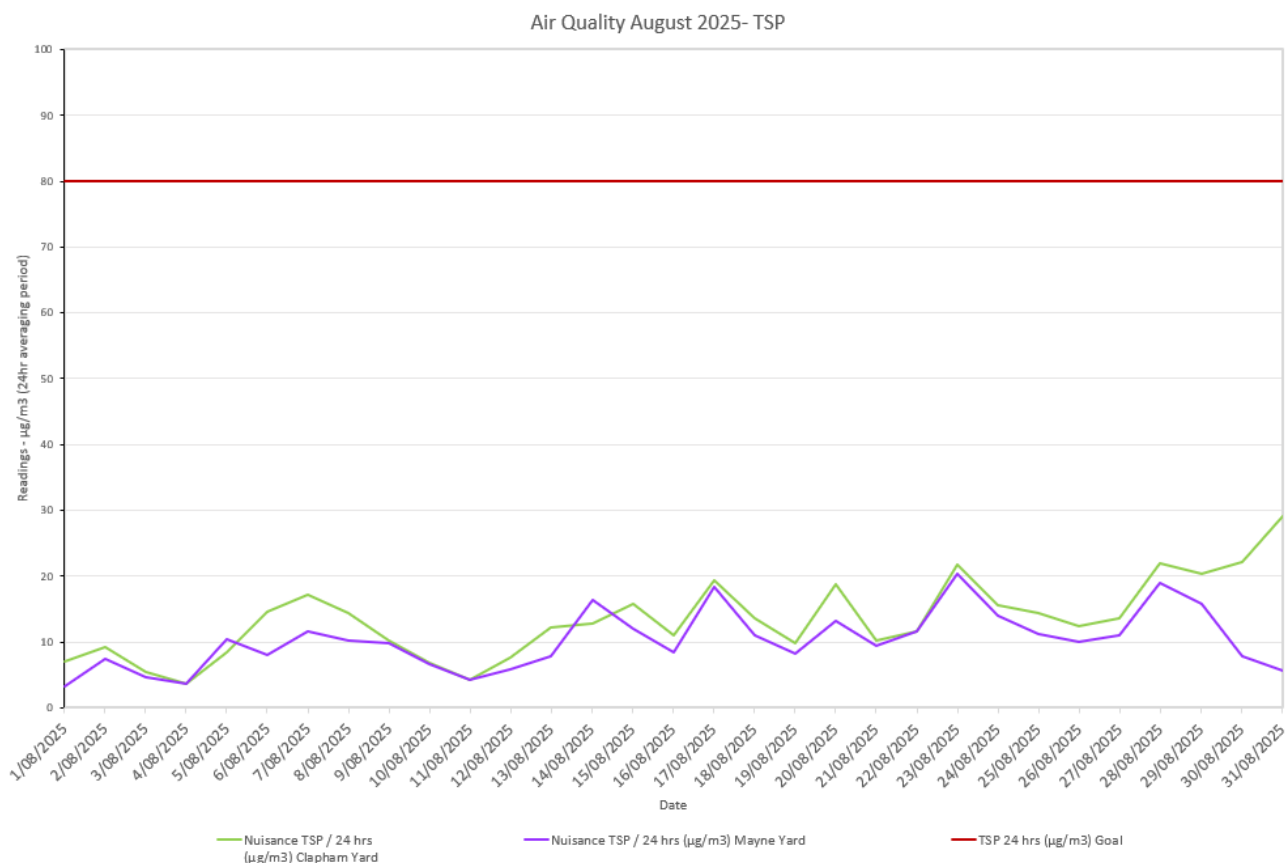
Figure 2: Air Quality Monitoring – Total Suspended Particles Data

TSP and PM10 monitoring were conducted during August 2025. Targeted monitoring of potential dust-generating activities is conducted by the mobile air quality units and was completed at the Mayne Yard and Clapham Yard worksites during August 2025. No exceedances were recorded during this reporting period.

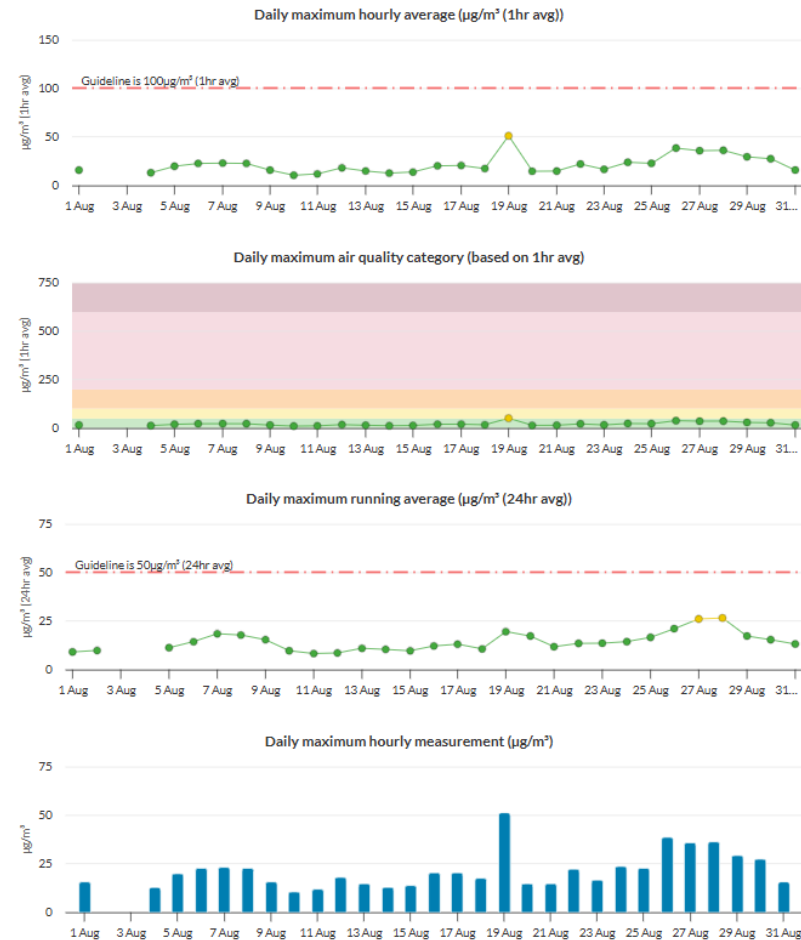
Figure 1: Brisbane CBD – DETSI Station - PM10 graph for August 2025 (reproduction from the DETSI website).

The guideline for Particle PM<sub>10</sub> is 100µg/m<sup>3</sup> (1hr avg) and 50µg/m<sup>3</sup> (24hr avg).

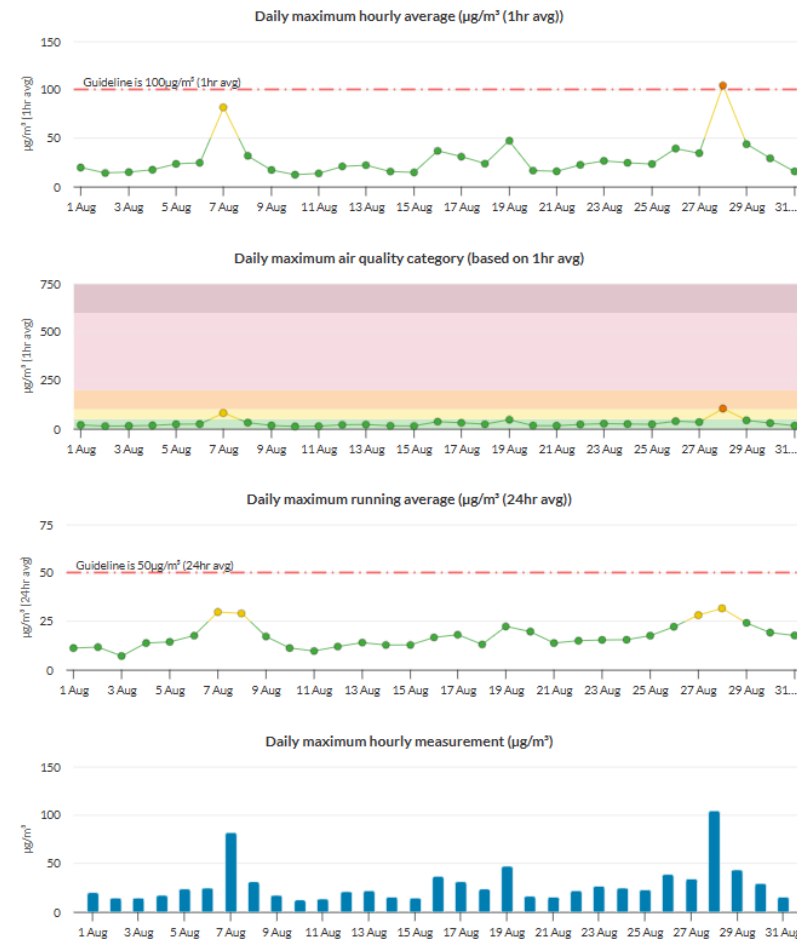
Figure 2: South Brisbane – DETSI Station - PM10 graph for August 2025 (reproduction from the DETSI website).

The guideline for Particle PM<sub>10</sub> is 100µg/m<sup>3</sup> (1hr avg) and 50µg/m<sup>3</sup> (24hr avg).

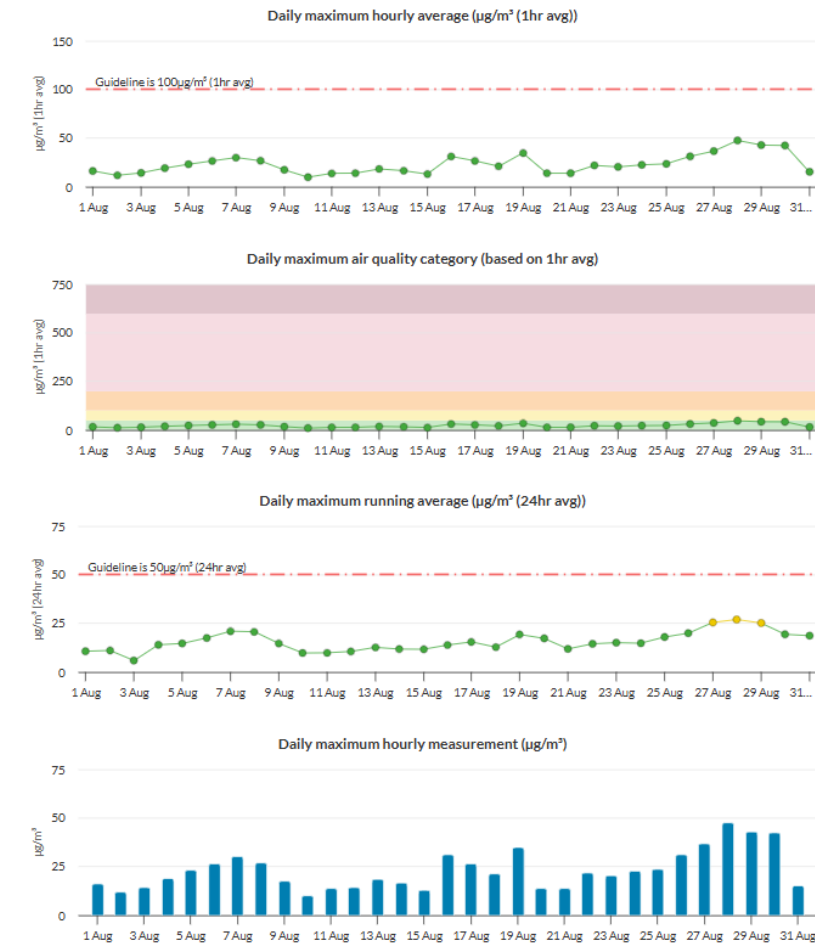
Figure 3: Woolloongabba – DETSI Station - PM10 graph for August 2025 (reproduction from the DETSI website).

The guideline for Particle PM<sub>10</sub> is 100µg/m<sup>3</sup> (1hr avg) and 50µg/m<sup>3</sup> (24hr avg).
