Cross River Rail Project

Monthly Environmental Report

December 2025

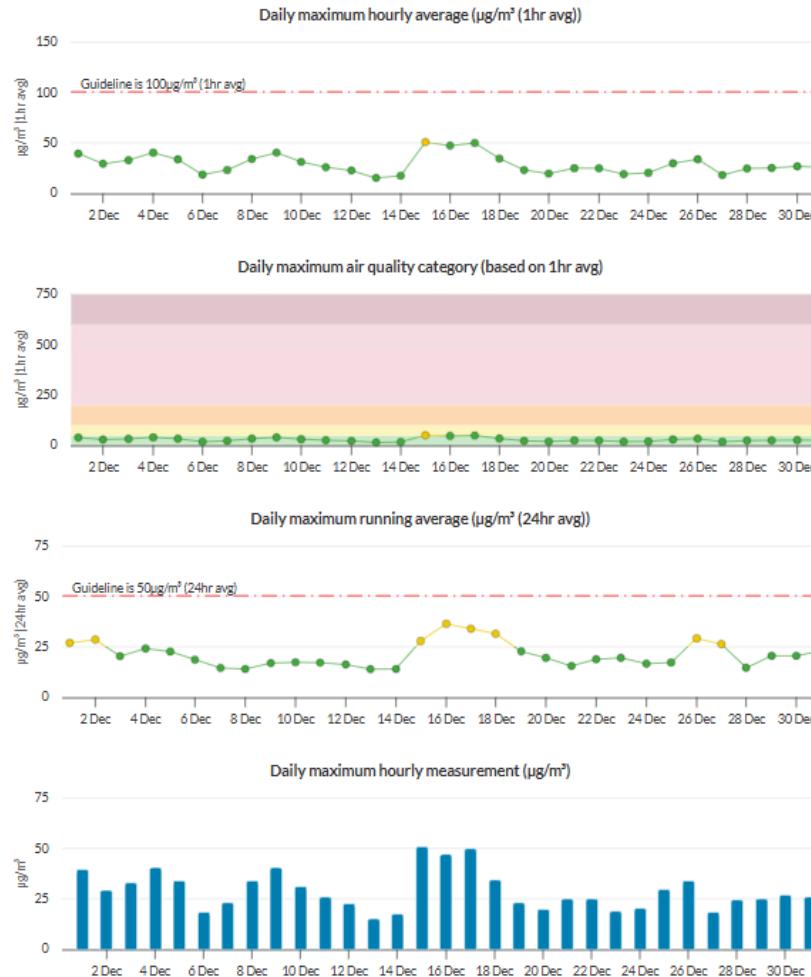
The guideline for Particle PM₁₀ is 100 $\mu\text{g}/\text{m}^3$ (1hr avg) and 50 $\mu\text{g}/\text{m}^3$ (24hr avg).

Figure 2: South Brisbane – DETSI Station - PM10 graph for December 2025 (reproduction from the DETSI website).

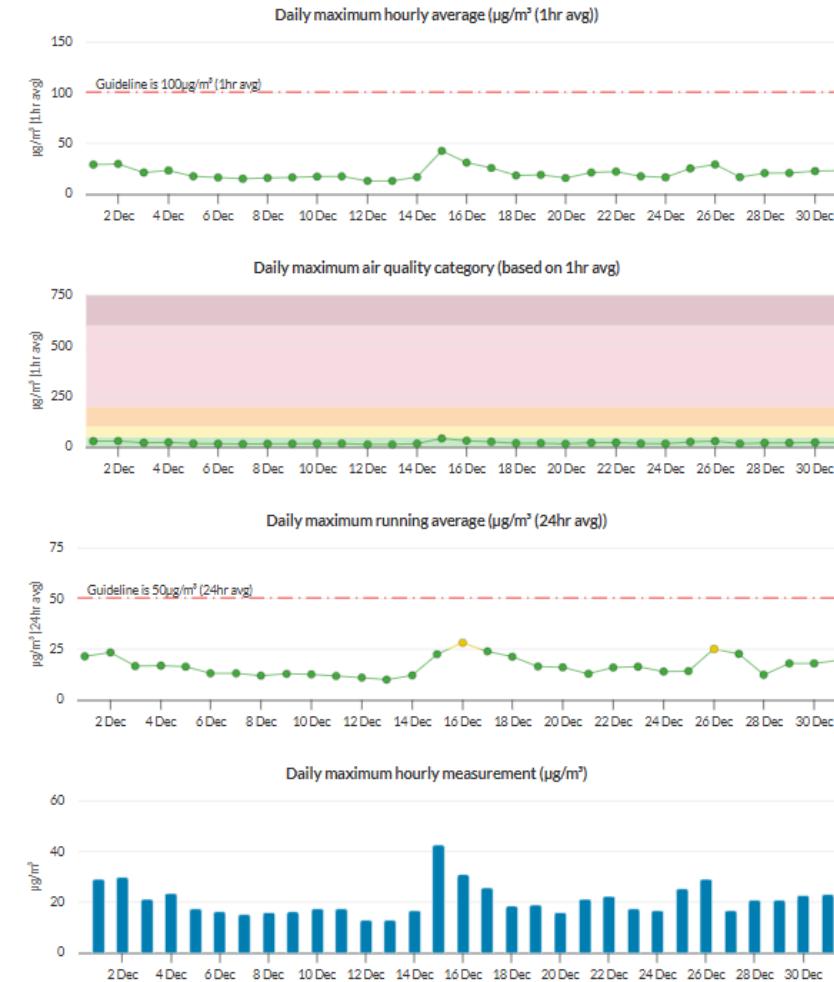
The guideline for Particle PM₁₀ is 100 $\mu\text{g}/\text{m}^3$ (1hr avg) and 50 $\mu\text{g}/\text{m}^3$ (24hr avg).

Figure 3: Woolloongabba – DETSI Station - PM10 graph for December 2025 (reproduction from the DETSI website).

In the Central Area, the Woolloongabba air quality unit experienced technical difficulties from 5 December 2025. This was first detected during the data download for the reporting period as the error notification alarm failed to activate. The Contractor is investigating solutions to resolve the issue. The nearby DETSI (Woolloongabba) air quality monitoring station confirmed air quality levels were below the air quality goals during the outage period. Refer to **Appendix B** (Section 3.3.2, Table 5 and Figure 3).
