Cross River Rail

Monthly Environmental Report

March 2026

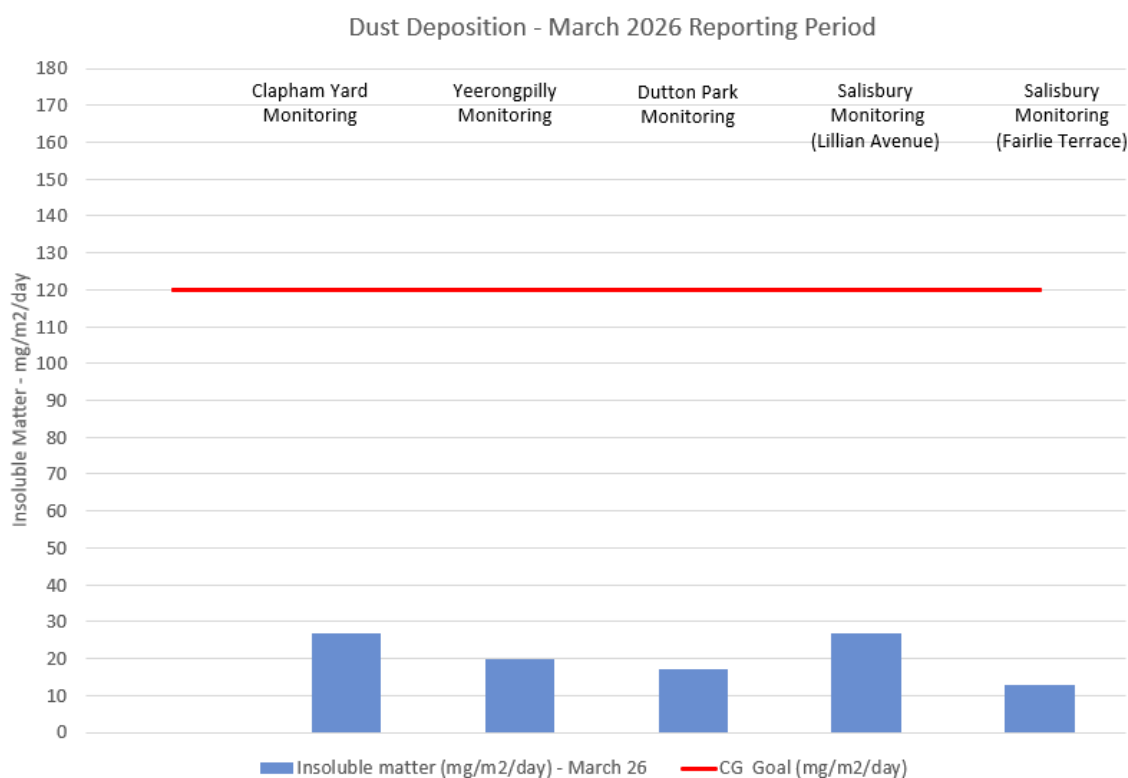
Figure 1: Air Quality Monitoring - Deposited Dust Data

CGCR Goal (mg/m ² /day)	AQ-04 Grafton Street (Mayne Yard) (mg/m ² /day)	AQ-06 Clapham Yard (mg/m ² /day)	AQ-09 Yeerongpilly Station (mg/m ² /day)	AQ-11 Dutton Park (mg/m ² /day)	AQ-12 Salisbury, Lillian Avenue (mg/m ² /day)	AQ-13 Salisbury, Fairlie Terrace (mg/m ² /day)
120	[1]	27	20	17	27	13
Total Rainfall (mm)	72.6	94.1	94.1	121.0	63.4	63.4

[1]: The AQ-04 DDG apparatus was found tampered with and reinstated, as required. Monitoring of potential dust-generating activities for the reporting period was conducted by the mobile air quality unit and during routine environmental inspections. No exceedances and/or dust nuisance complaints were recorded for the reporting period (also refer to further notes within section 2.3.3).

In the Mayne Area, the dust deposition gauge (DDG) was found tampered with and was reinstated as soon as practicable. The air quality unit monitoring particulate matter (PM₁₀) and TSP recorded air quality levels well below the air quality goals and the Contractor received no dust related complaints in the reporting period, confirming the Contractor met the requirements of the Imposed Conditions. For further details see **Appendix A** (Section 2.3.1, Table 3 and Figure 1).

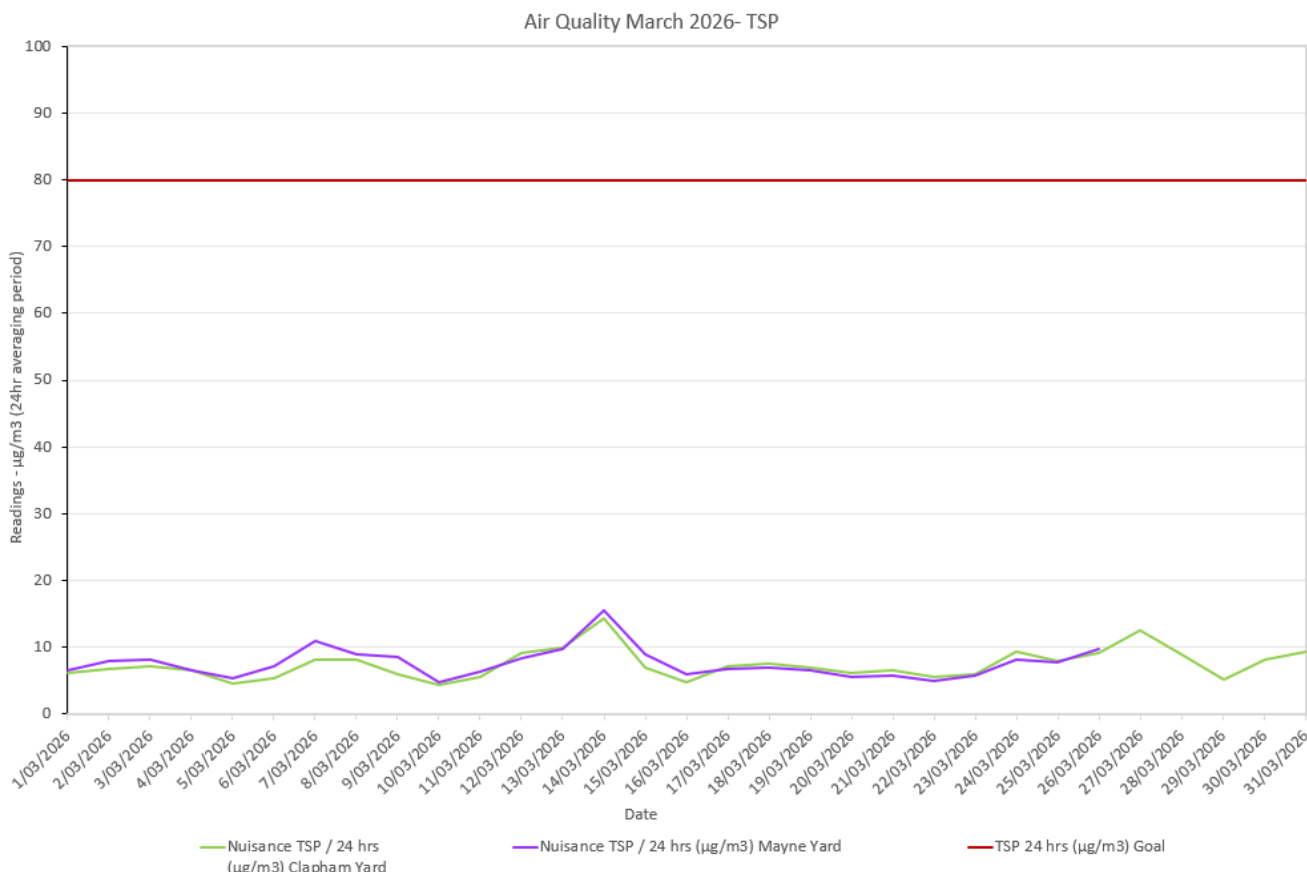
Figure 2: Air Quality Monitoring – Total Suspended Particles Data

TSP and PM10 monitoring were conducted during March 2026. Targeted monitoring of potential dust-generating activities is conducted by the mobile air quality units and was completed at the Mayne Yard and Clapham Yard worksites during March 2026. No exceedances were recorded during this reporting period.

The Mayne Yard mobile air quality unit experienced technical issues during the reporting period. Troubleshooting was conducted as soon as practical and following the manufacturer’s recommendations. The issue could not be resolved remotely and the unit was sent out for further assessment to the authorised supplier. A replacement (rental) unit was installed on site as soon as practical.

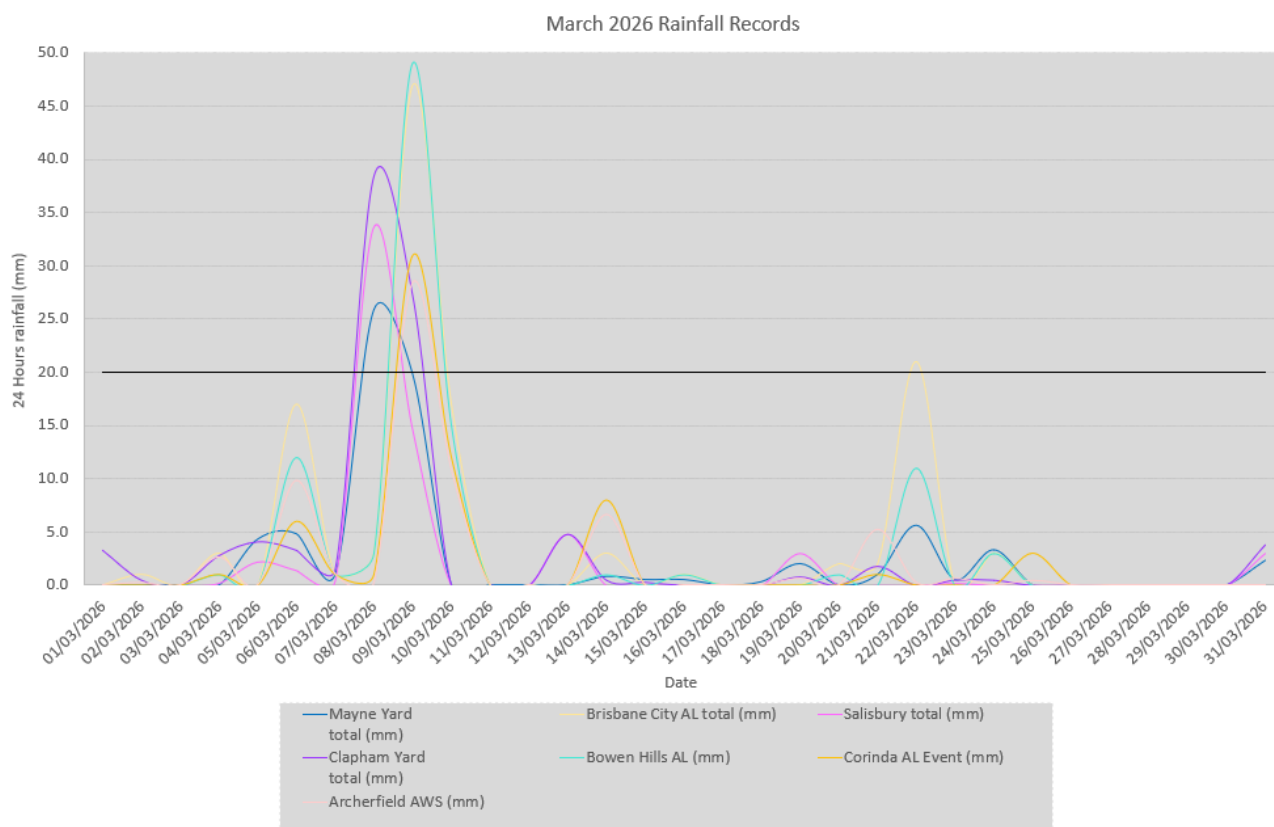
Figure 4: Rainfall Data

Water quality monitoring was conducted on one (1) occasion during the reporting period. Water quality monitoring was conducted in line with post-rainfall requirements. Monitoring confirmed no impacts were generated by the Project.

In the Mayne Area, post-rainfall monitoring was triggered in the receiving waters of Mayne Yard. Results reflect the condition of the broader catchment upstream from the worksites. Refer to **Appendix A** (Section 2.4, Figure 4 and Table 4) for further details.

In the Southern Area, post-rainfall monitoring was triggered in the receiving waters of Clapham Yard and Salisbury. Results reflect the condition of the broader catchment upstream from the worksites. Refer to **Appendix A** (Section 2.4.1 and Figure 4 and Table 4) for further details.

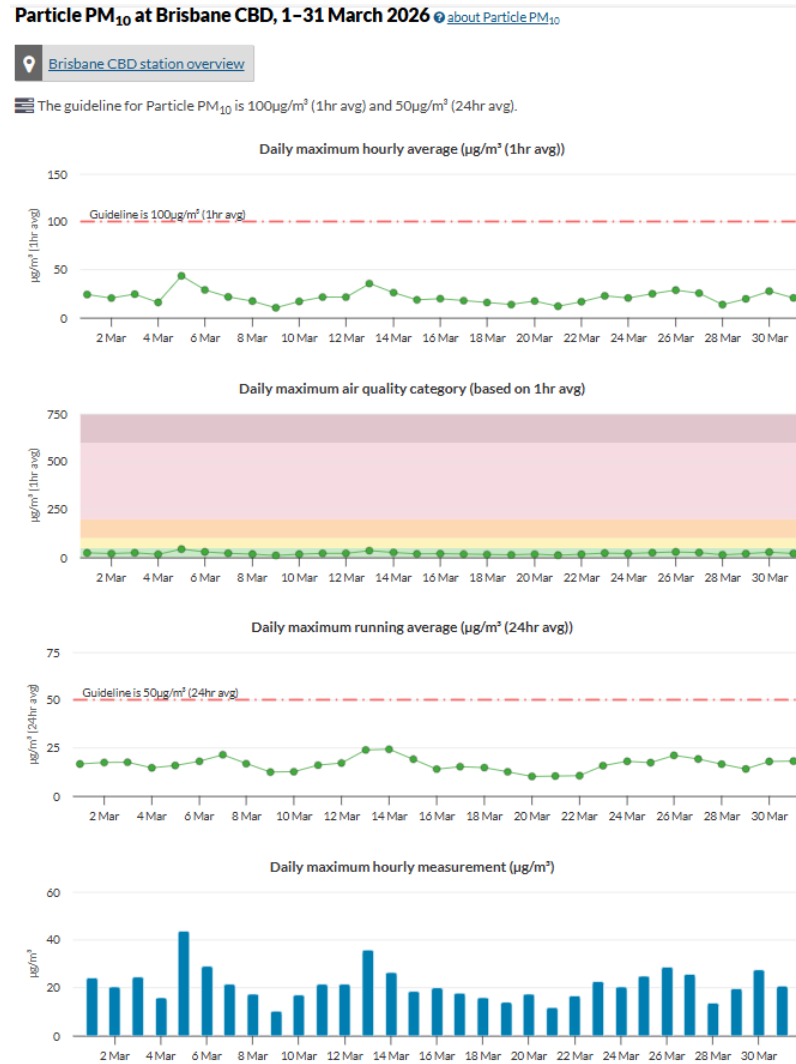
Figure 1: Brisbane CBD – DETSI Station - PM10 graph for March 2026 (reproduction from the DETSI website).

- Brisbane CBD: PM10 daily maximum average: **24.4 µg/m³/24 hr** (<https://apps.des.qld.gov.au/air-quality/chart/?station=cbd¶meter=18&date=1/03/2026&timeframe=month>)
- South Brisbane: PM10 daily maximum average: **26.7 µg/m³/24 hr** (<https://apps.des.qld.gov.au/air-quality/chart/?station=sbr¶meter=18&date=1/03/2026&timeframe=month>)
- Woolloongabba: PM10 daily maximum average: **25.1 µg/m³/24 hr** (<https://apps.des.qld.gov.au/air-quality/chart/?station=woo¶meter=18&date=1/03/2026&timeframe=month>)

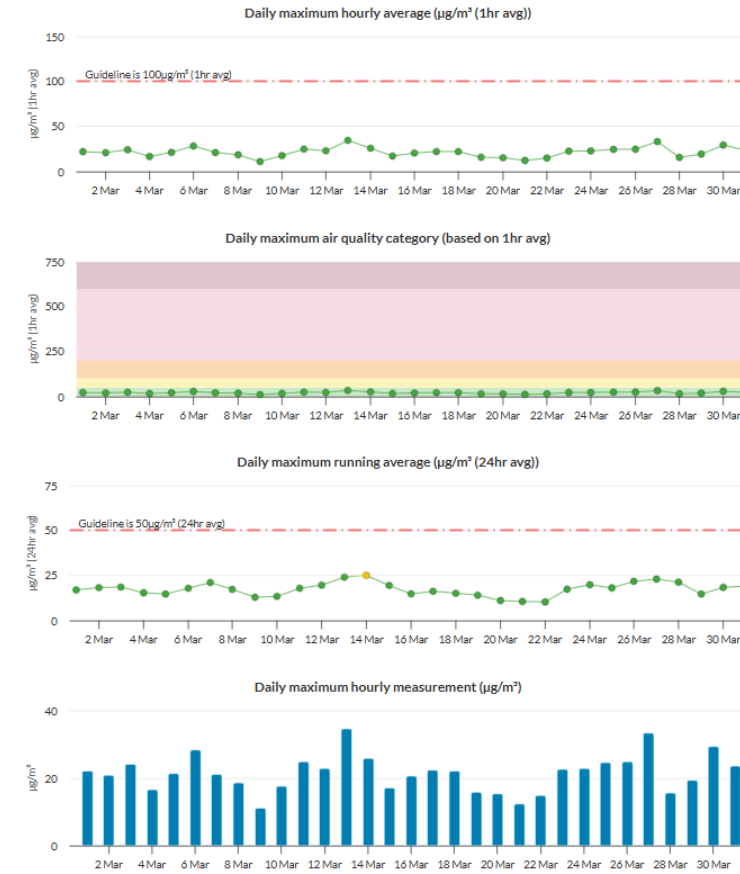
Figure 3: Woolloongabba – DETSI Station - PM10 graph for March 2026 (reproduction from the DETSI website).

The guideline for Particle PM₁₀ is 100µg/m³ (1hr avg) and 50µg/m³ (24hr avg).
